4-5/2012 - Parte II

**The Pianura Padana
Emiliana Earthquake**

58 Damage to religious buildings due to the Pianura Padana Emiliana earthquake

105 Damage mechanisms in some residential building typologies during the Pianura Padana Emiliana Earthquake

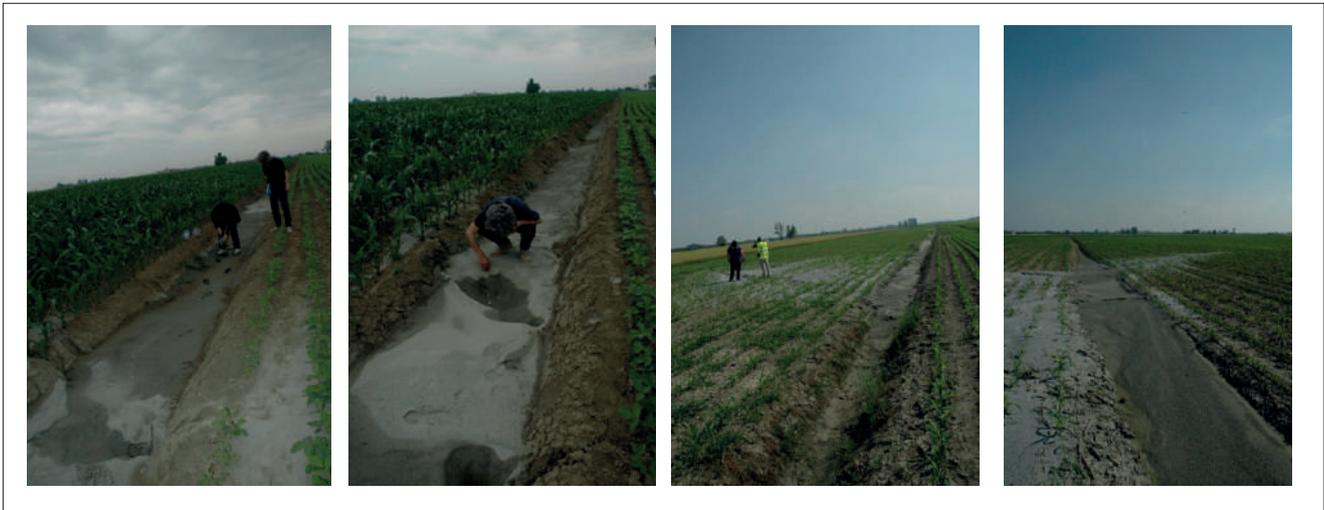
FIGURE 11 Bondeno Municipality: sand spill that affected the irrigation channels in rural areas

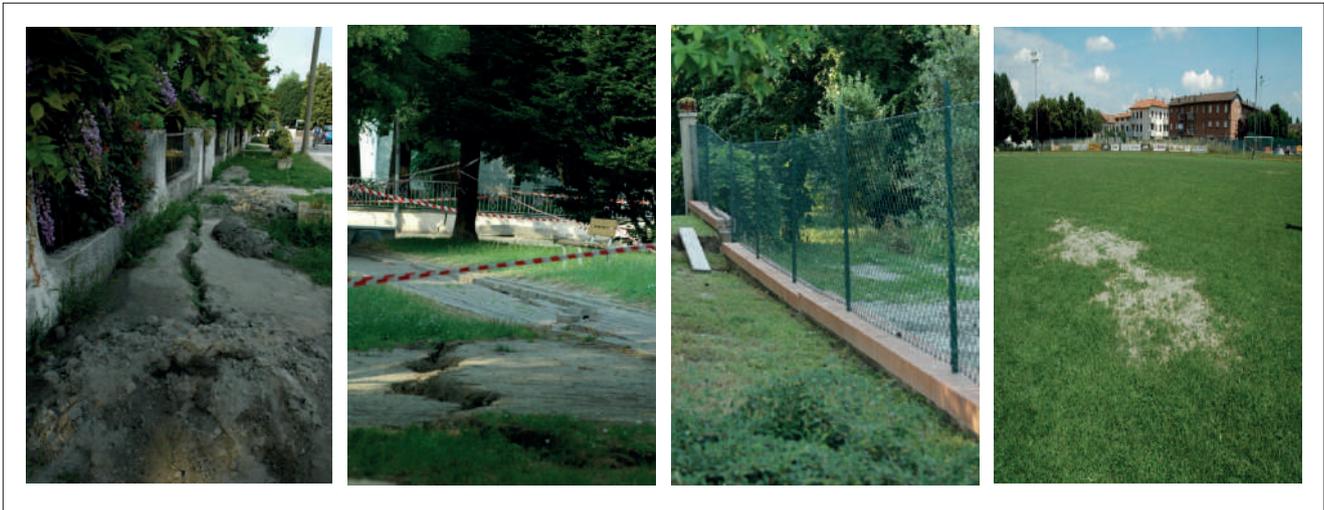
FIGURE 12 Sant'Agostino Municipality: cracks with sand spill that affected the buildings and the road surface, and the sports field of San Felice

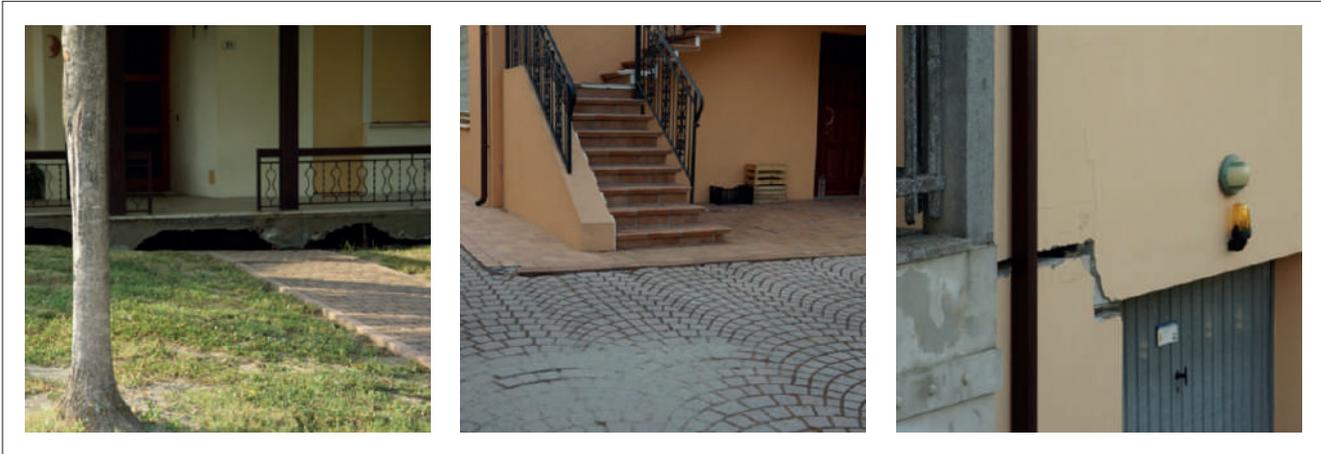
FIGURE 13 San Carlo, Sant'Agostino Municipality: damage in residential buildings

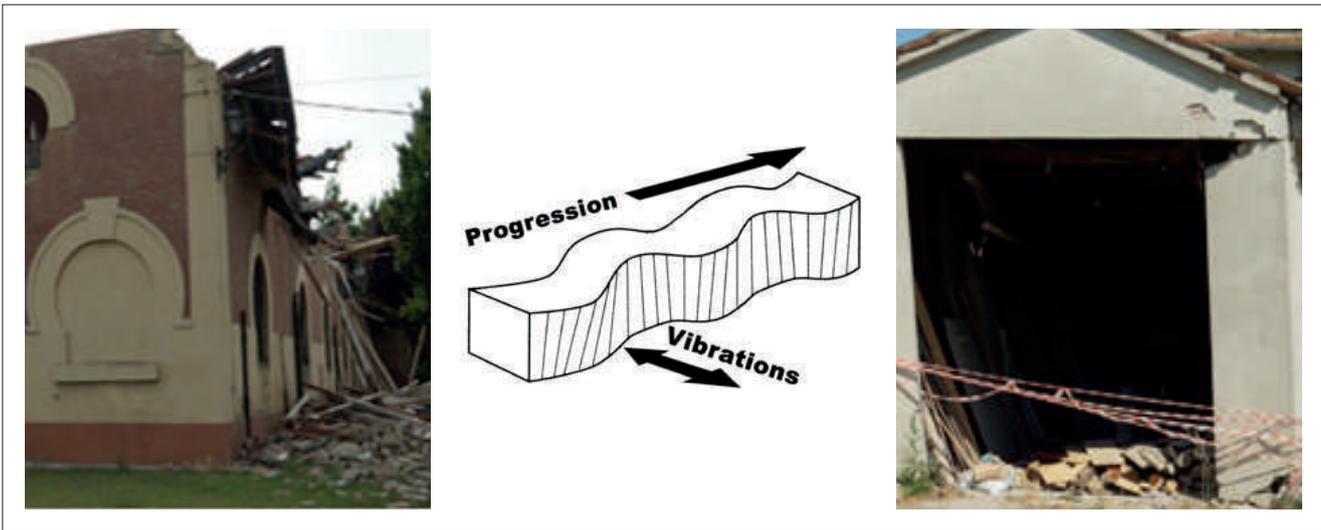
FIGURE 14 Deformation by P waves due to L wave: rural buildings damaged in the Sant'Agostino area

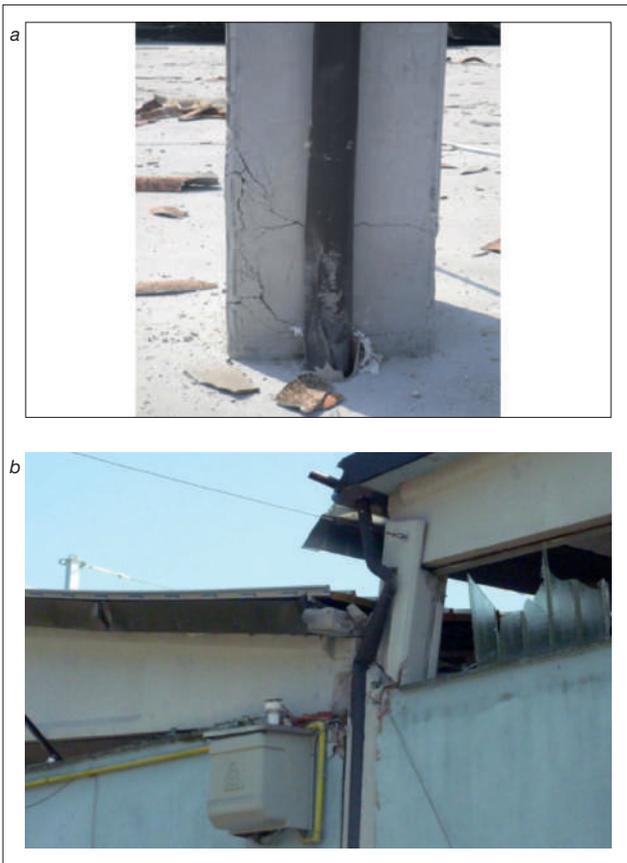
FIGURE 11 Damage to columns
Source: ENEA

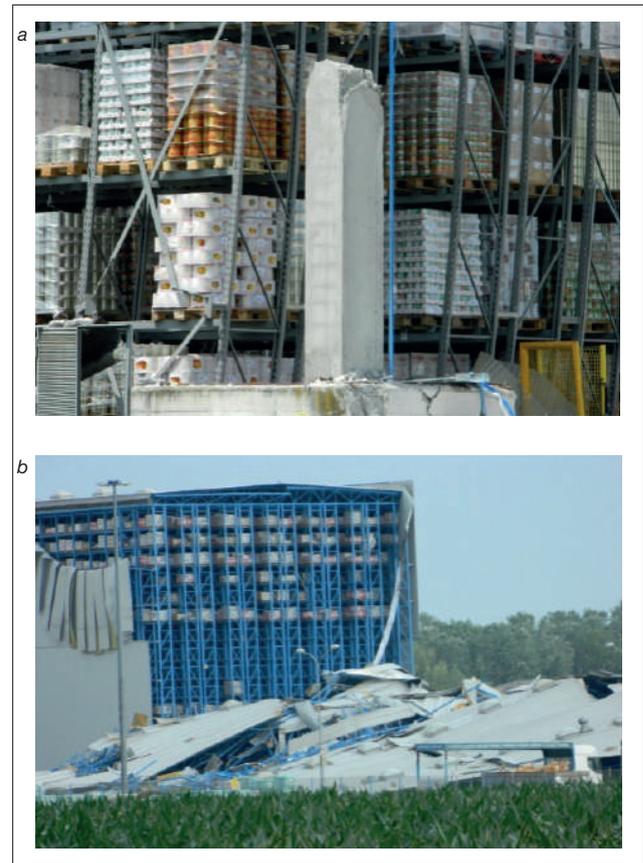
FIGURE 12 Instability of shelves
Source: ENEA

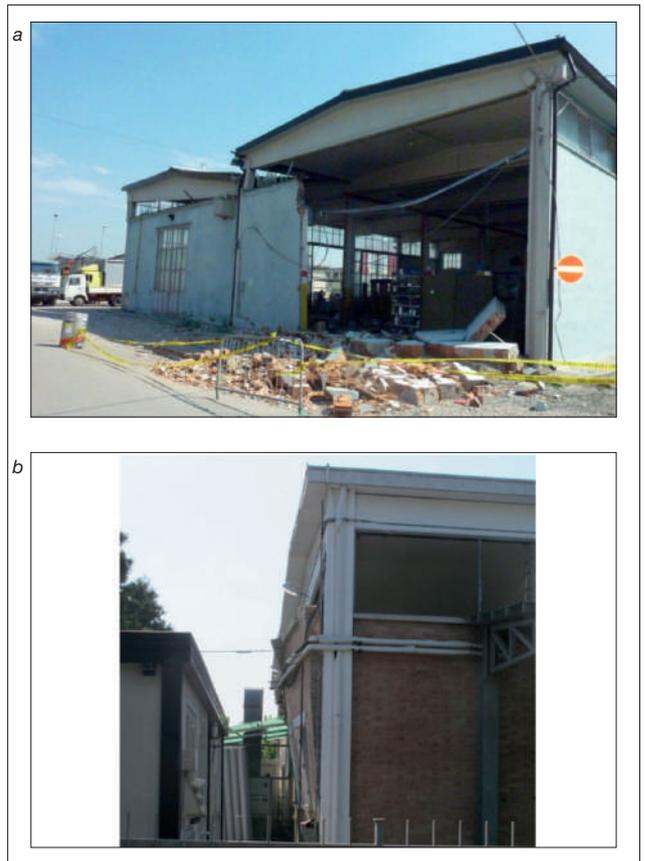
FIGURE 14 Solid brick cladding damage
Source: ENEA

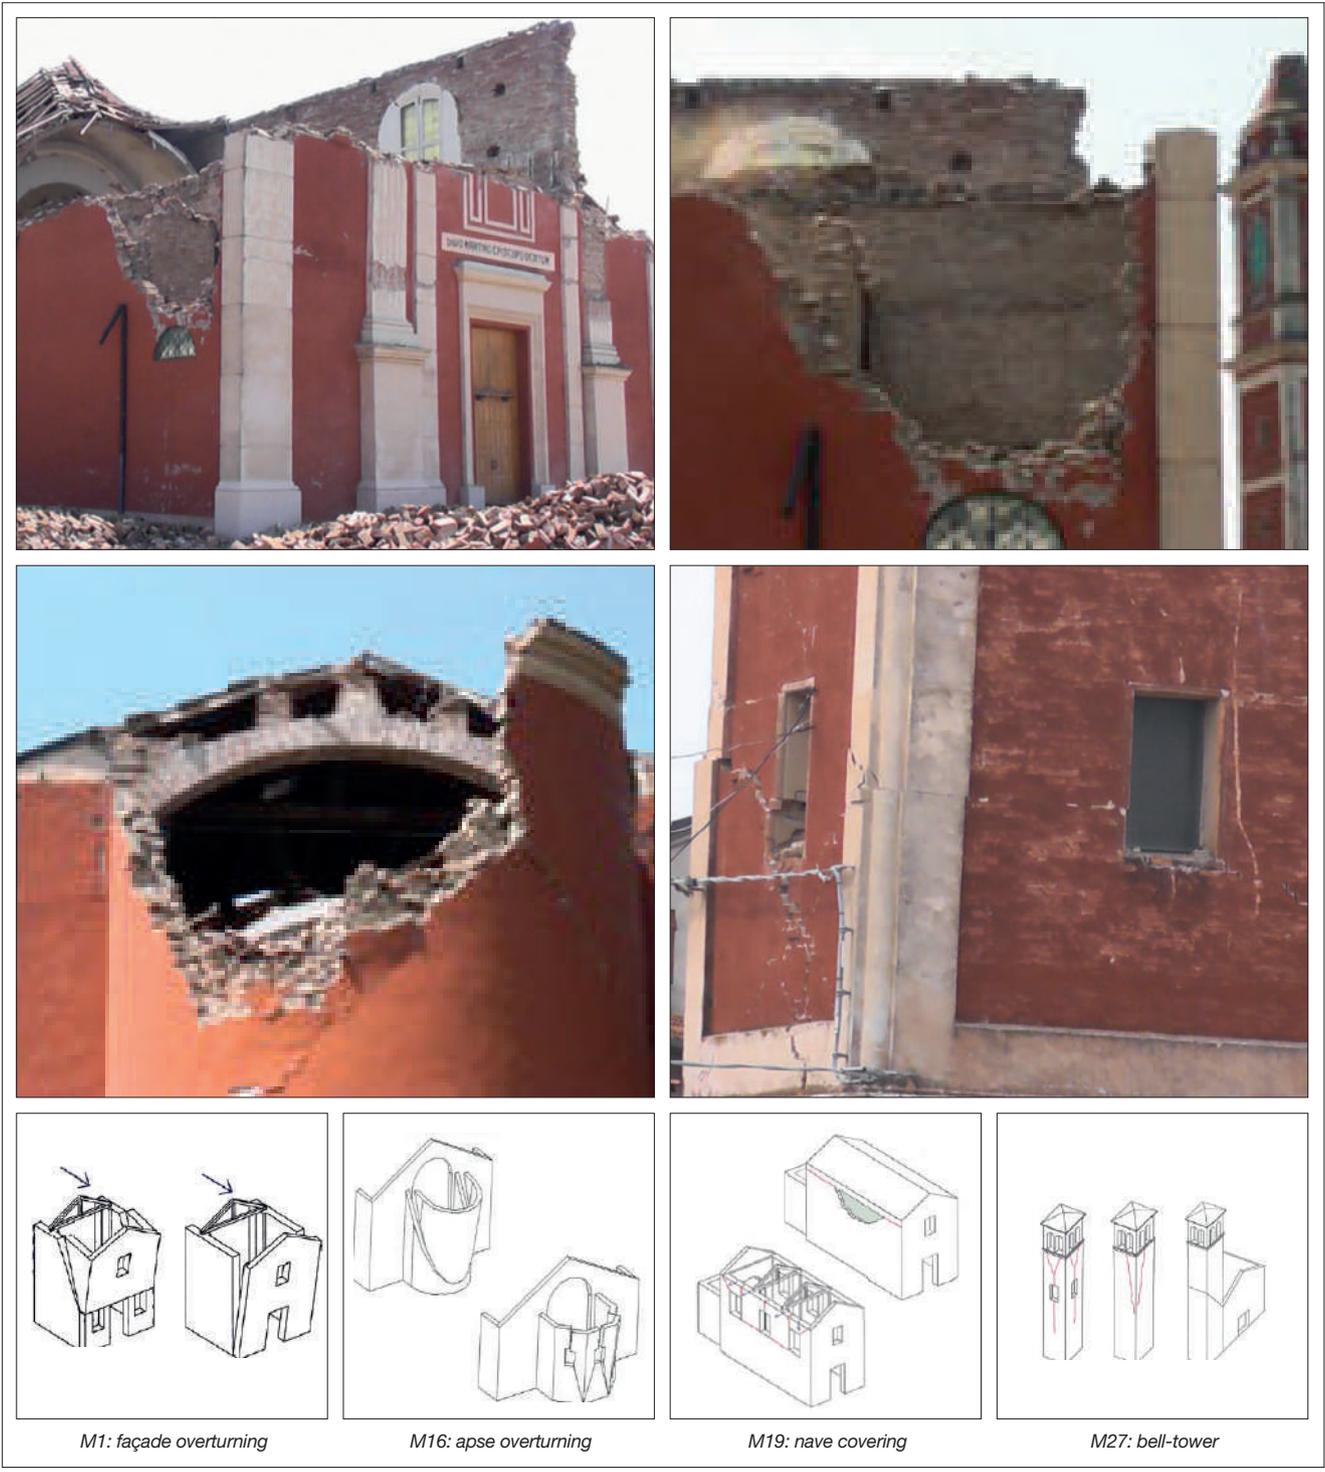
FIGURE 5 Damage in the San Martino di Tours church and bell-tower in Buonacompra (Cento, Ferrara) and main collapse mechanisms

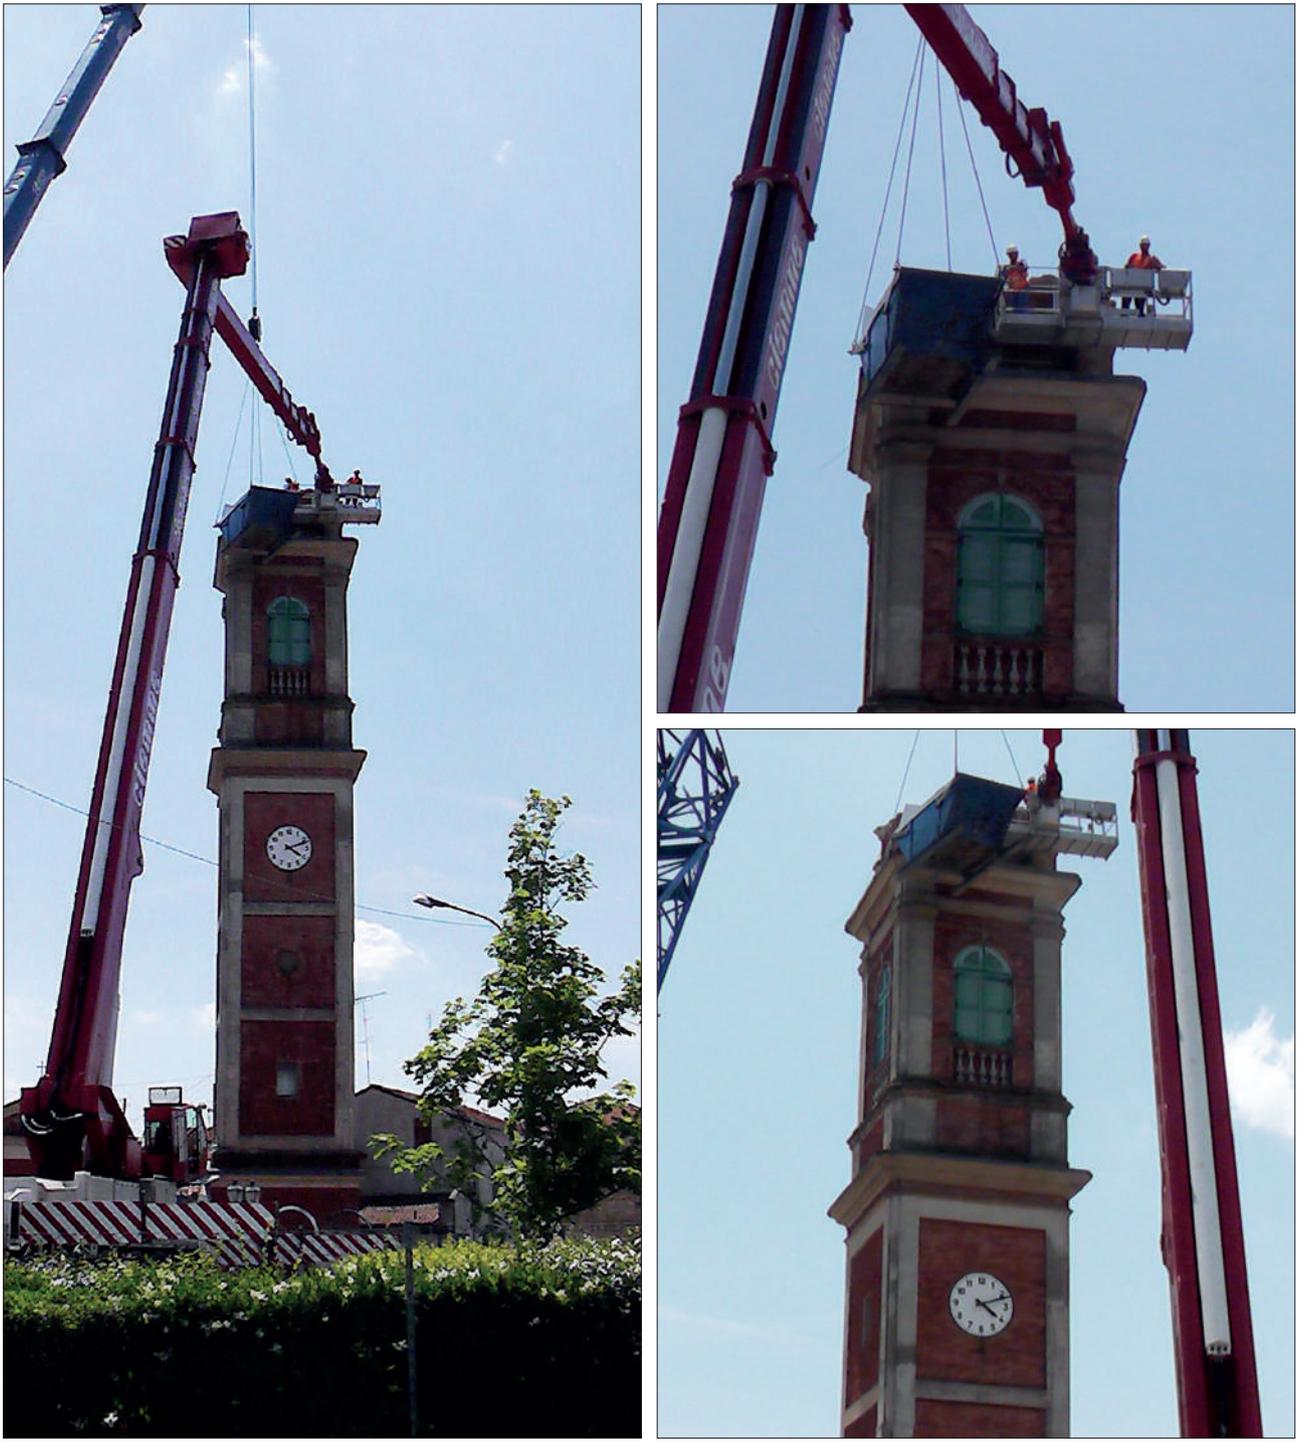
FIGURE 6 Controlled demolition in the San Martino di Tours church bell-tower in Buonacompra (Cento, Ferrara)

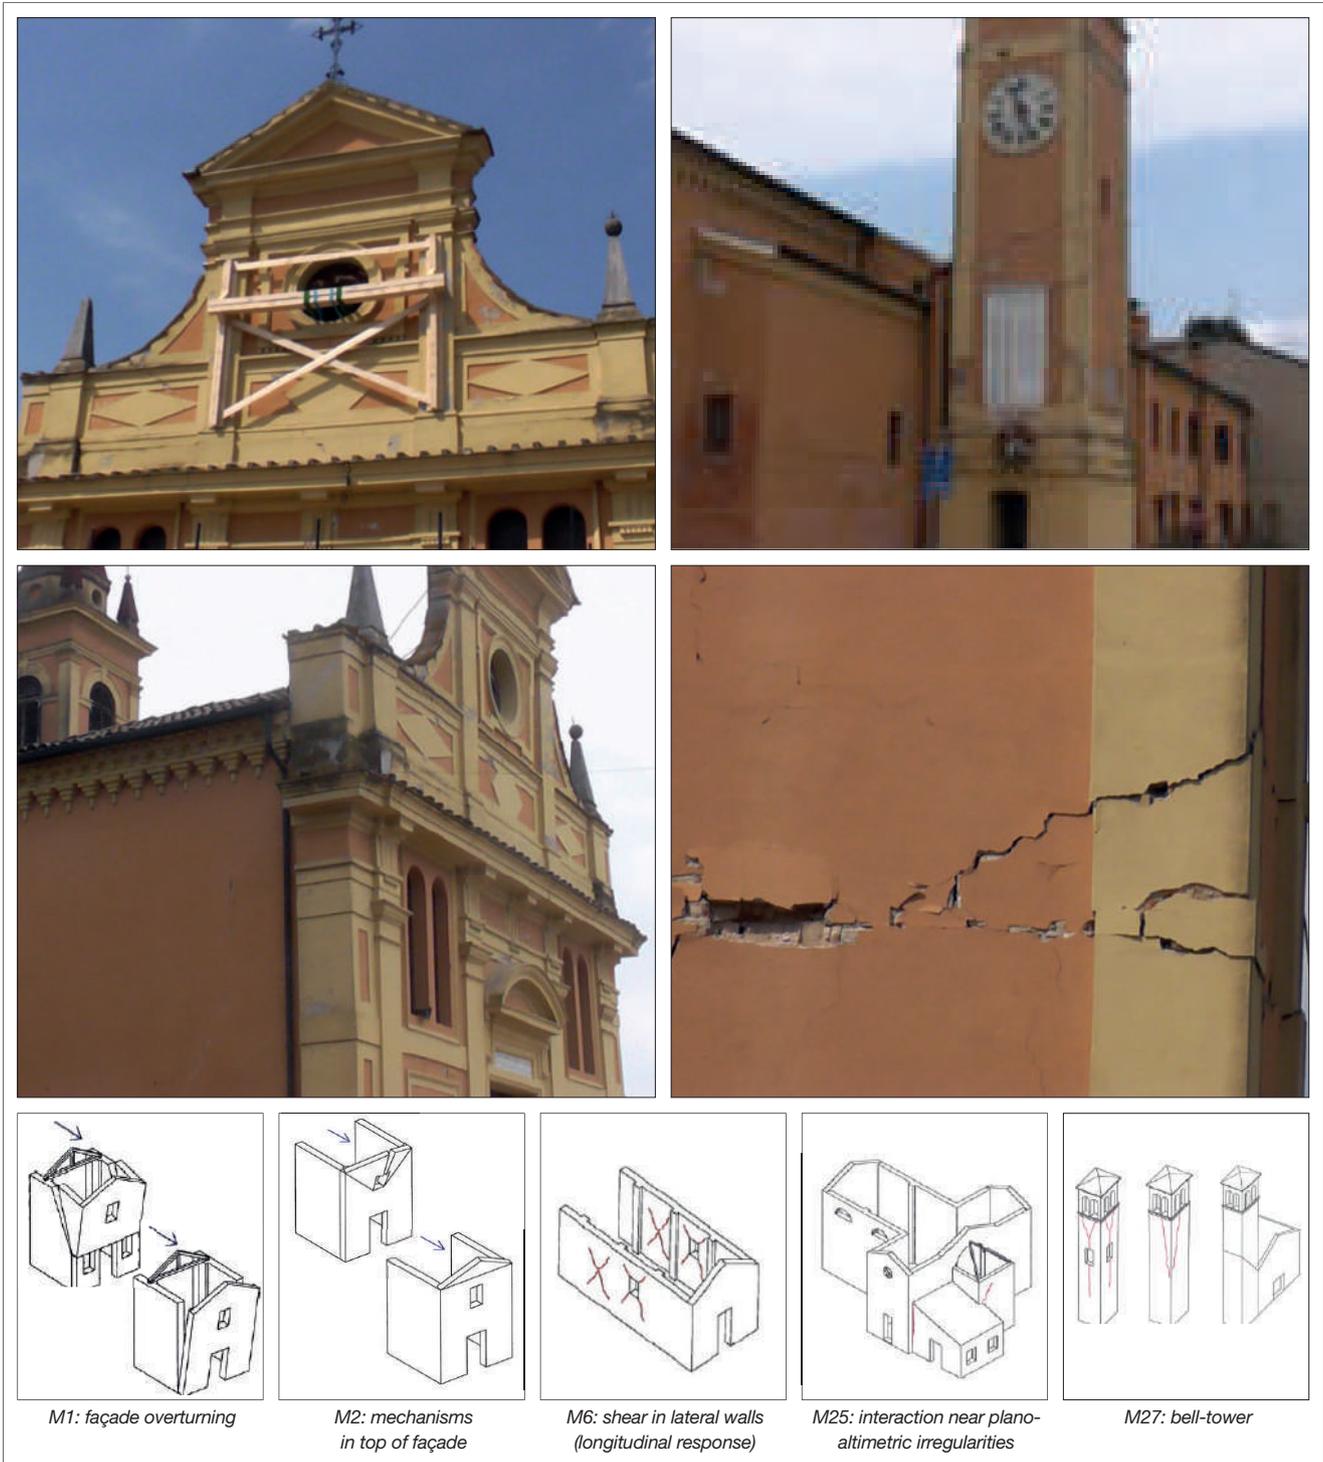
FIGURE 7 Damage to the San Lorenzo church in Casumaro (Cento, Ferrara) and main collapse mechanisms

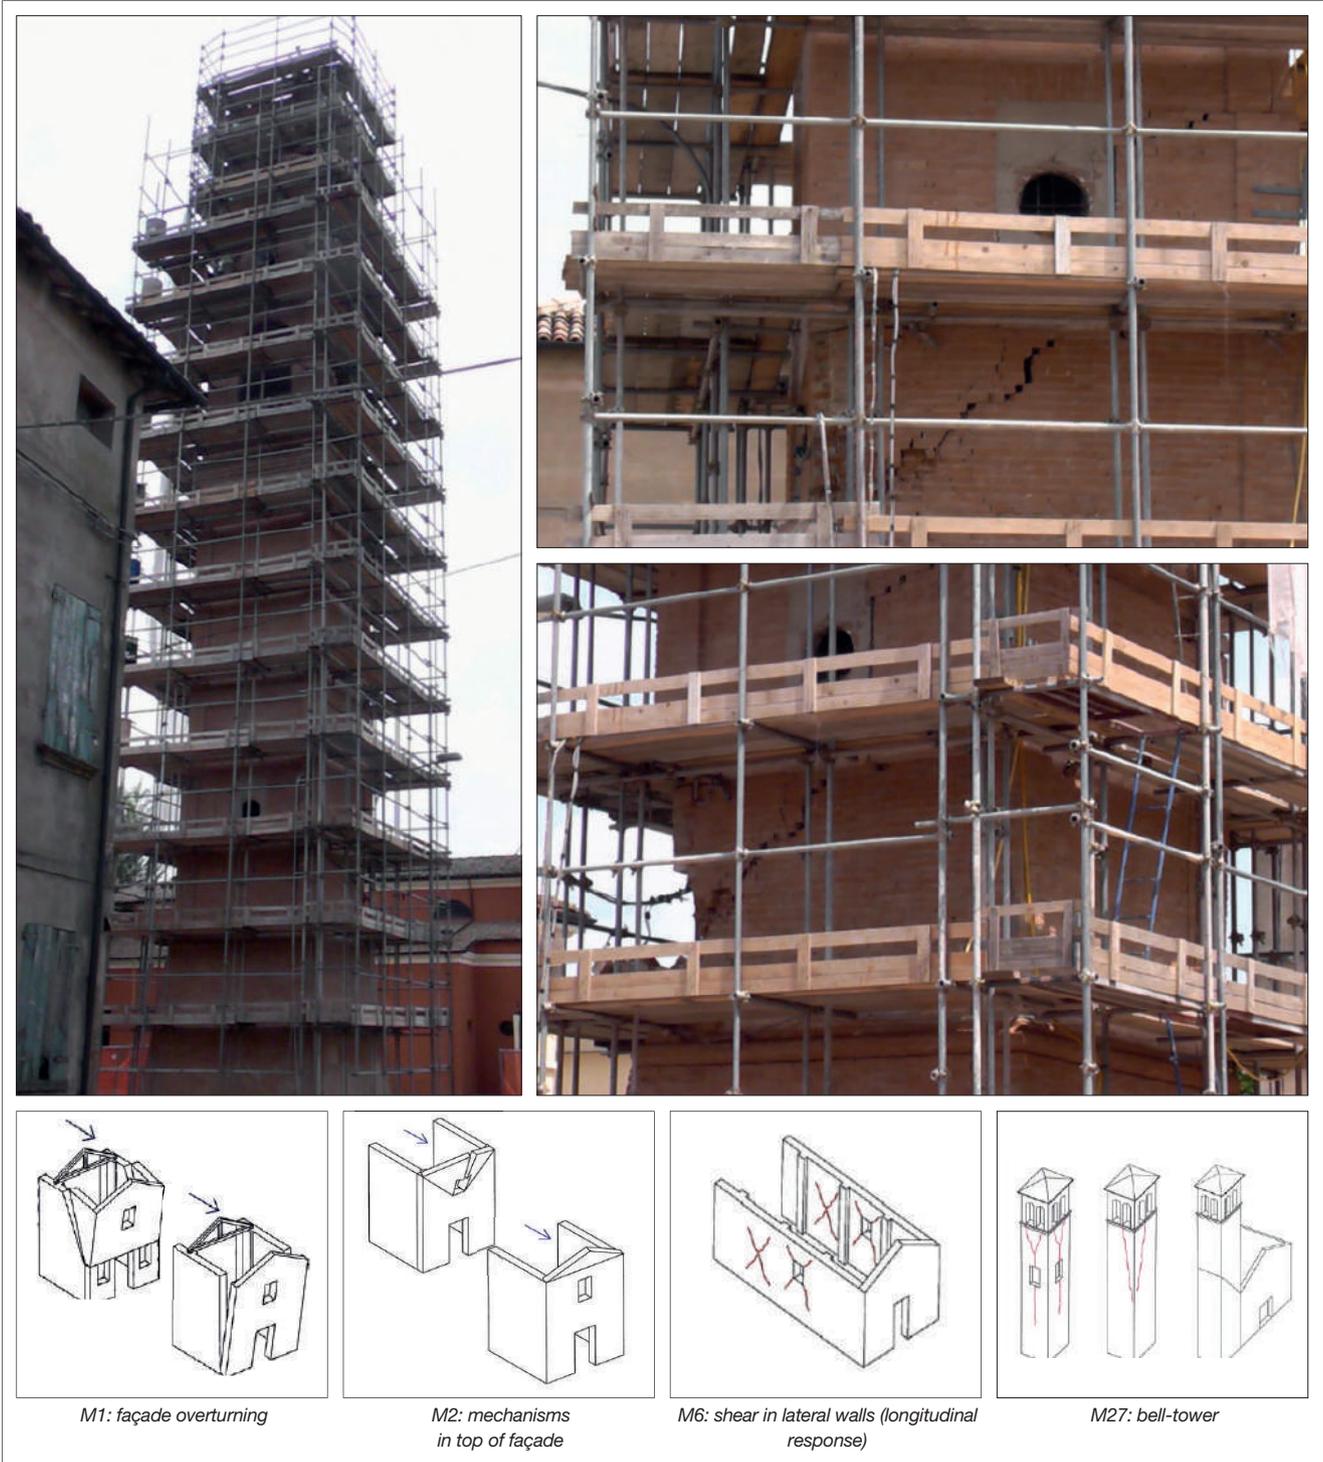
FIGURE 8 Damage to the Sant'Anna church in Reno Centese (Cento, Ferrara) and main collapse mechanisms

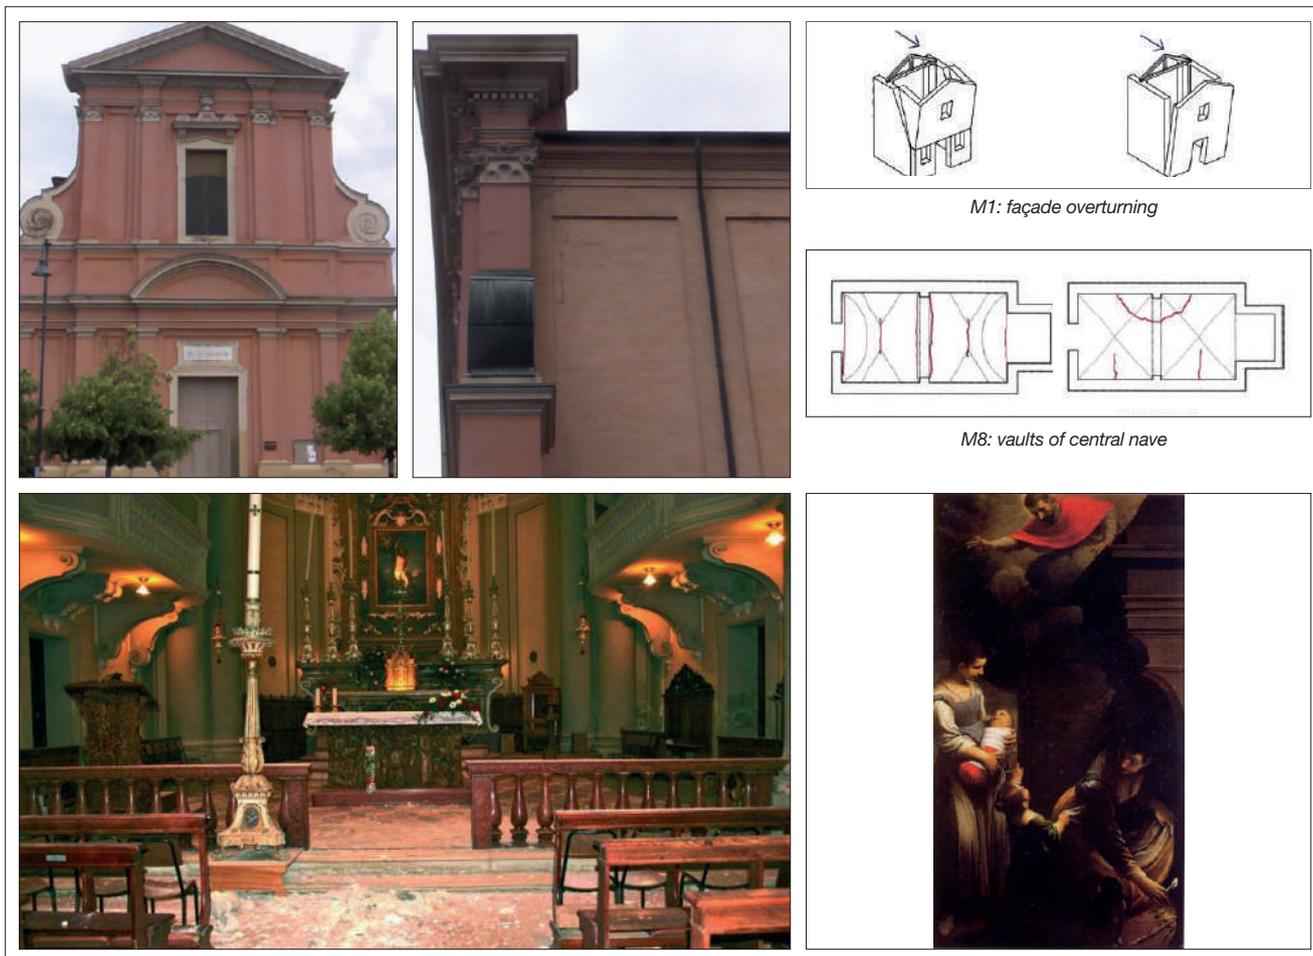
Also the church of San Sebastiano (XV century, modified in the XVIII) in Renazzo (Cento, Ferrara, PGAs as before) was damaged (Fig. 9). Several works of art were removed by the firemen, including a famous painting of Guercino (the miracle of San Carlo Borromeo), put in a temporary safe place.

FIGURE 9 Damage to the Church of San Sebastiano in Renazzo (Cento, Ferrara) and main collapse mechanisms

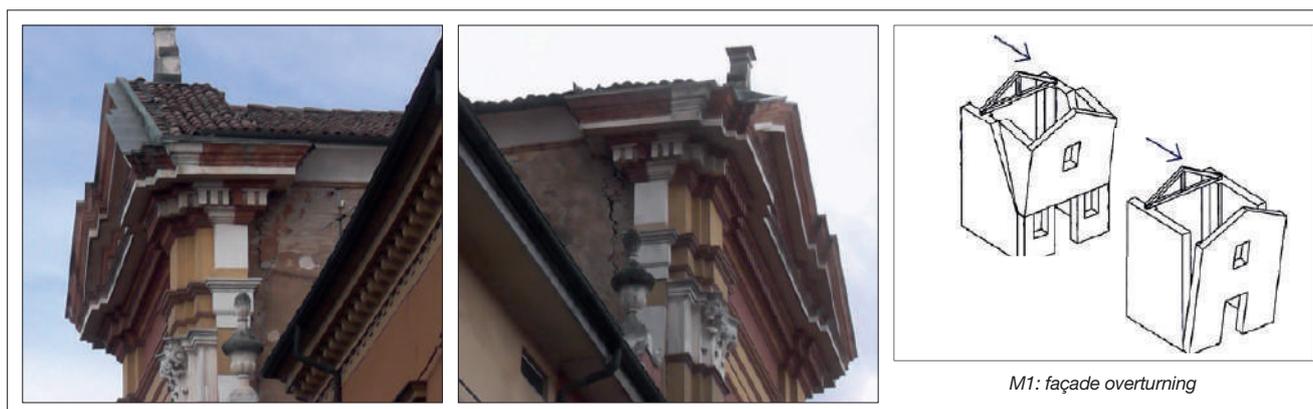
FIGURE 10 Cento (Ferrara) historic centre: the church of San Filippo Neri and main collapse mechanisms

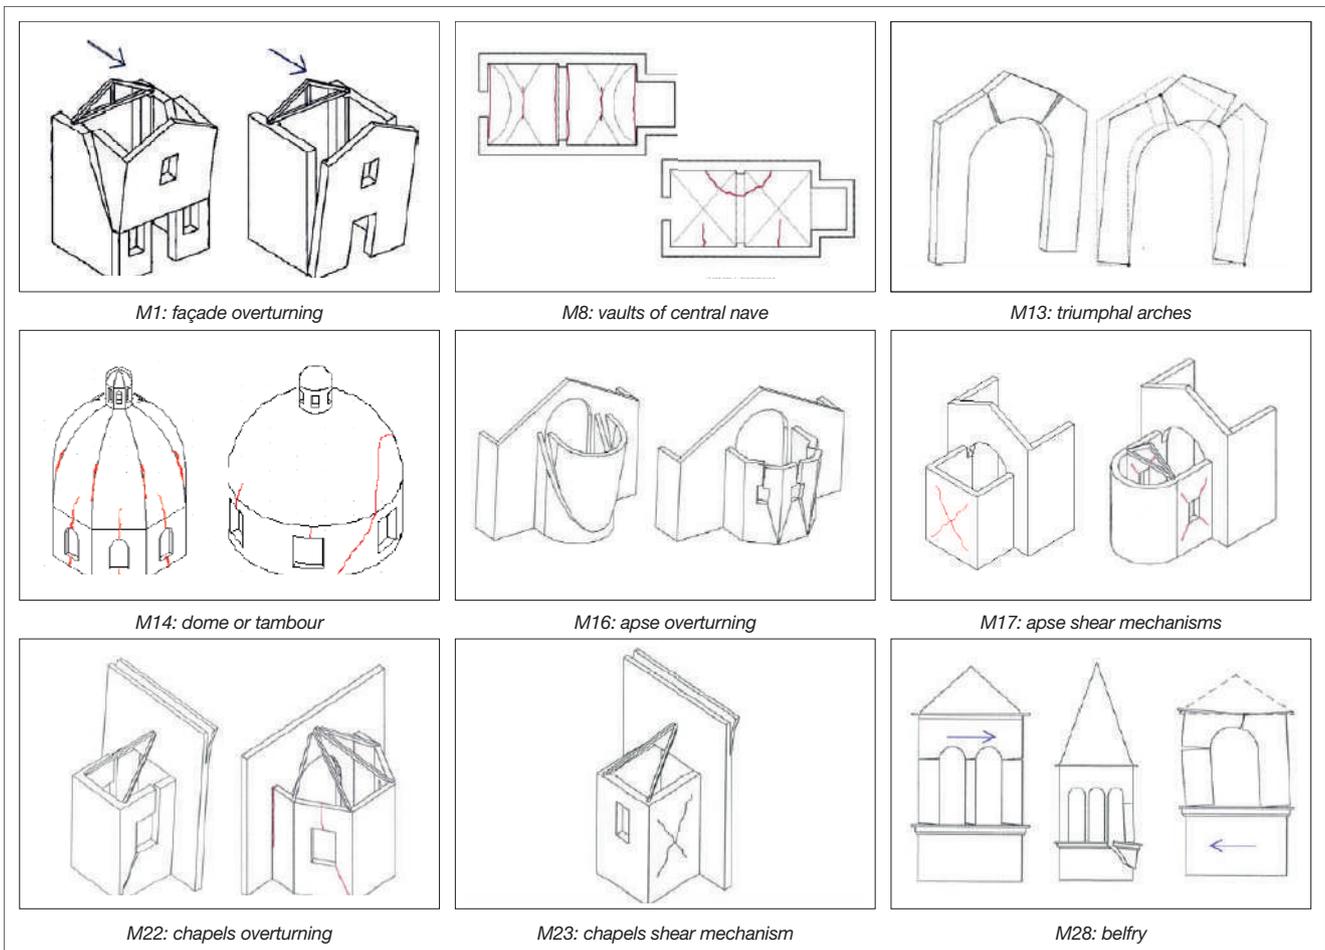
FIGURE 18 Damage mechanisms observed in the Monumental Temple of Fallen (Modena)

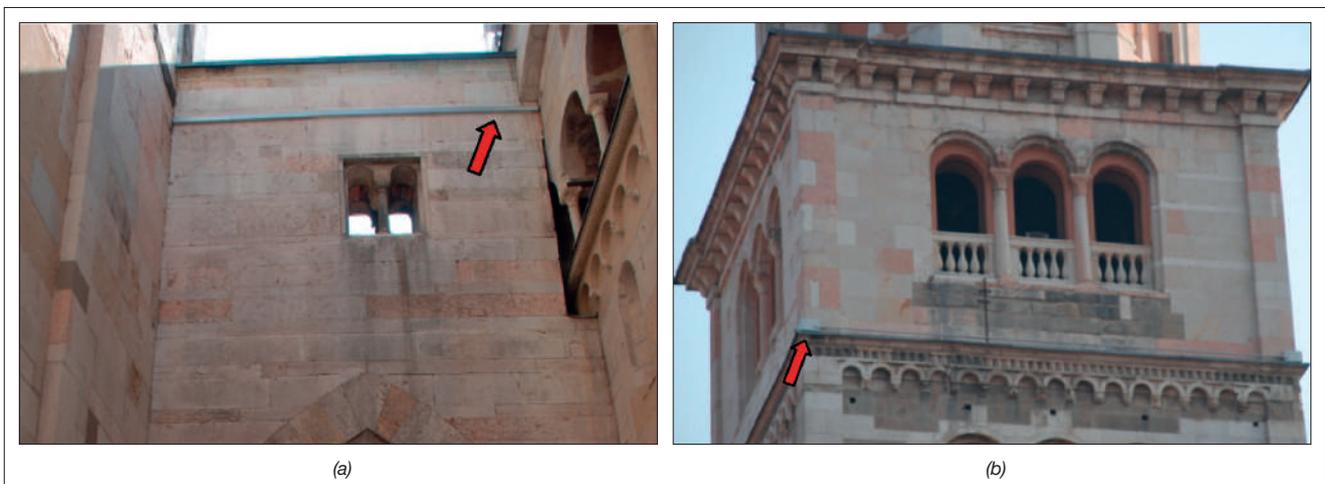
FIGURE 22 Monitoring and seismic devices: relative displacement measure device between Cathedral and Tower (left); b) steel tie all around the last square level of the Tower (right)

The following several interventions were suggested after the investigation: structural re-establishment of damaged vaults, arches, ribs and unconnected wall portions. The implementation of the monitoring system – for a deep and permanent dynamic characterization of the whole complex, evaluating in particular church/tower interactions – is considered necessary and propaedeutic to complete the existing strengthening systems, in both the Cathedral and the Ghirlandina.

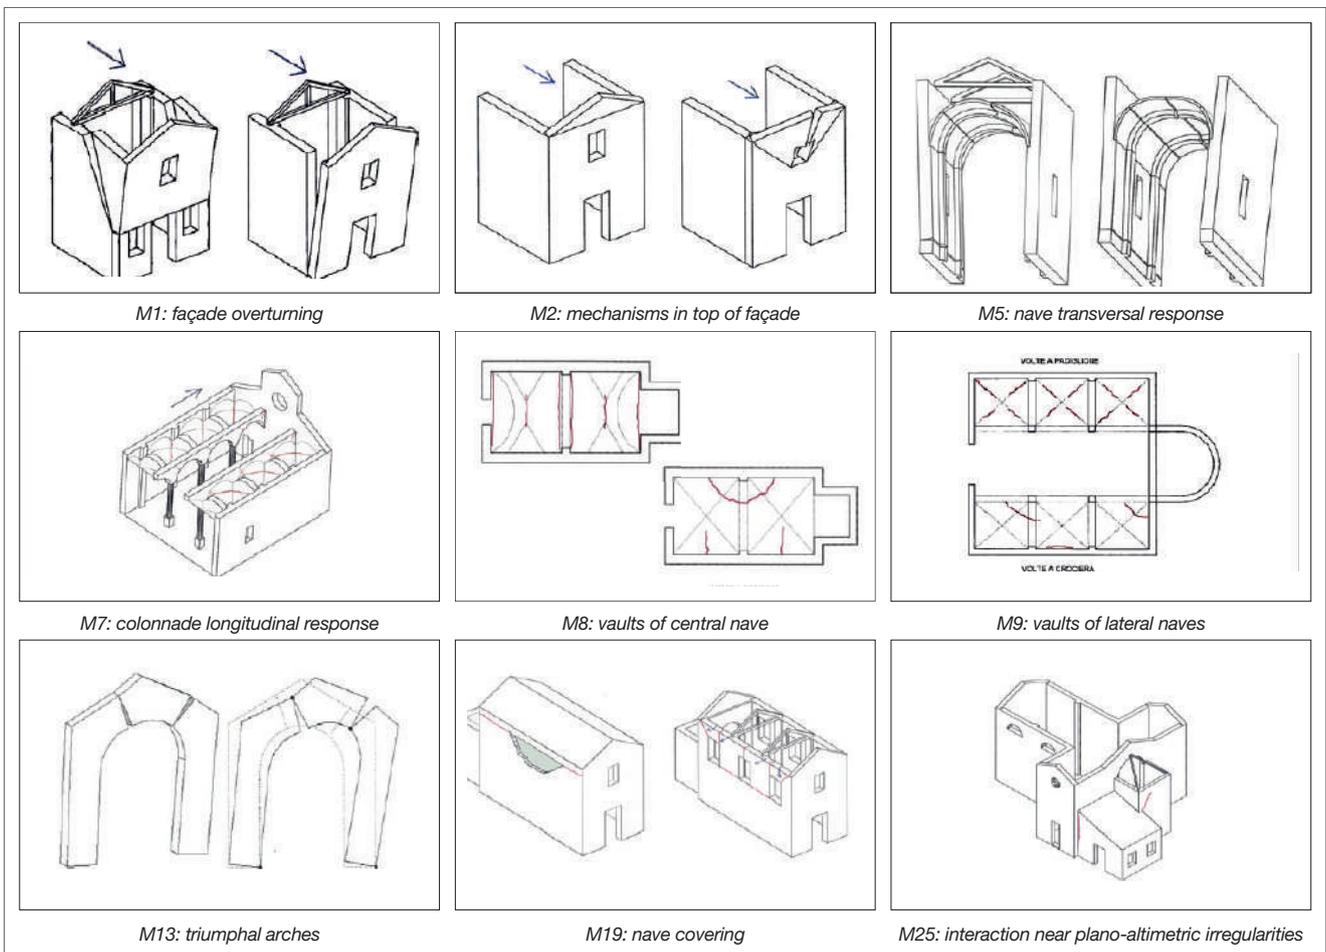
FIGURE 26 Damage mechanisms in the Cathedral of San Geminiano (Modena)

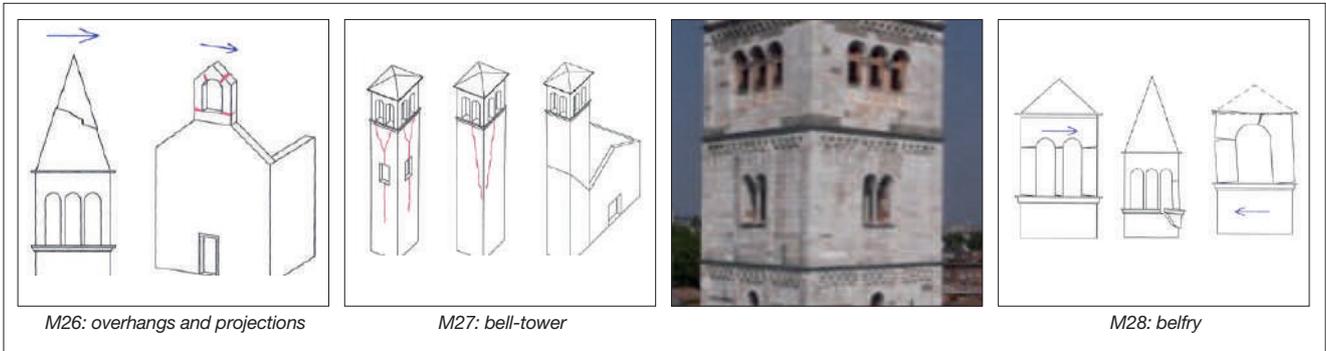
FIGURE 27 Damage mechanisms in the Ghirlandina Tower (Modena)

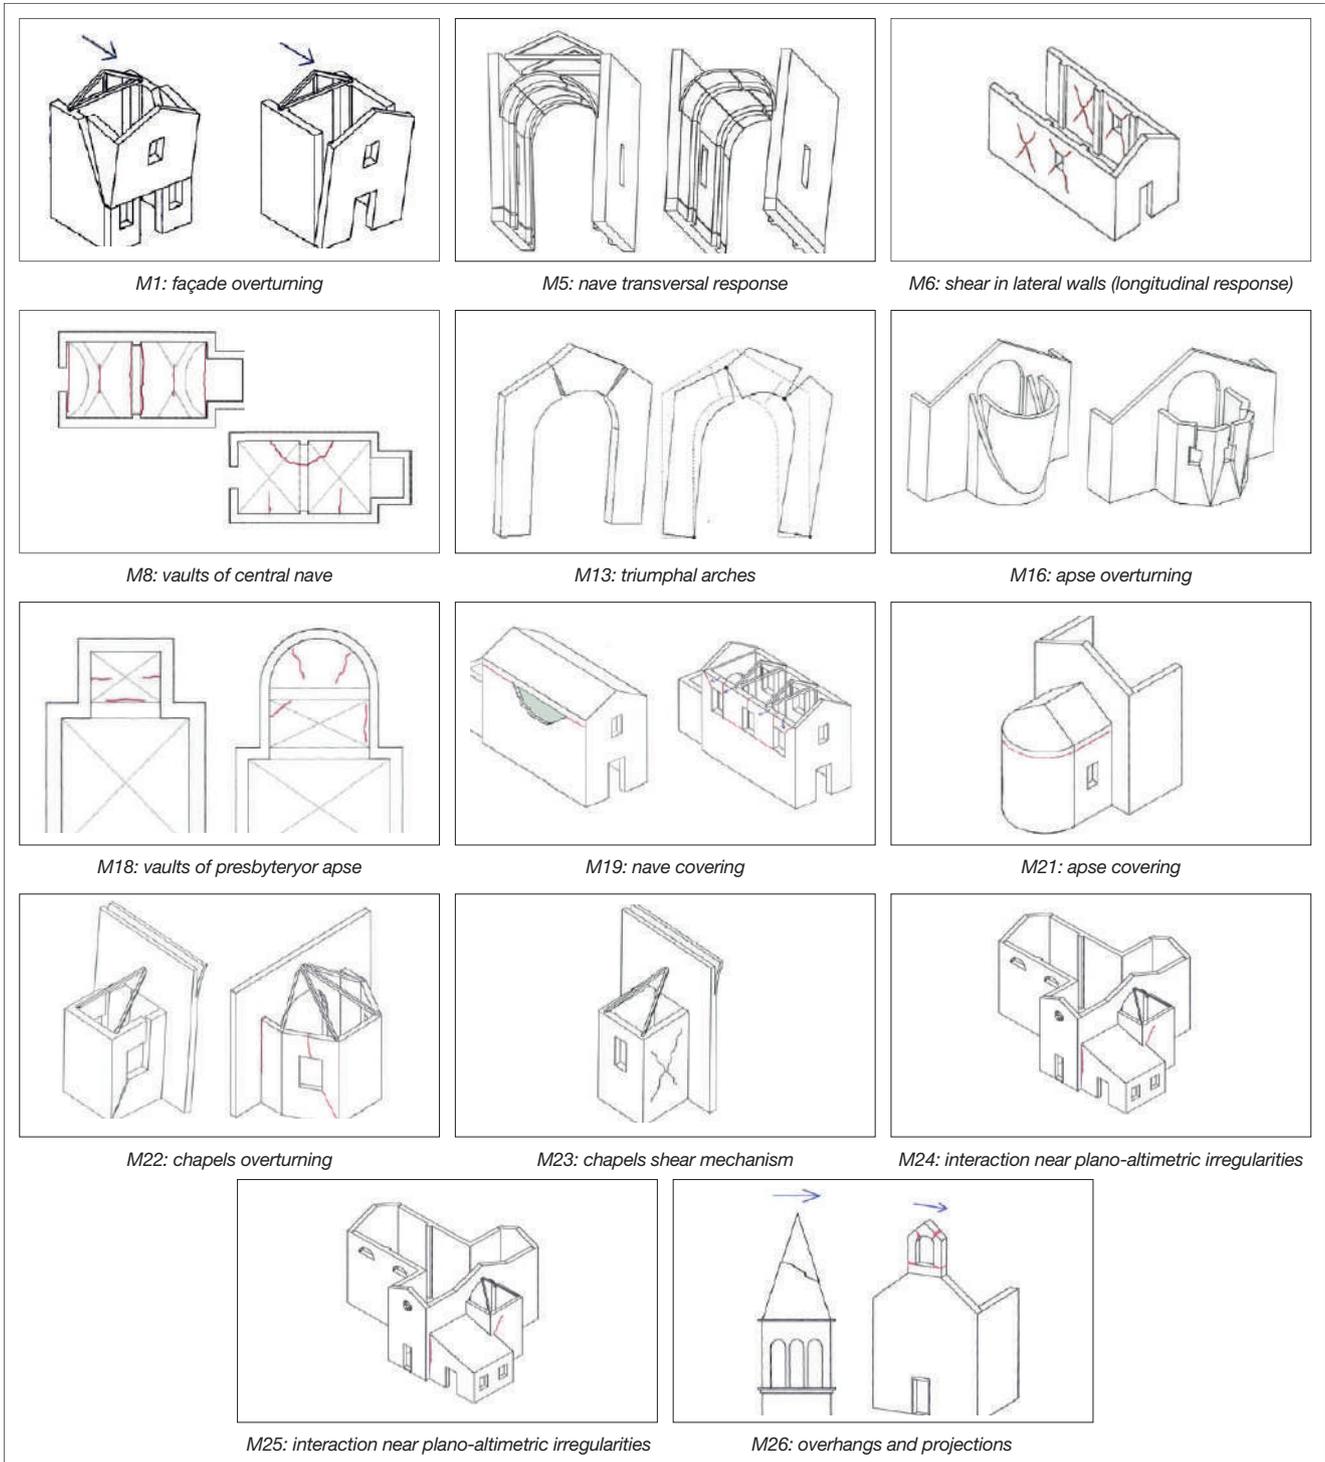
FIGURE 30 Damage mechanisms in the Parish of San Giovanni Battista in Triario (Minerbio, Bologna)

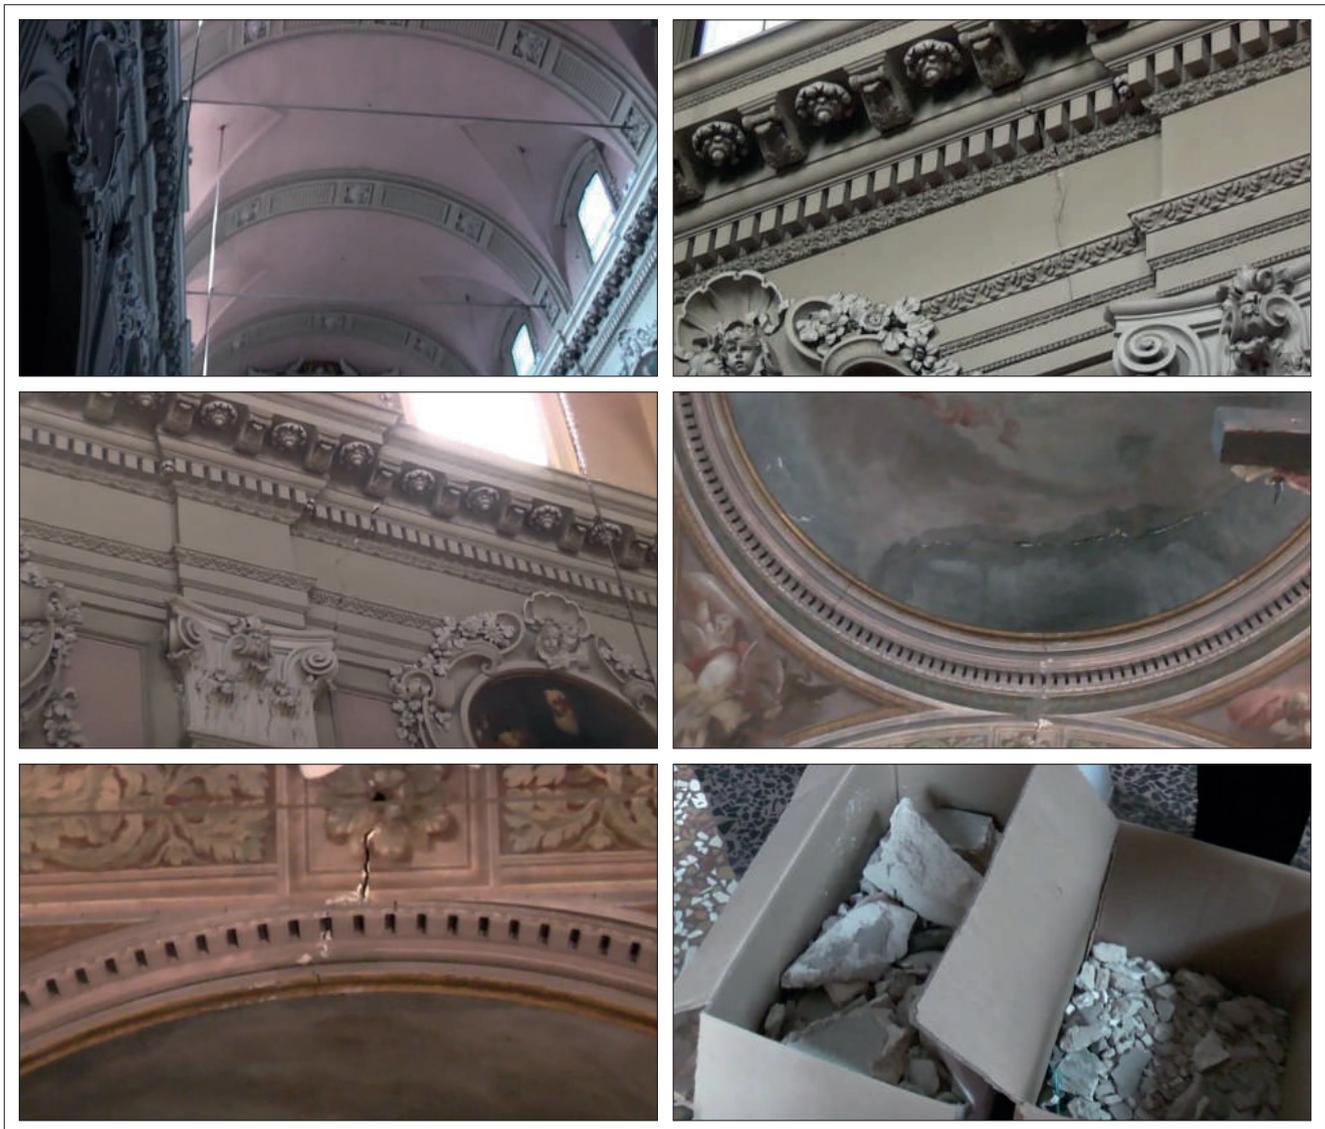
FIGURE 32 Damage to the Church of San Lorenzo (Budrio, Bologna)

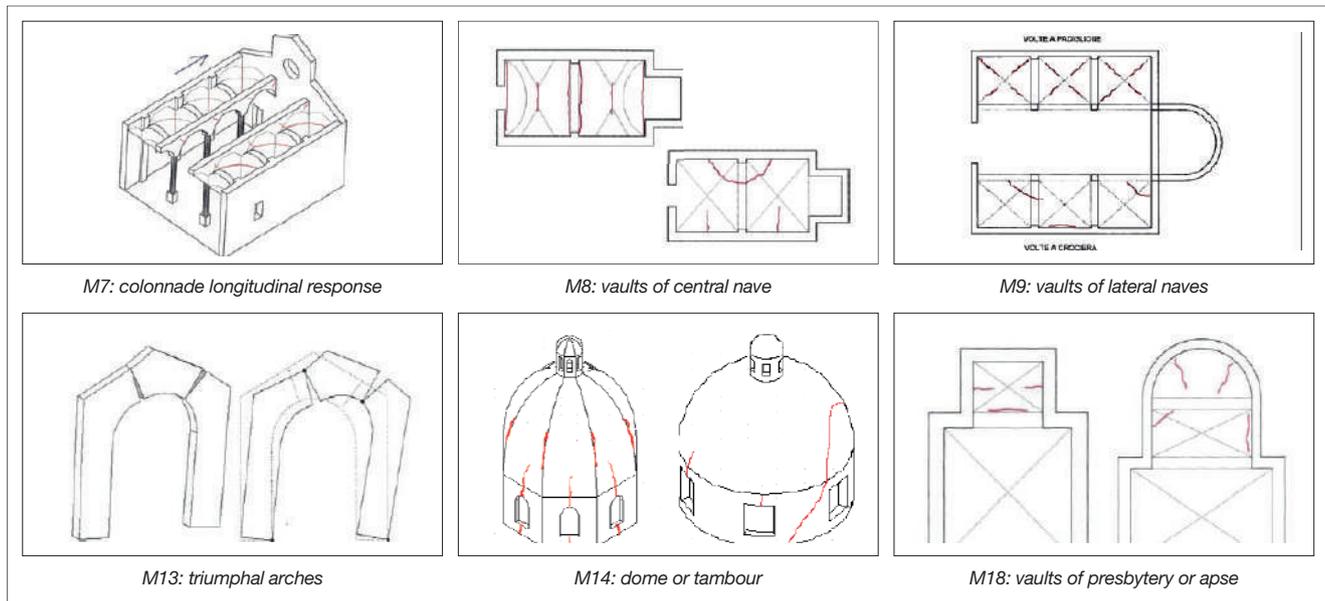
FIGURE 33 Damage mechanisms in the Church of San Lorenzo (Budrio, Bologna)

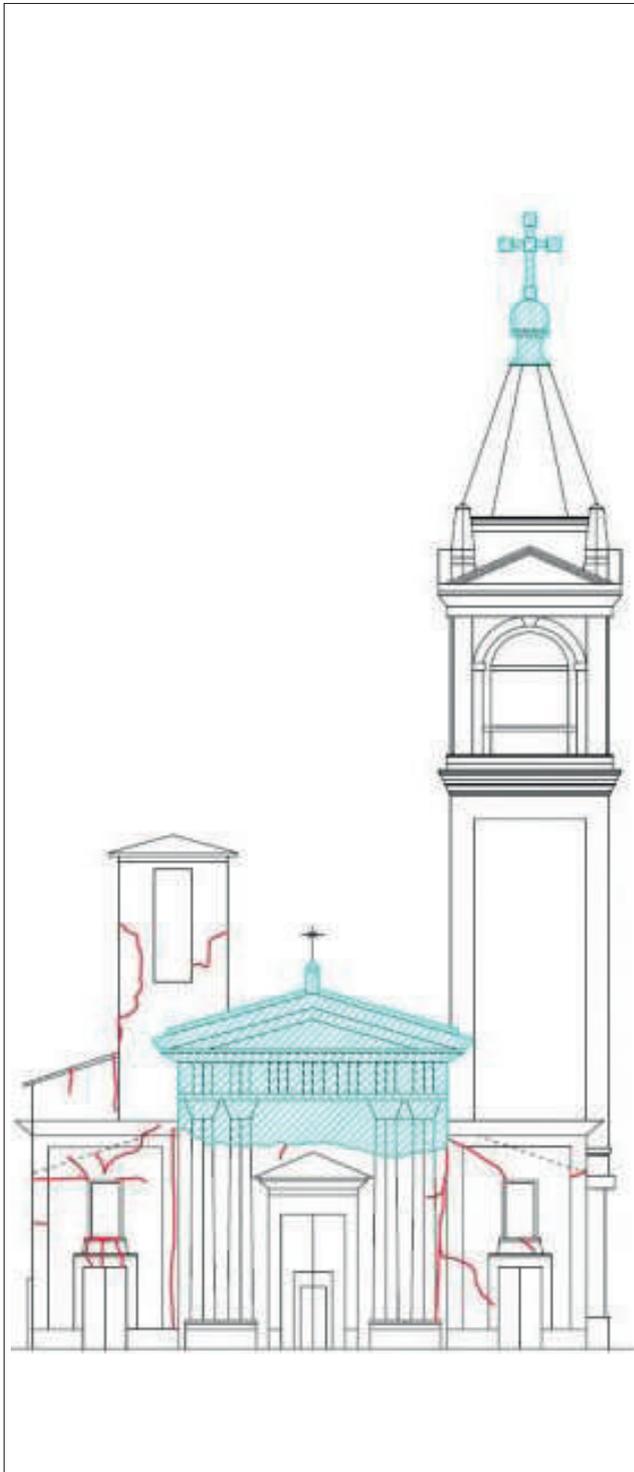
FIGURE 6 Cracks on the main façade
