4-5/2012 - Parte II

**The Pianura Padana
Emiliana Earthquake**

58 Damage to religious buildings due to the Pianura Padana Emiliana earthquake

105 Damage mechanisms in some residential building typologies during the Pianura Padana Emiliana Earthquake

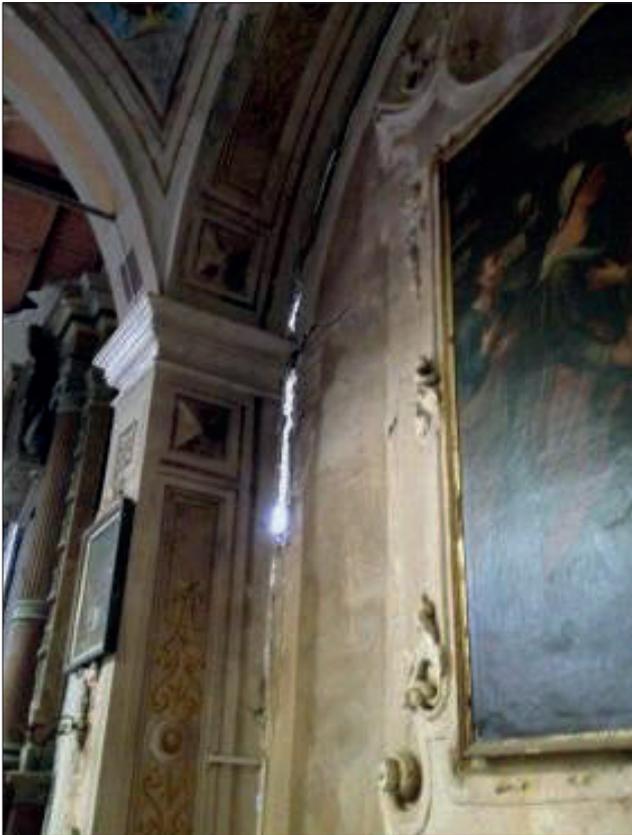
FIGURE 13 Overturning mechanism of the walls on the left nave

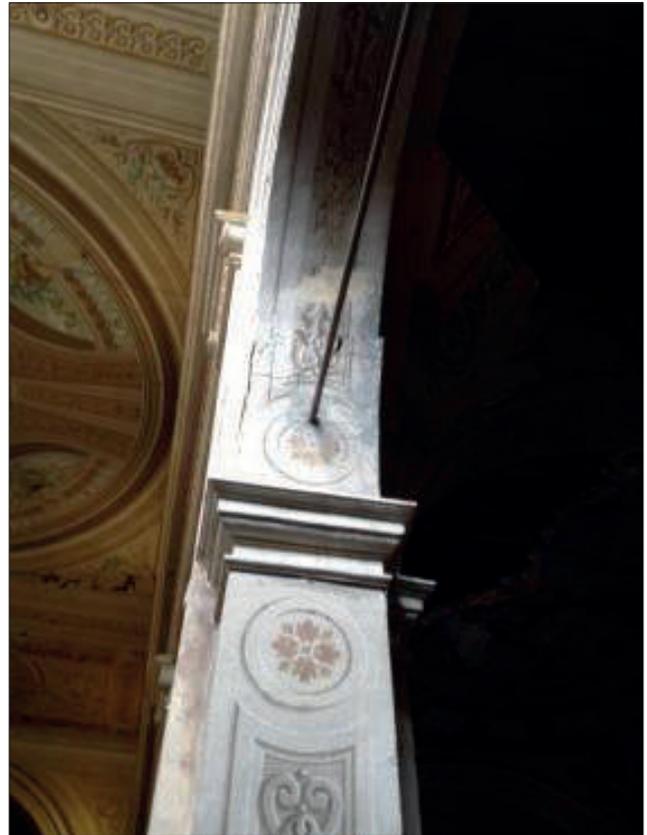
FIGURE 14 Crack and translation on the arch

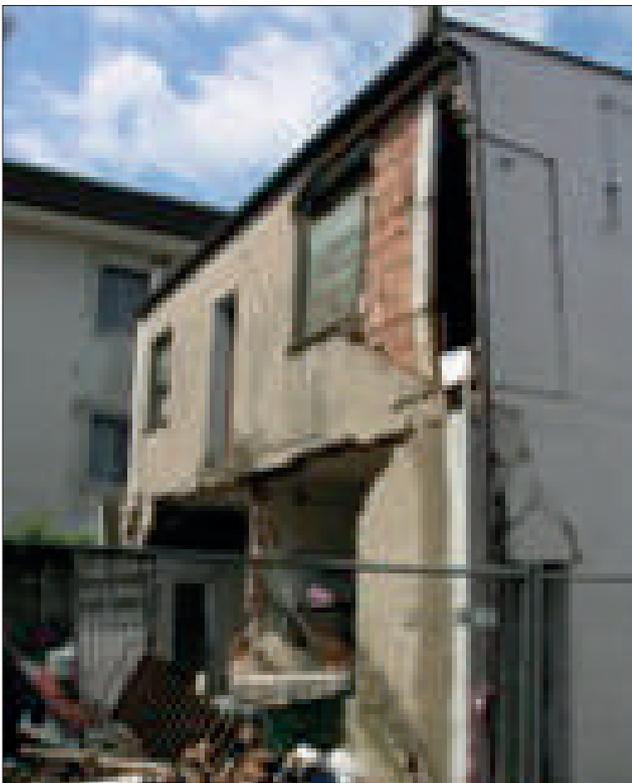
FIGURE 7 Serious failure of the walls, the damage is grade 4

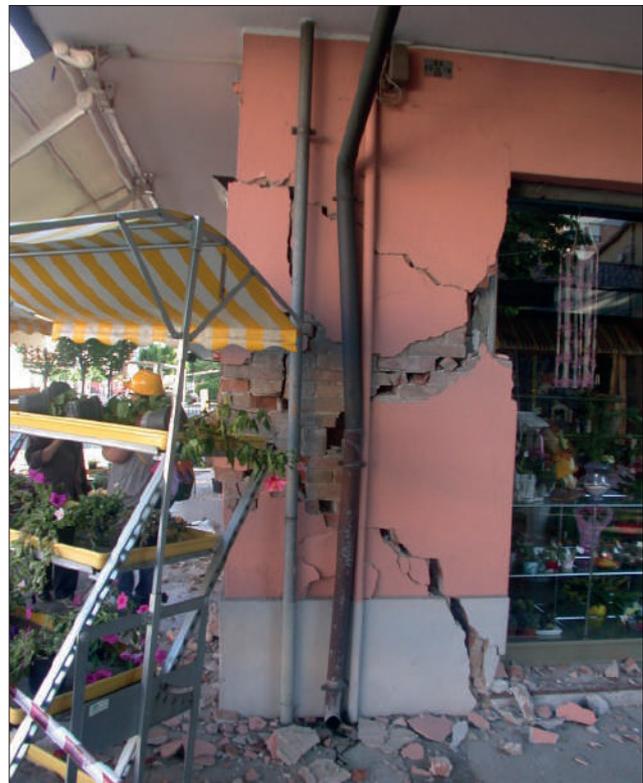
FIGURE 8 Heavy diagonal cracks with partial loss of connection between external walls (damage of grade 4)

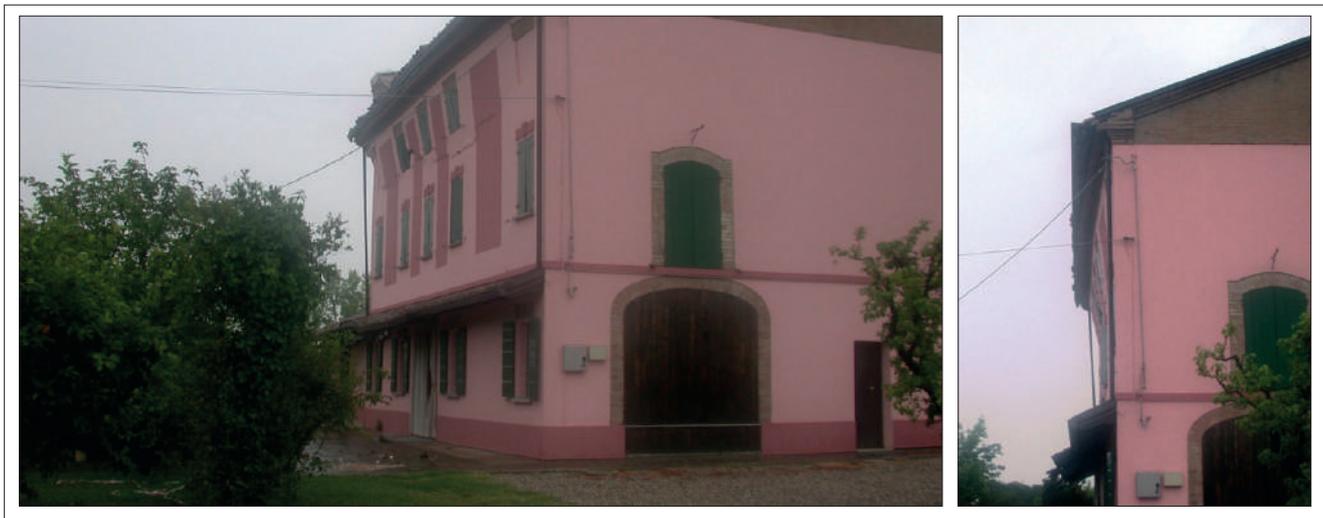
FIGURES 9-10 Out-of-plane mechanism of the upper part of the longitudinal façade

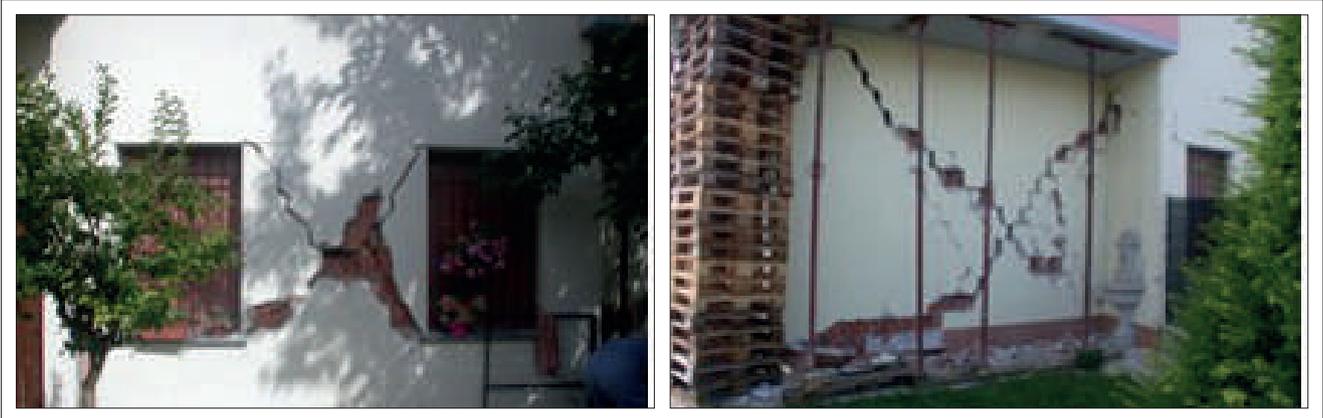
FIGURES 14-15 Large shear cracks on exterior walls; the damage level il 3

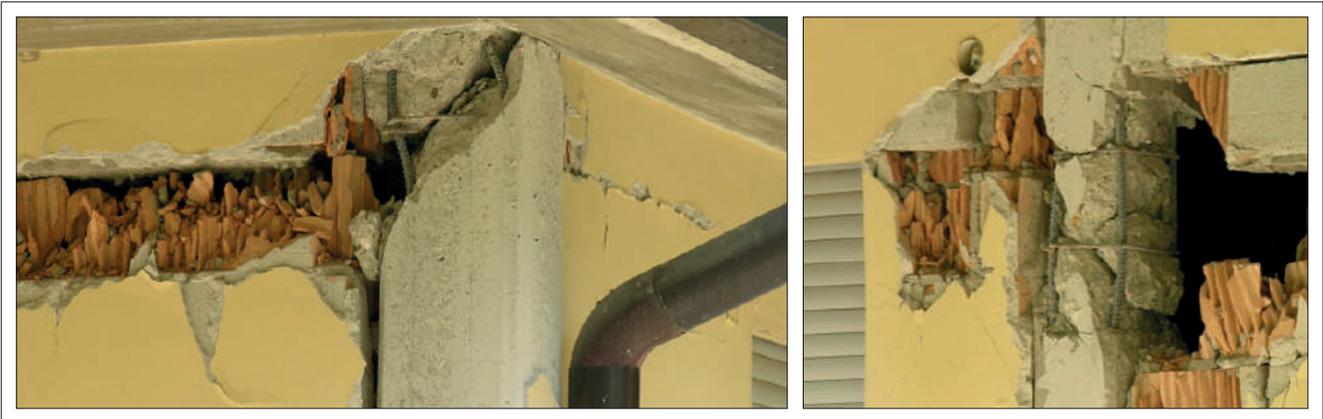
FIGURES 18-19 Failure of RC columns

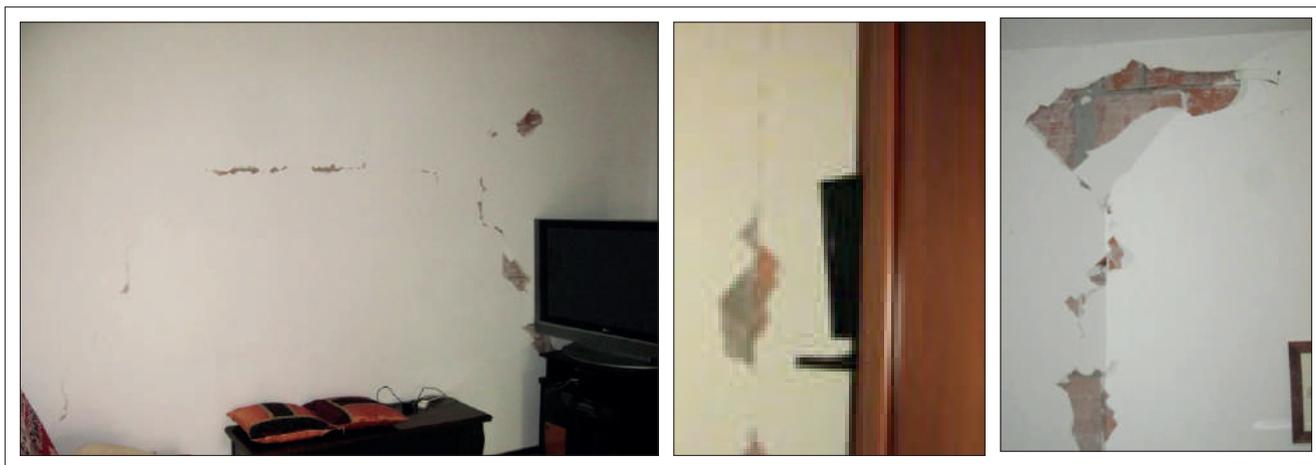
FIGURES 23-24-25 Damage to the partition walls

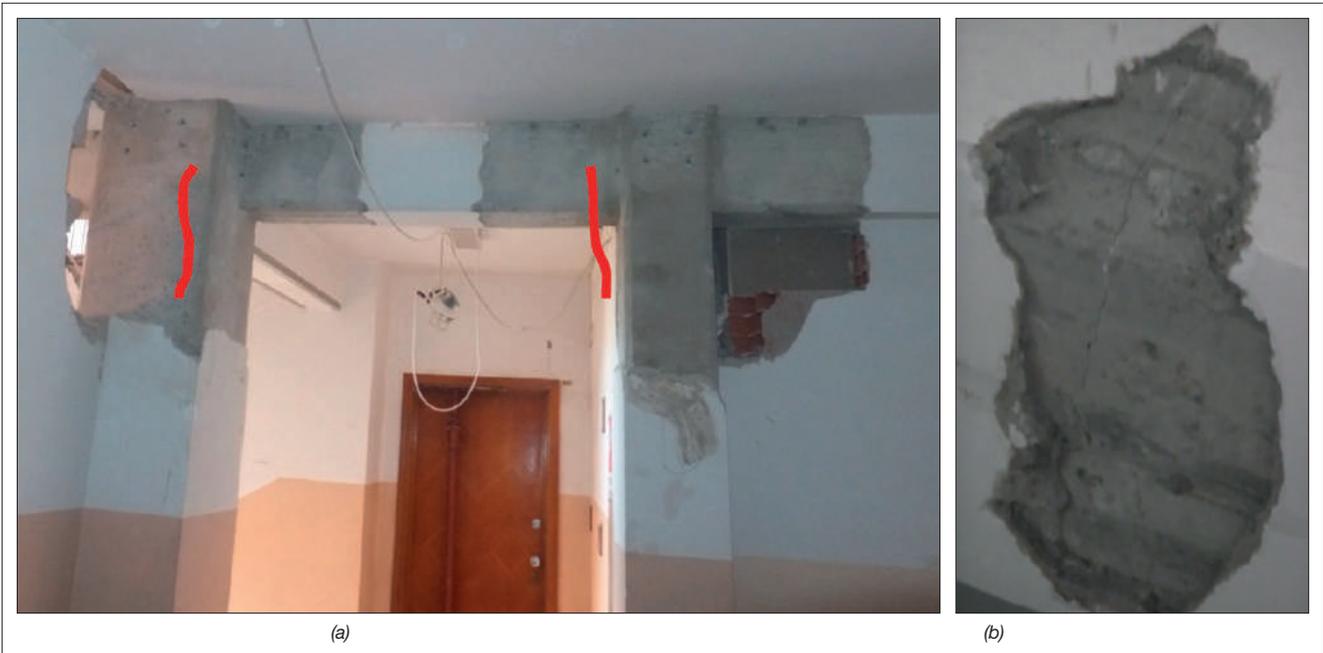
FIGURE 32 Structural seismic damage: a) location of the cracks on the stair beams; b) crack detail

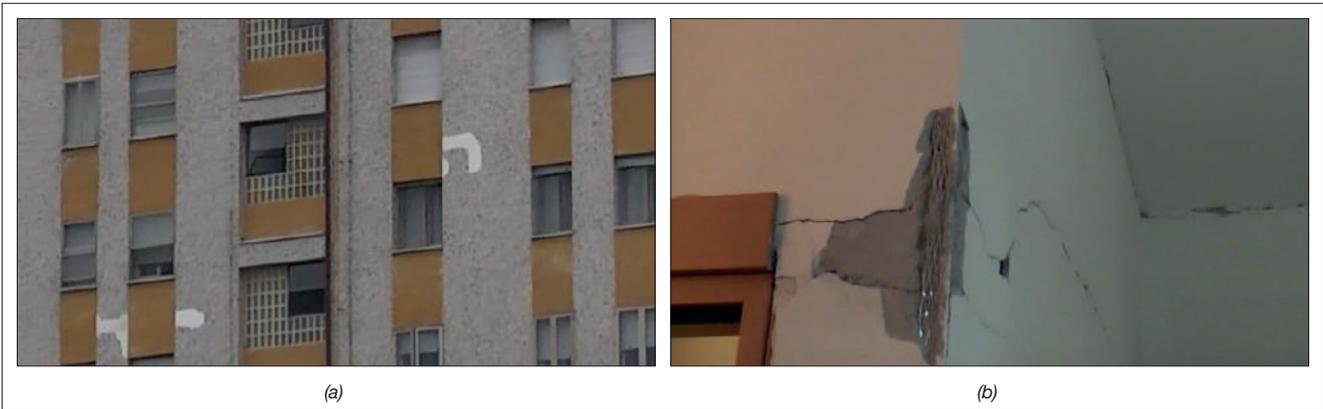
FIGURE 33 Non-structural seismic damages: a) façade covering layers; b) partition walls
