## THE PIANURA PADANA EMILIANA EARTHQUAKE

# Behaviour of industrial buildings in the Pianura Padana Emiliana Earthquake

■ *Fernando Saitta, Giovanni Bongiovanni, Giacomo Buffarini, Paolo Clemente, Alessandro Martelli, Anna Marzo, Giuseppe Marghella, Maurizio Indirli, Alessandro Poggianti*

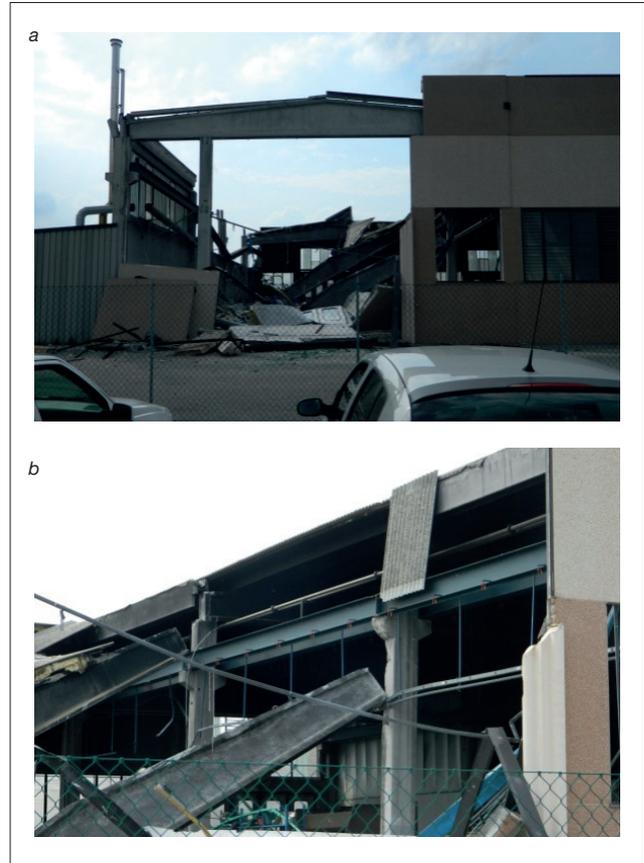
**FIGURE 6** Longitudinal toppling of beams for displacement limit  
Source: ENEA

The observed damage in industrial buildings was mainly due to the following reasons: loss of bearing, pillar damage, collapse of external cladding panels, instability of steel shelves. Figs. 6 and 7 show some examples of loss of bearing. In many cases, the length of the bearing was too short to allow the beam-support relative motion under the seismic action. Each portal, from a structural point of view, can be depicted schematically as in Fig. 8, where the static equilibrium exists only if the horizontal forces acting on the beam do not overcome the friction forces. Some general considerations can be made for the in-plane behaviour of the roof. To guarantee a good transfer of the horizontal actions to the vertical ele-

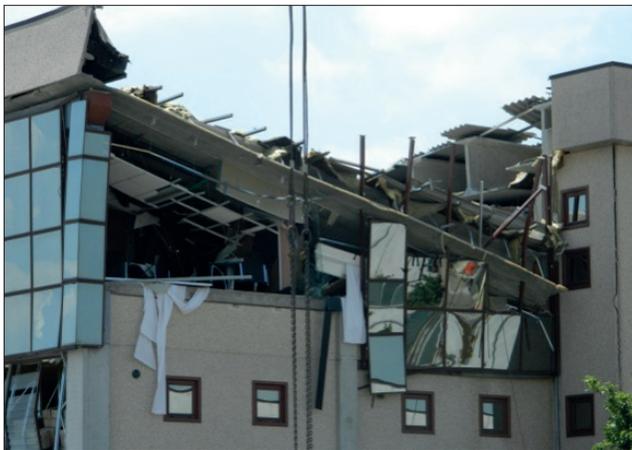
**FIGURE 7** Longitudinal slipping of the roof beams  
Source: ENEA

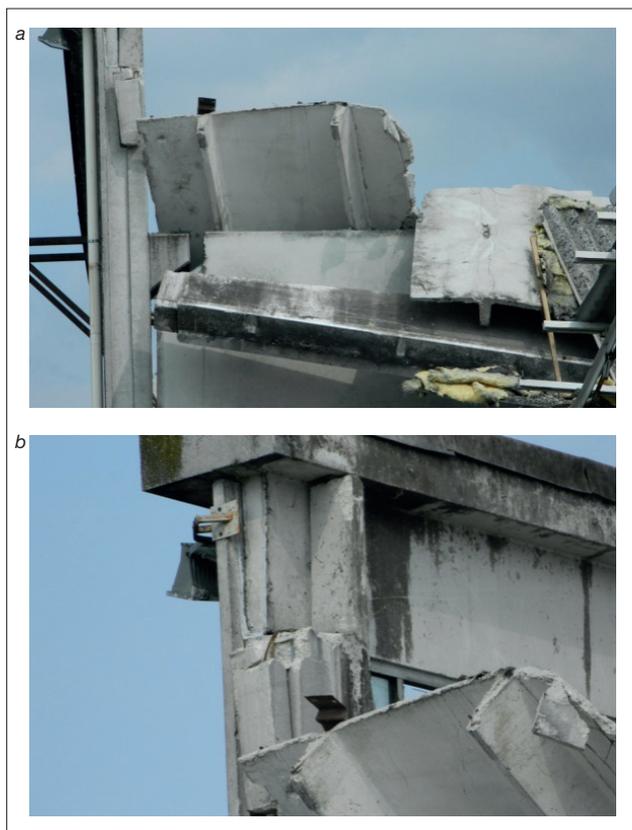
**FIGURE 10** Lateral toppling of the beam  
Source: ENEA

In some cases the beam toppled down laterally, as shown in Fig. 10, after the failure of the lateral restraint present at the top of the columns, unable to resist to horizontal actions. Clearly, the failure mechanism depended also on the prevalent direction of the seismic motion. Different types of damage to columns are shown in Fig. 11.

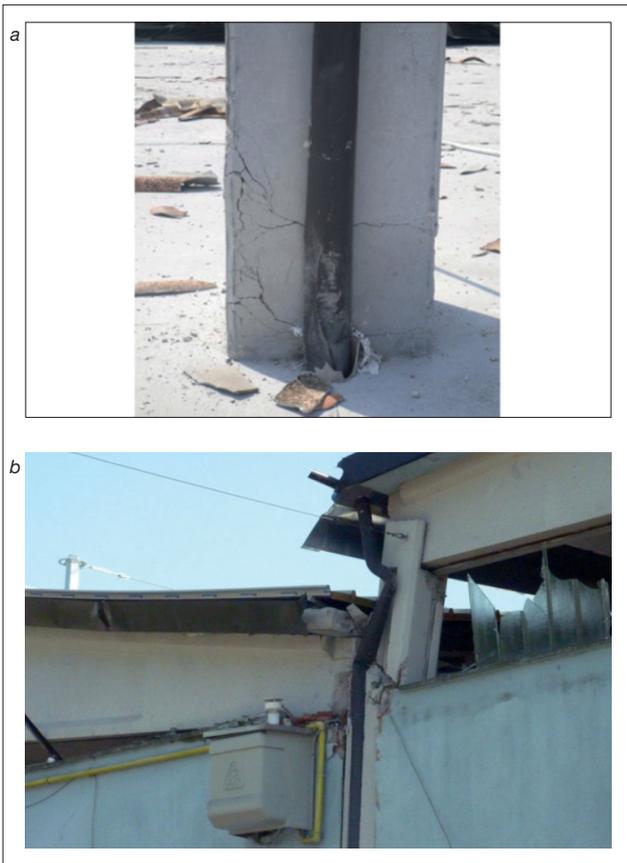
**FIGURE 11** Damage to columns  
Source: ENEA

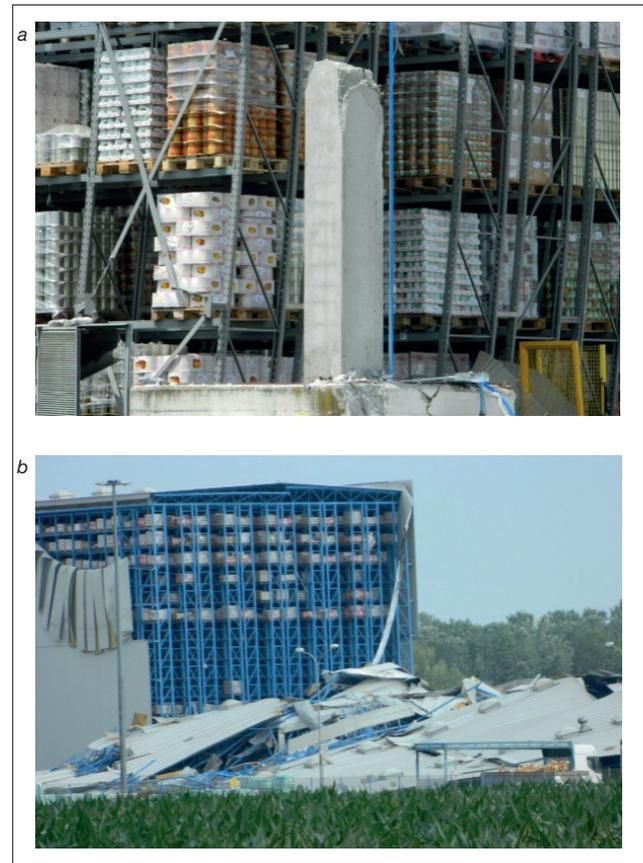
Under horizontal actions, such as those due to seismic excitations, these inadequately braced structures

exhibited instability (Fig. 12a). When the shelves were part of the structure (Fig. 12b), the evaluation of second order effects in the design phase is certainly significant.

**FIGURE 12** Instability of shelves  
Source: ENEA

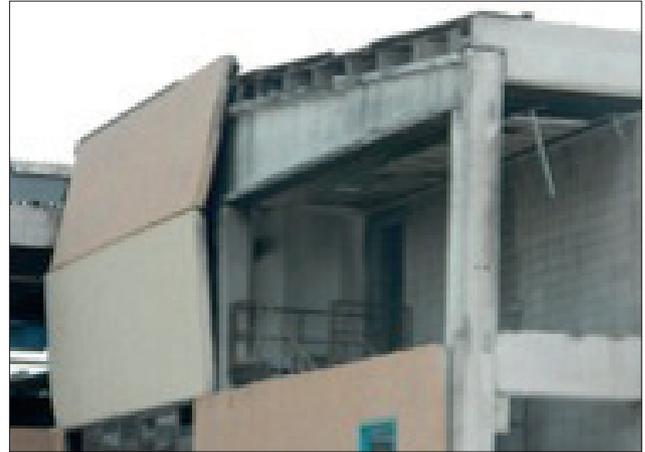
Another situation observed in many cases is related to the detachment of precast external walls, due to the absence of effective connections with the main structure (Fig. 13).

In particular, the claddings were often constituted by precast panels, attached to the façade and not contained by the main structural elements, i.e., beams and columns. The mechanical connections were based on the cohesion between concrete and steel, and/or on the shear resistance of the steel element. Depending on the mass of the panels and their

consequent inertial loads, they were unable to support stresses.

Therefore, the connections failed in many cases, leading to the detachment of the walls. Cladding made of solid brick was observed in more recent one-storey structures. In this case, the cladding suffered vast damage such as cracks (due to in-plane mechanism) or overturning (due to out-of-plane effect, Fig. 14).

**FIGURE 13** Detachment of the external wall  
Source: ENEA

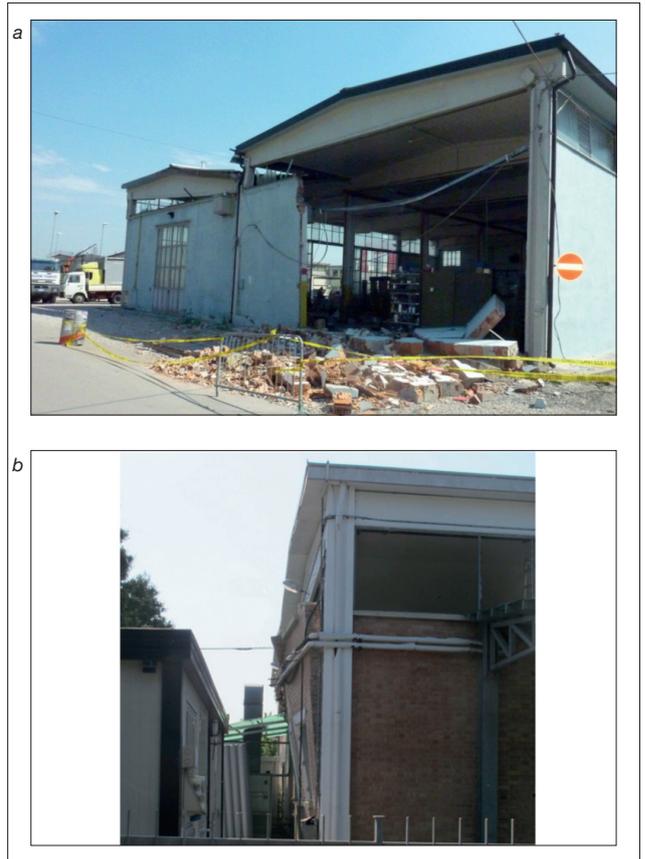
**FIGURE 14** Solid brick cladding damage  
Source: ENEA

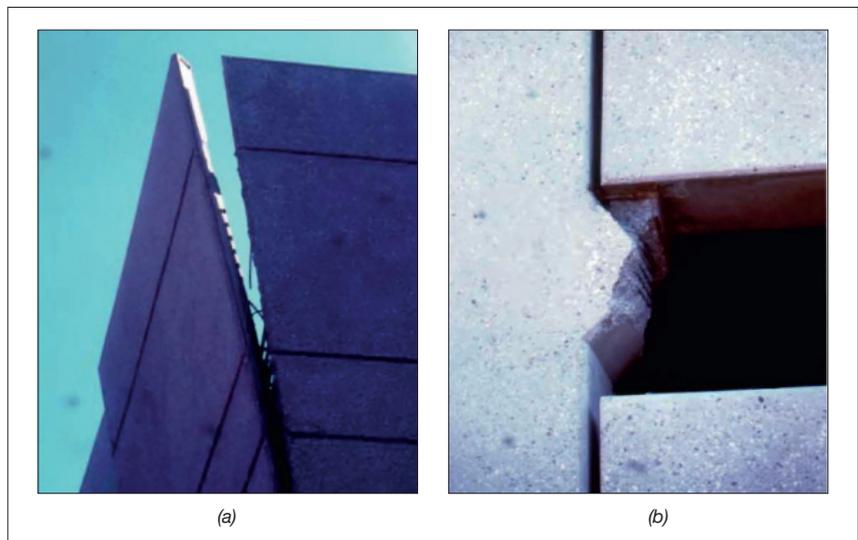
For example, after the January 17<sup>th</sup>, 1994 Northridge earthquake (California, USA,  $M_w=6.7$ ), several parking lots suffered widespread damage or collapse [6]. Among others, a typical example was the Cigna Garage, a multi-storey assemblage of precast and cast in-situ elements (Fig. 15), located at a distance of

approximately 5.5 km from the epicentre (the closest recording station measured peak values of 0.47g, horizontal, and 0.30g, vertical). The building connections failed, due to loss of bearing of supporting elements [7].

**FIGURE 15**  
Cigna Garage damaged by the 1994 Northridge earthquake [7]

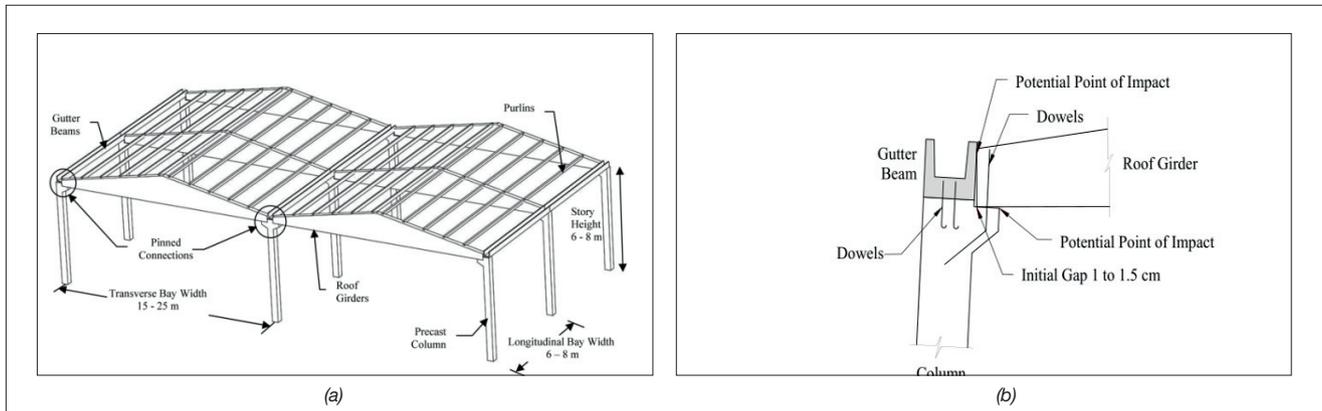
**FIGURE 16** A Turkish typical configuration of one storey precast construction near Kocaeli and details [11-14]

hand, collapse and extensive damage was concentrated in pre-1981 r.c. and steel stock. Some typical one-storey industrial pre-cast structures (Fig. 16), located in the epicentre area of the August 17<sup>th</sup>, 1999, Kocaeli earthquake (Turkey,  $M_w=7.4$ ), didn't show good results, while others remained undamaged (Fig. 17) [10].

The collapse was mainly due to poor design, detailing, and construction, leading to the lack of diaphragm action caused by the inadequate connections (pinned or dowel, simple to realize by the prefabricators) between columns and beams. In addition, buildings under construction were susceptible to collapse when the roof girders rotated off their supports.

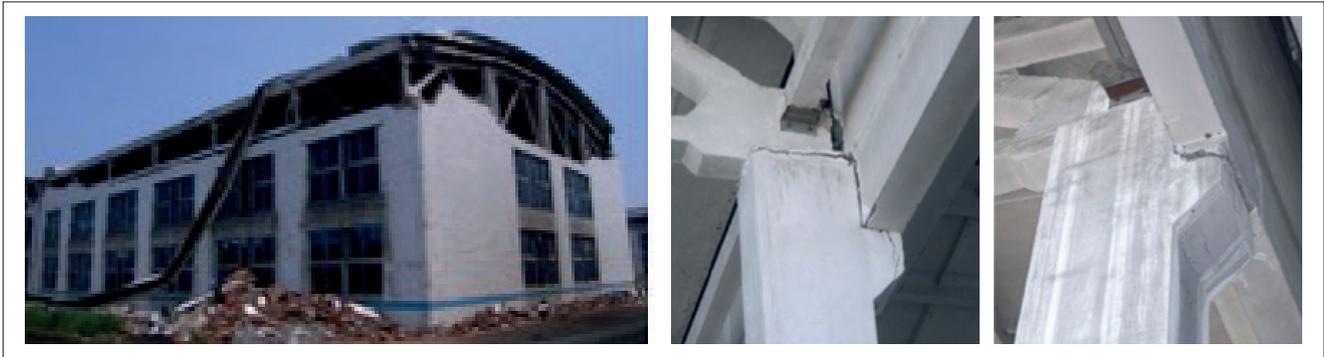
**FIGURE 18** Damage and partial collapse of the Xiting Package Ltd. Factory complex in Mianzhu City, Wenchuan, China [15]

Also after the May 12<sup>nd</sup>, 2008, Wenchuan earthquake (China,  $M_w=7.9$ ), industrial buildings and facilities in the area near the fault rupture were severely affected, as shown in Fig. 18 [15].

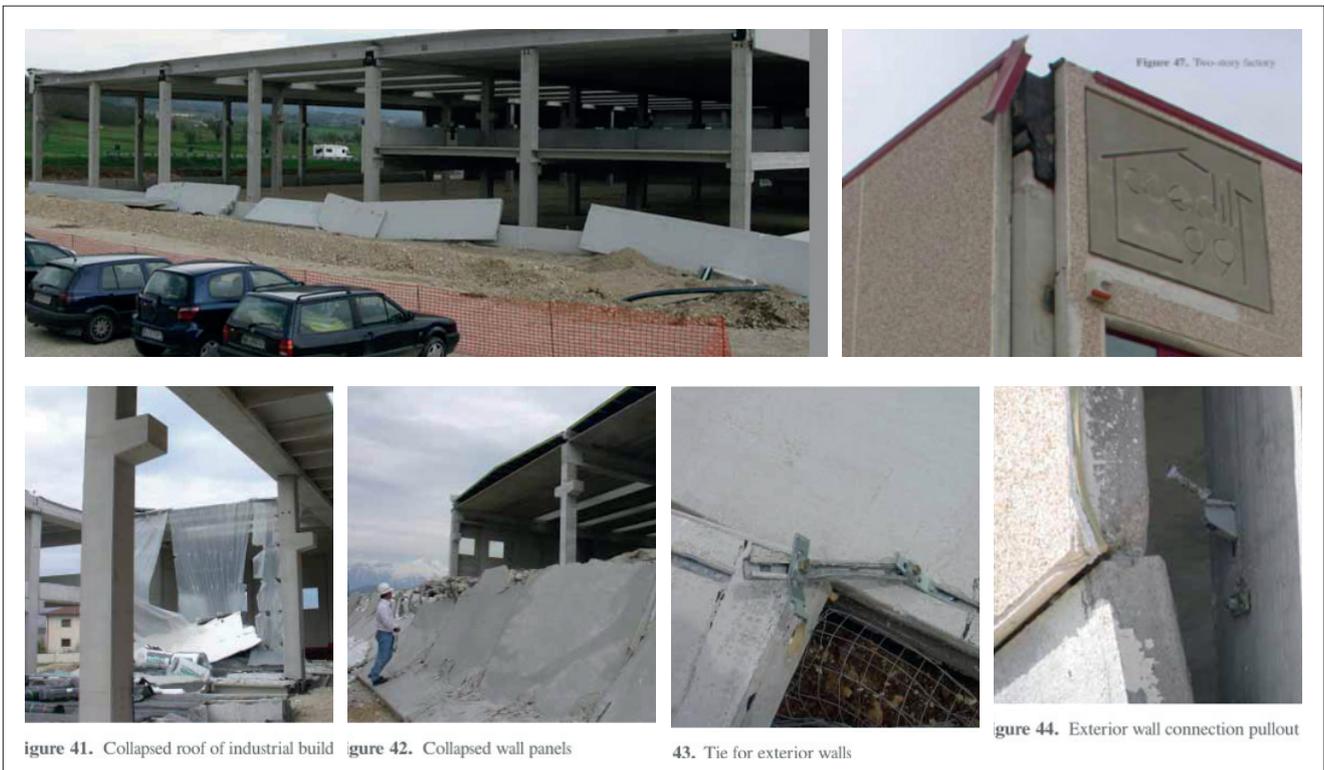
**FIGURE 19** Collapse due to lack of adequate anchoring in p/p. r.c. structures in L'Aquila [17]

The April 6<sup>th</sup>, 2009, Abruzzo earthquake (Italy,  $M_w=6.3$ ) again seriously affected some p/p. r.c. buildings, generally unanchored or inadequately braced [16, 17]; taking into account the relatively new vintage and the

existing seismic classification of the area before the event, the level of damage was surprising (Fig. 19).
