THE PIANURA PADANA EMILIANA EARTHQUAKE

Post-earthquake safety interventions on the Visitazione di Maria Santissima Church in Reno Finalese

■ Bruno Carpani, Giuseppe Marghella, Anna Marzo, Alessandra Gugliandolo, Maria-Anna Segreto

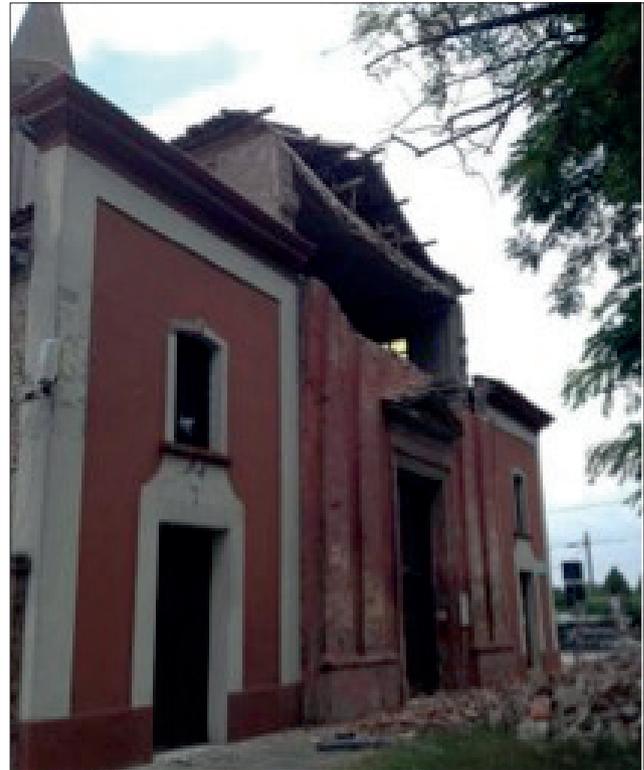
The most evident effect of the seismic action is the collapse of the upper portion of the main façade of the church, due to the lack of connection with the transversal walls. The occurred mechanism is the vertical overturning of the Façade and the collapse of the top one. The non-collapsed part of the façade is separated from the transversal walls and greatly inclined towards the churchyard. The two façades of the lateral naves are connected to the transversal walls and are lower than the main one, therefore they are less damaged (Figs. 2-3).

FIGURE 2 The main façade

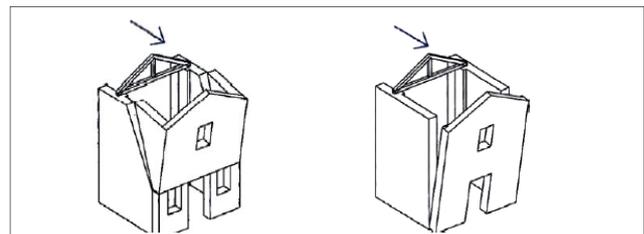
Both the portion of the roof directly connected to the main façade and the façade itself collapsed at the same time. The timber trusses appear to be connected to the walls, with the “capochiave” (anchor plate)

FIGURE 3 Overturning of the façade

anism of the façades is realized by ties made of high-resistance, 20mm-diameter steel cable (Fig. 21), anchored to the masonry walls by employing the Bossong system (Fig. 22). At the corners, the cables are anchored to the corner-shaped, 50x40 cm steel plates, in order to adequately distribute the actions on the masonry walls.

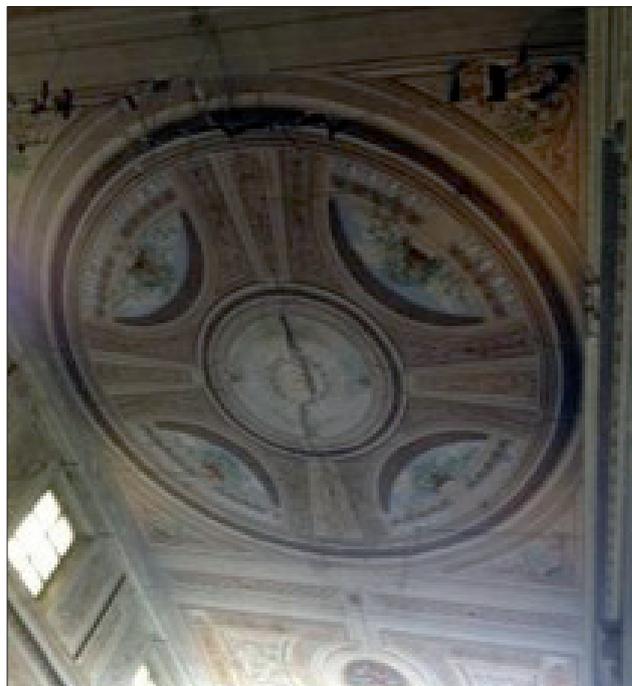
timber trusses and is severely damaged (Fig. 4). On the contrary, the frescoed ceiling of the lateral naves, which are made of “*in sheet*” arranged bricks, have collapsed in many parts, especially in the left nave (Fig. 5). In addition, the cracks’ distribution and their depth outline a dangerous condition for the entrance.

FIGURE 4 The false ceiling of the central nave

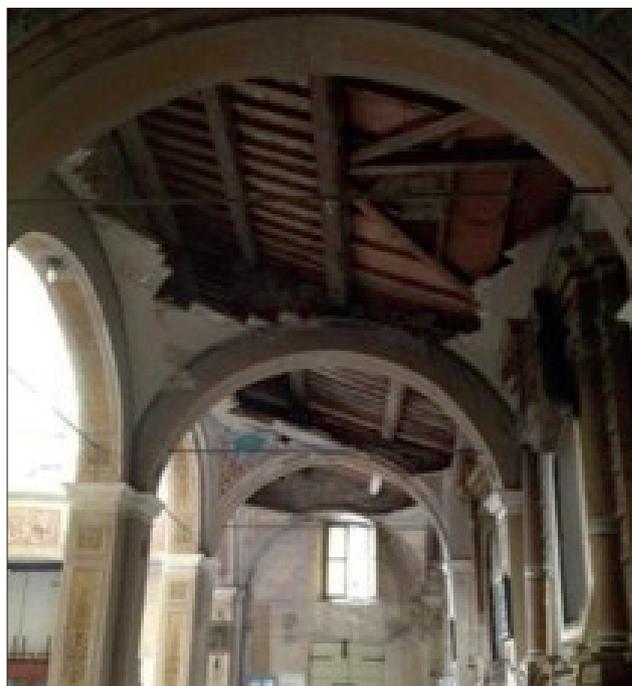
FIGURE 5 The collapsed vaults of the left nave

of the single bricks, therefore a possible intervention could consist in restoring the original painting layout. Regarding the original bell tower, the new intervention allows for the application of steel cables equal to those used for the church, which ensure the complete ringing of the tower in addition to the existing metallic ties, thus preserving the structure from collapsing. Finally, with reference to the more recent bell tower, the proposed intervention has been designed as permanent. It consists of four steel ties located at the four internal corners of the structure and fixed to both the upper floor and the ground floor by means of steel plates, each equipped with shape memory alloy (SMA) devices located at their middle length.

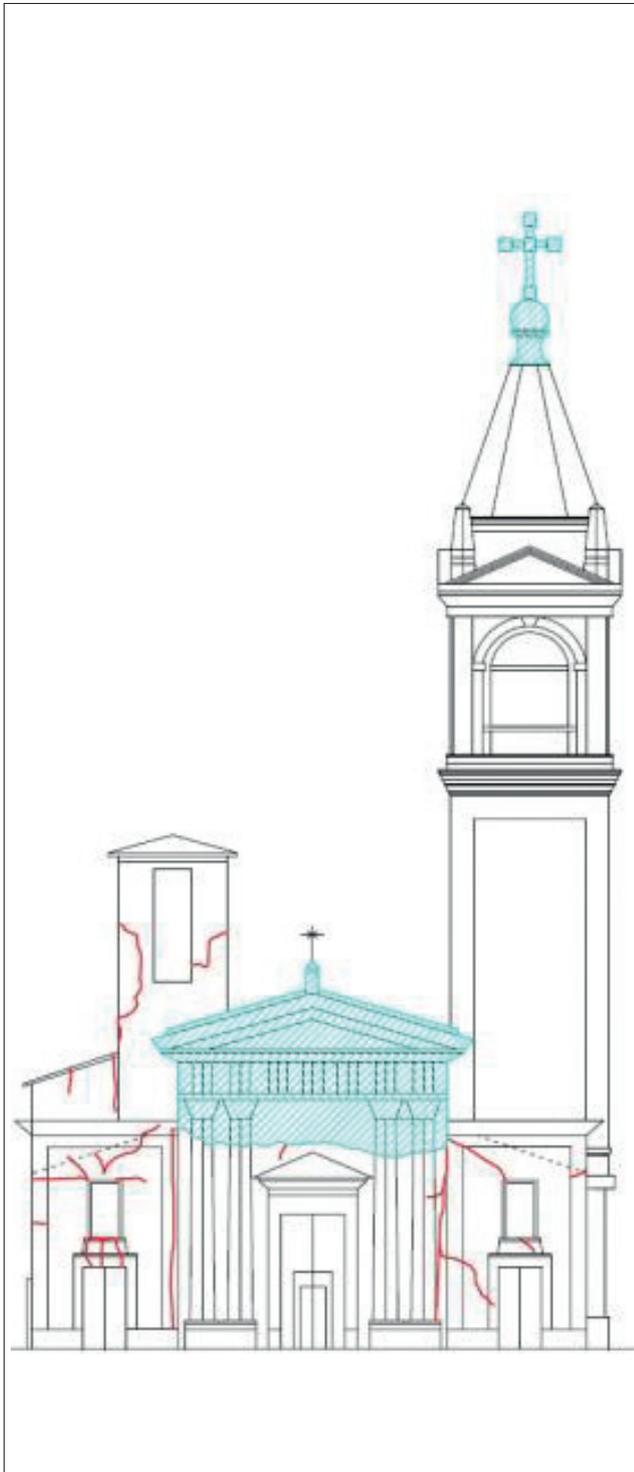
The cracks’ pattern (Figs. 6-8) related to the façades shows a rather critical situation: in addition to the overturning mechanism, many other deep cracks are visible, which are particularly severe. Moreover, a passing through vertical crack located between the second and third arch has been surveyed, also by using a thermal imaging camera (Figs. 9-10).

FIGURE 6 Cracks on the main façade

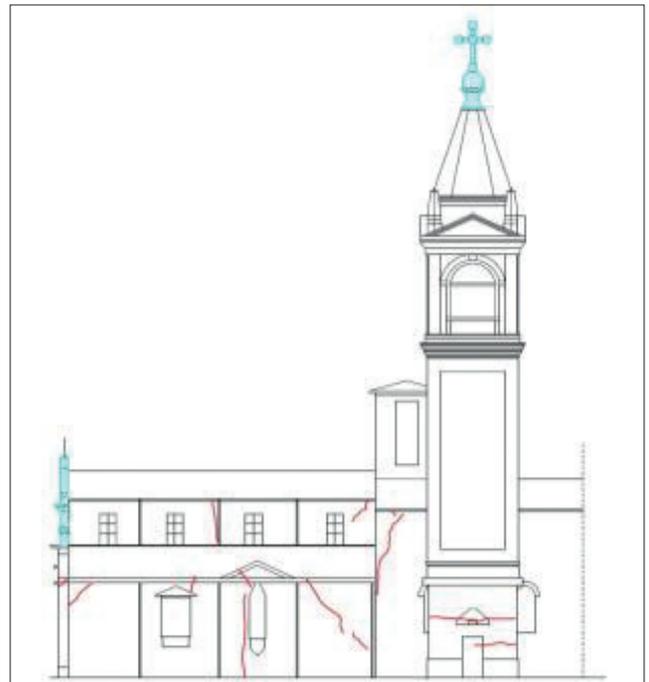
FIGURE 7 Cracks on the east side

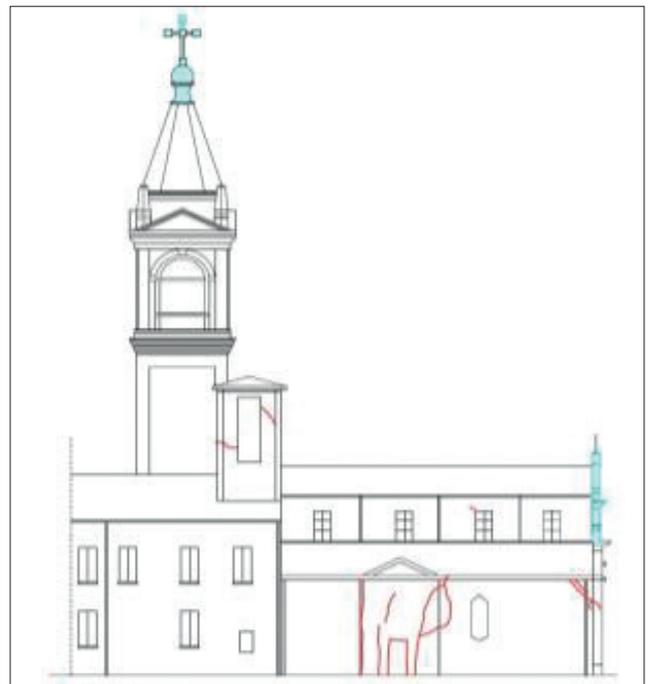
FIGURE 8 Cracks on the west side

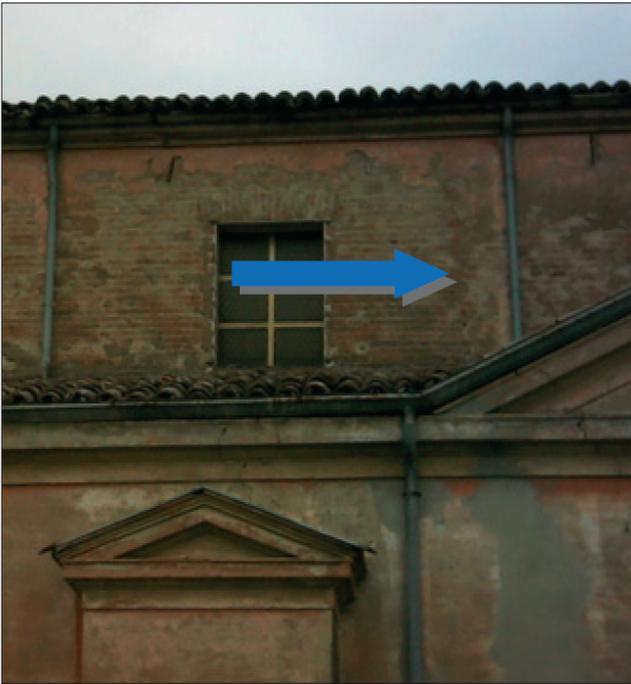
FIGURE 9 Passing through vertical crack

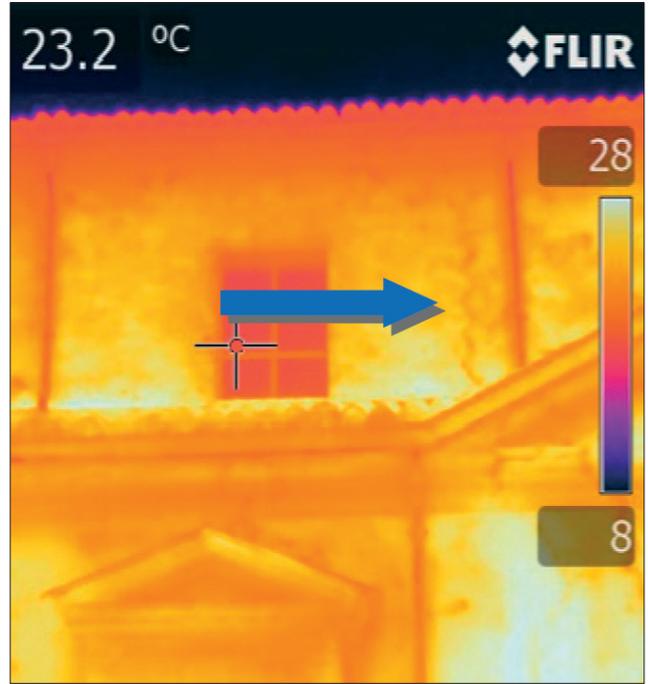
FIGURE 10 Passing through vertical crack (thermal imaging camera)

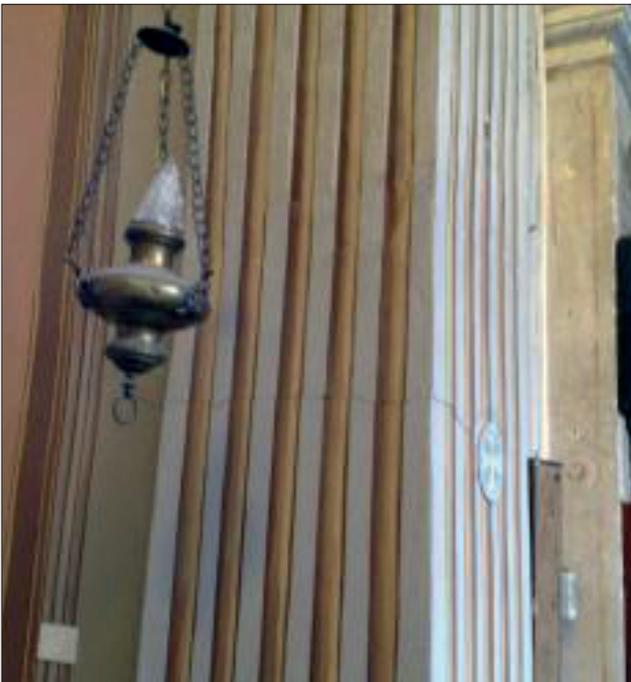
Other evident cracks are located between the central nave and the apse, where the walls seem unconnected to each other. A horizontal crack at about 2 meters from the ground level is surveyed on the pilaster on the right of the apse, in addition to a slight rotation. Moreover, diagonal cracks on the doors and separation of the corner have been evidenced on the wall located on the right of the apse (Fig. 11). On the contrary, on the left side of the apse, the presence of the oldest tower has provided a connection function between the two walls. In any case, the sacristy wall has been damaged because of the hammering action of the more rigid structure of the oldest tower on it (Fig. 12). Cracks are also present at the bottom wall of the apse.

FIGURE 11 Horizontal crack on the pilaster

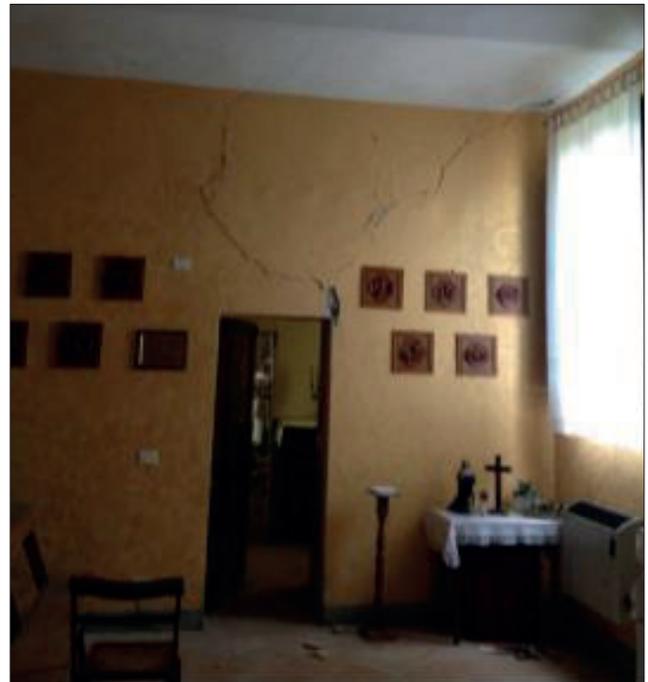
FIGURE 12 Diagonal crack on the sacristy wall

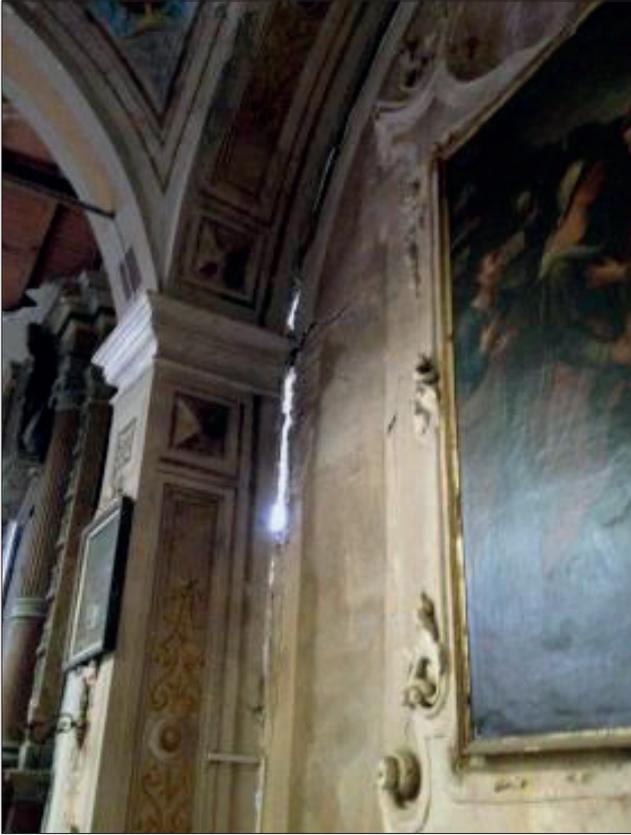
An overturning mechanism is located on the right nave (Fig. 13), in addition to several diagonal cracks. An arch separating the naves shows a severe crack and a relative translation between the two realized parts, despite the presence of the metallic tie (Fig. 14). On the left nave, no mechanism has been evidenced.

FIGURE 13 Overturning mechanism of the walls on the left nave

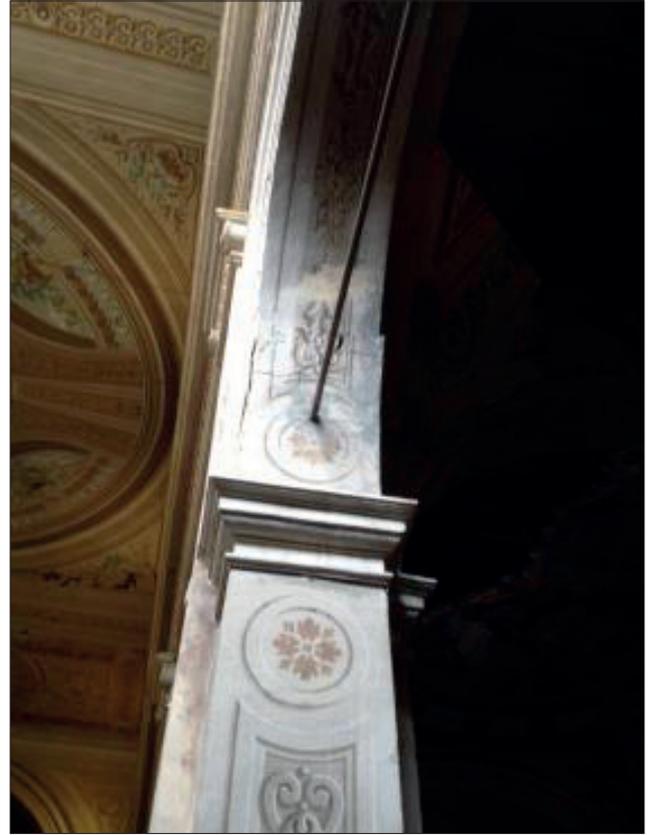
FIGURE 14 Crack and translation on the arch

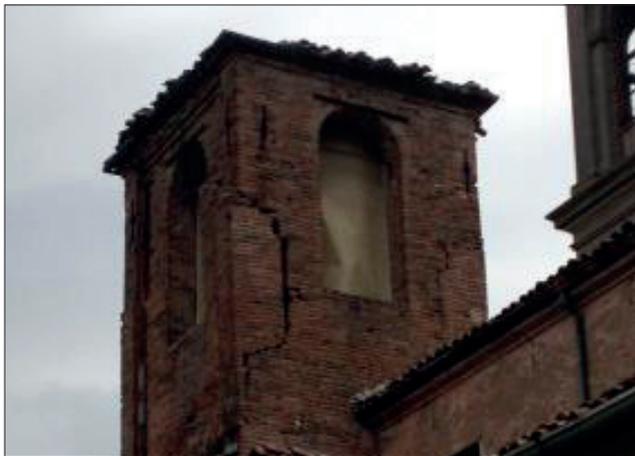
Very serious damage have been surveyed on the two towers of the church. The oldest tower – which is the original bell tower nowadays substituted from the more recent one – is about 16 meters high. With masonry structure and equipped with metallic ties in both directions, it shows a very critical situation. The separation and expulsion of the corners (cantonal) occurred, which predicts a potential global collapse of the tower and the subsequent increasing in the damage of the structures below it (Figs. 15-16).

FIGURE 15 Separation and expulsion of the corner

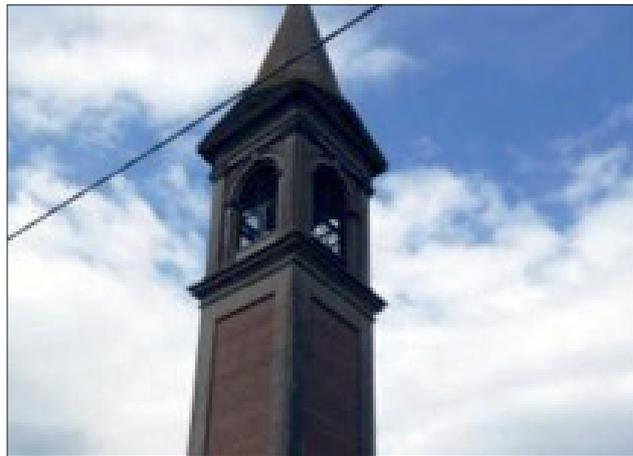
The more recent tower, being made of solid bricks, is more than 38 meters high and was built adjacent to the right side of the church using bricks and concrete. The earthquake caused the twisting of the whole structure, cutting it at about 2 meters from the ground, in correspondence of a discontinuity in the material of the basement. In addition, a minor rotation occurred (Figs. 17-18).

Further damage has not been observed above the horizontal crack, at least from the outside. The steeple, which is also cut and rotated at the base, has been quickly removed in order to ensure the passage through the nearby street. Finally, the more recent bell tower is dangerous for the street users and surrounding buildings in case of collapse, in addition to the potential danger for the whole adjacent structure of the church.

FIGURE 17 The more recent bell tower
