## THE PIANURA PADANA EMILIANA EARTHQUAKE

# Damage mechanisms in some residential building typologies during the Pianura Padana Emiliana Earthquake

■ Bruno Carpani, Maurizio Indirli, Giuseppe Marghella, Anna Marzo, Alessandra Gugliandolo, Maria-Anna Segreto

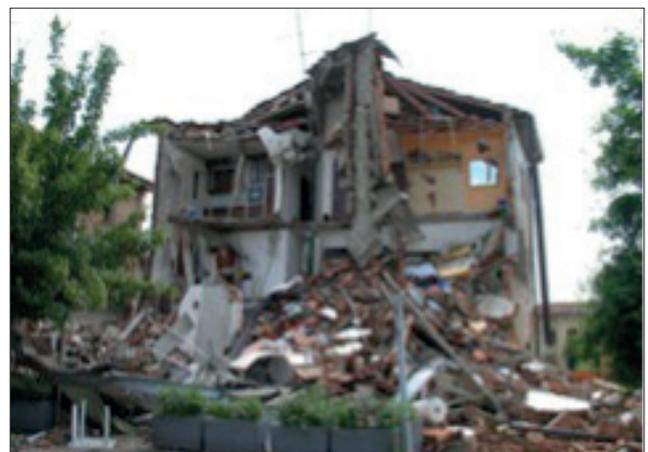
**FIGURE 4** The front part of the building has completely collapsed; the damage grade is 5

ity and well preserved conditions. On the other hand, where heavy structural alterations were introduced (for example the insertion of RC floors not properly connected to the walls or the replacement of light wooden roofs with heavy RC ones), the vulnerability increased dramatically. Fig. 4 shows a case of near to total collapse (damage of grade 5 EMS98). Note the heavy roof structure bearing on slender walls, the poorly reinforced beams (Fig. 5) and ring course concrete, as well as the absence of steel reinforcement in the floor slabs (Fig. 6).

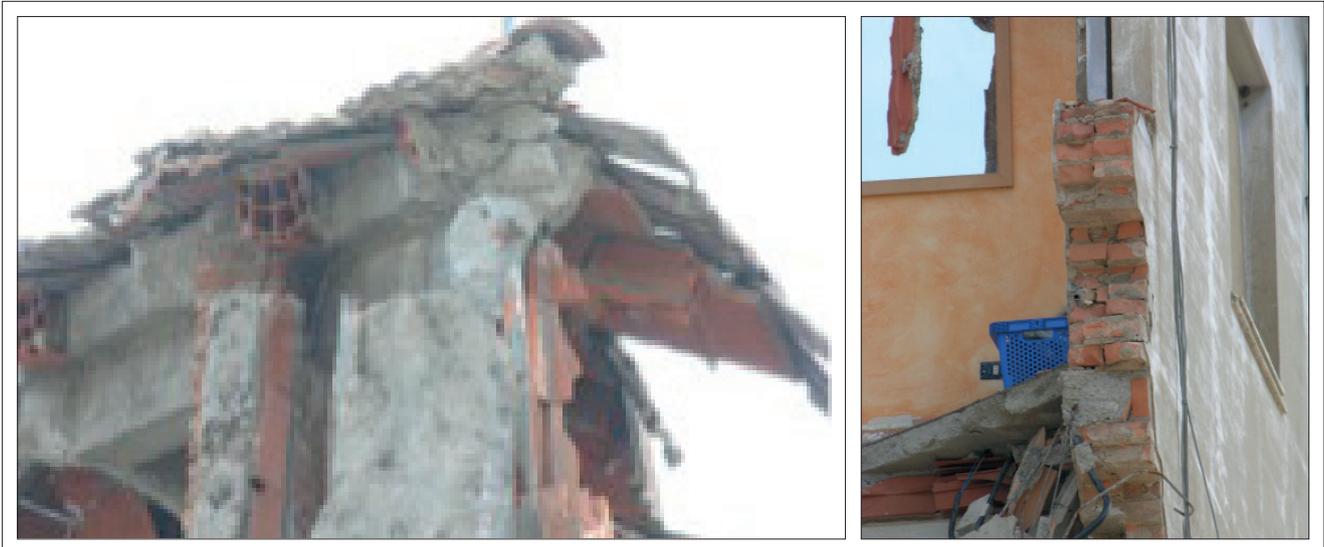
FIGURES 5-6 Details of RC elements

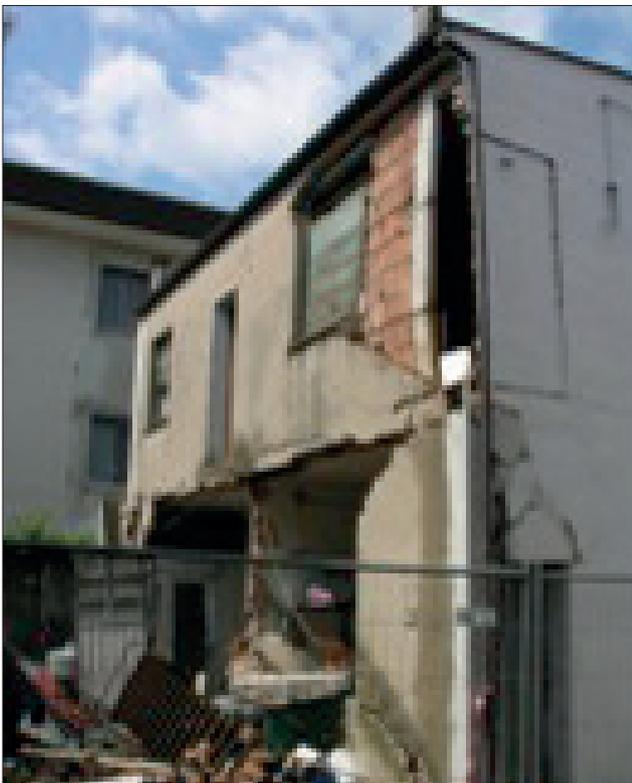
FIGURE 7 Serious failure of the walls, the damage is grade 4

A further example is shown in Fig. 7. Besides structural weaknesses (lacking in connection at wall corners as well as between walls and floors, openings near the corners, use of non-bearing hollow bricks), vulnerability was also affected by the addition of an external stair.

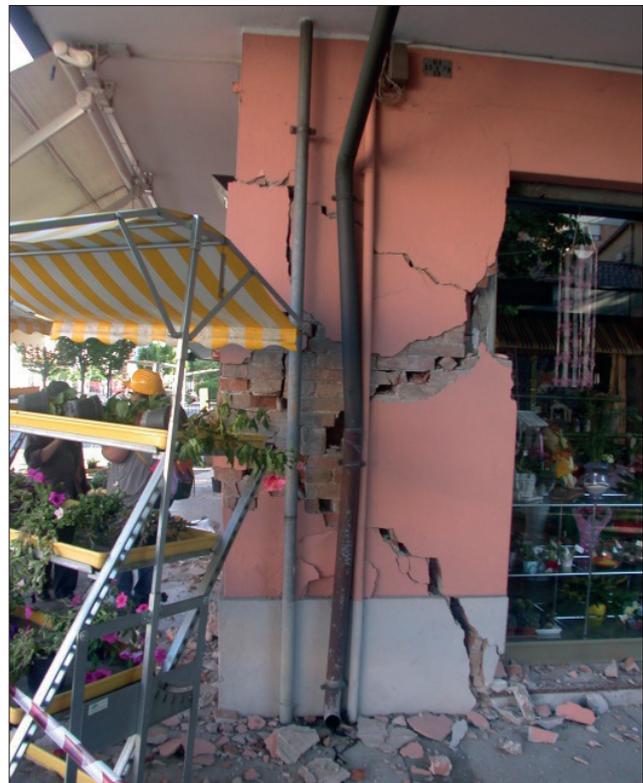
FIGURE 8 Heavy diagonal cracks with partial loss of connection between external walls (damage of grade 4)

In the example of Fig. 8, the presence of rigid concrete slabs combined with wide openings at the first floor affected the seismic response of the building, which shows severe shear cracks in the external walls. Looking at the damage patterns, it should be noted that first mode damage mechanisms (outward overturning of the walls) are not numerous. A clear example is shown in Figs. 9-10, where roof thrust load plays an evident role.

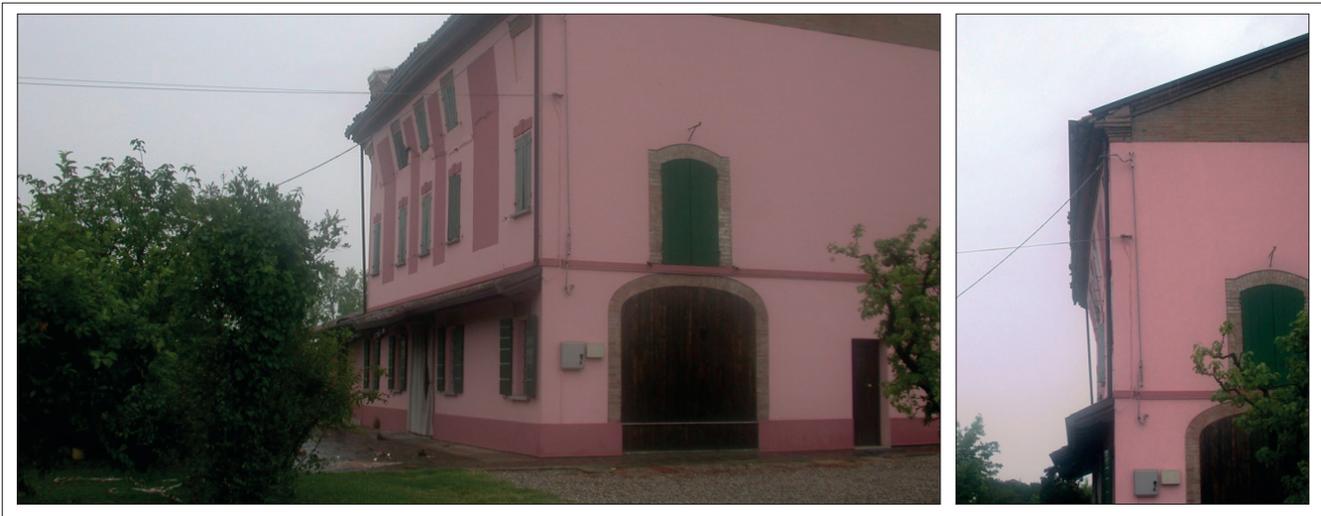
**FIGURES 9-10** Out-of-plane mechanism of the upper part of the longitudinal façade

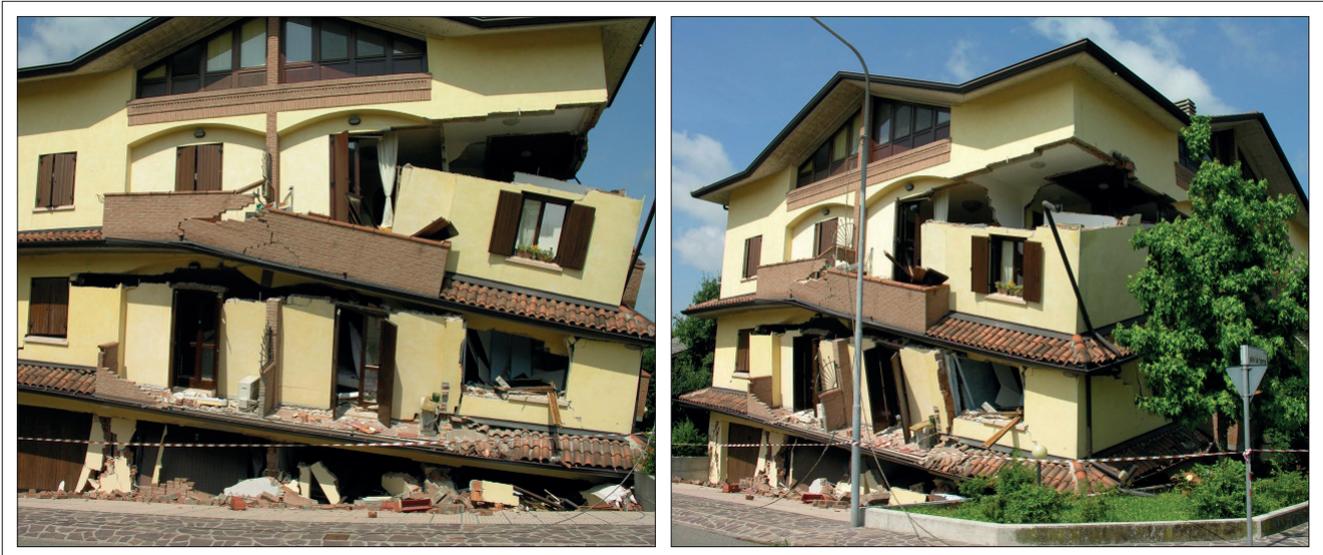
The urban development that took place in the last thirty years was marked by the coming of new materials and techniques and witnesses the evolution of the traditional building type. In new houses, RC-brick mixed slabs replaced steel joist floors and wooden roofs, whereas bearing-load walls were no more built in solid brick but in hollow brick masonry. If the weight of heavy horizontal elements rests entirely on such a masonry, vulnerability can be severely affected by geometry, size and layout of openings. An emblematic case, and a very impressive one, is represented by a cottage on three levels that was literally split by the earthquake.

The collapse was caused by the presence of a soft storey in which there were large openings and small piers between openings and corners. Due to the absence of any reinforcements, the masonry corner pier on the right (Fig. 11) completely crushed, with the consequent opening up of the structure up to the top (Fig. 12). Even though the change in stiffness between the rigid upper floors and the ground soft storey has further aggravated the response of the building under the seismic stress, undoubtedly the main cause of the collapse depends on the type of masonry used (hollow bricks) and its inadequate dimensioning.

**FIGURES 11-12** The soft storey has collapsed, the damage grade is 5

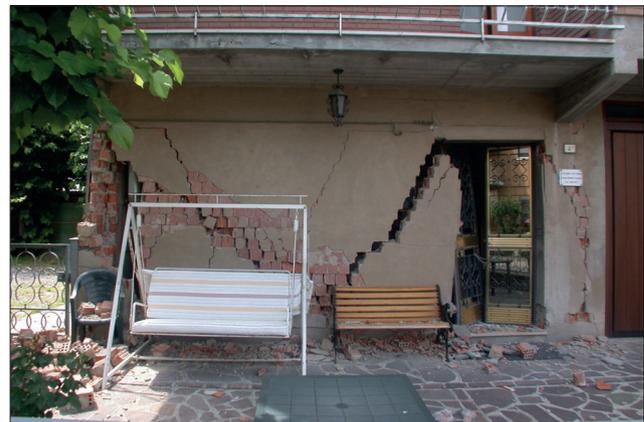
The weakness of ground floors walls built in perforated bricks is again dramatically shown in Fig. 13, where the failure reached almost the collapse. Making of niches in load-bearing walls, containing pipelines and boiler (Fig. 13, on the left), contributes considerably to increase the seismic vulnerability of masonry buildings.

**FIGURE 13** Serious failure of the walls, the damage is grade 4

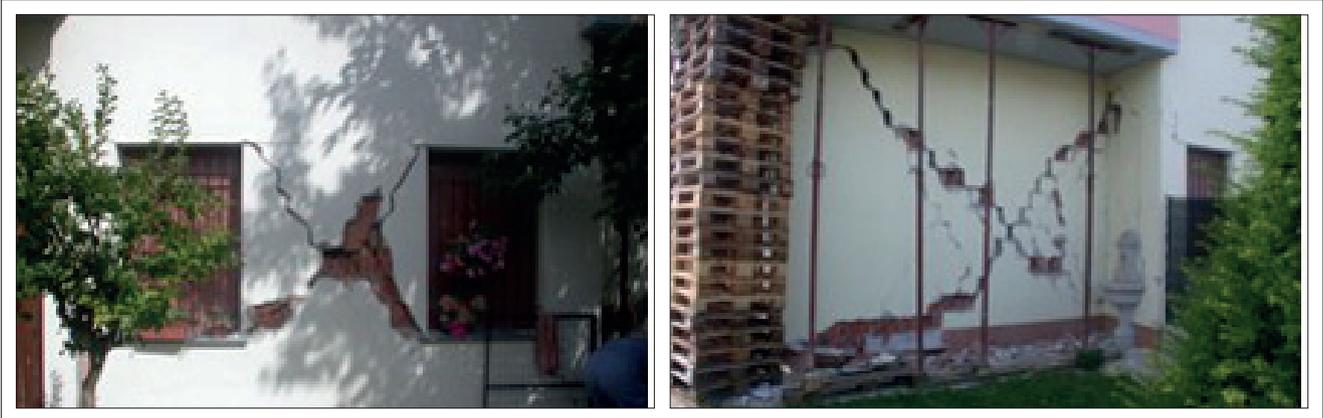
The above said damage mechanism has been diffusely observed in this type of construction. Common examples of this damage (of lower level, if compared to the previous ones) are shown in Figs. 14-15.

**FIGURES 14-15** Large shear cracks on exterior walls; the damage level il 3

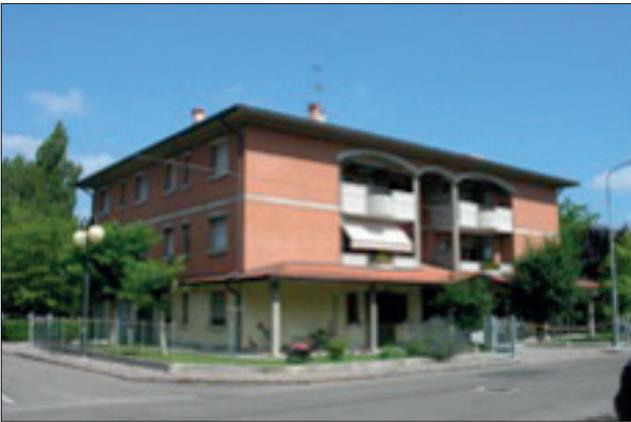
In recently erected buildings, the structure is often provided with RC columns and beams, but they are never placed in all the four sides of the building, in order to perform as a moment resistant frame. In other cases (Fig. 16), when a sort of RC frame is present, the beams run in the thickness of the floor slab (“thickness beam” is the equivalent Italian technical term), making the beam-column joints very vulnerable to lateral loads. This type of structure performed badly and suffered heavy damage (Fig. 17).

**FIGURE 16** Example of mixed structure

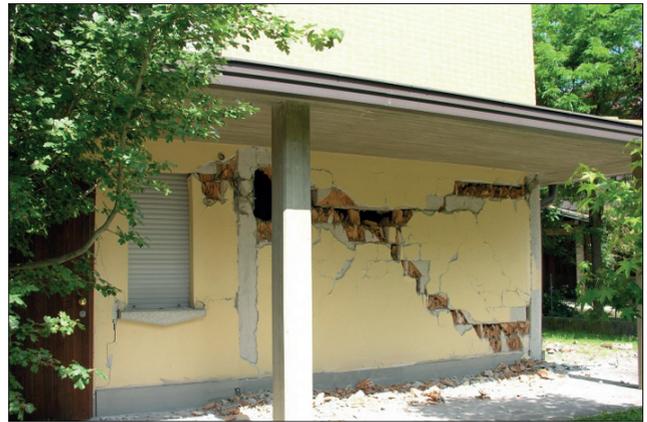
**FIGURE 17** Damage to ground floor wall

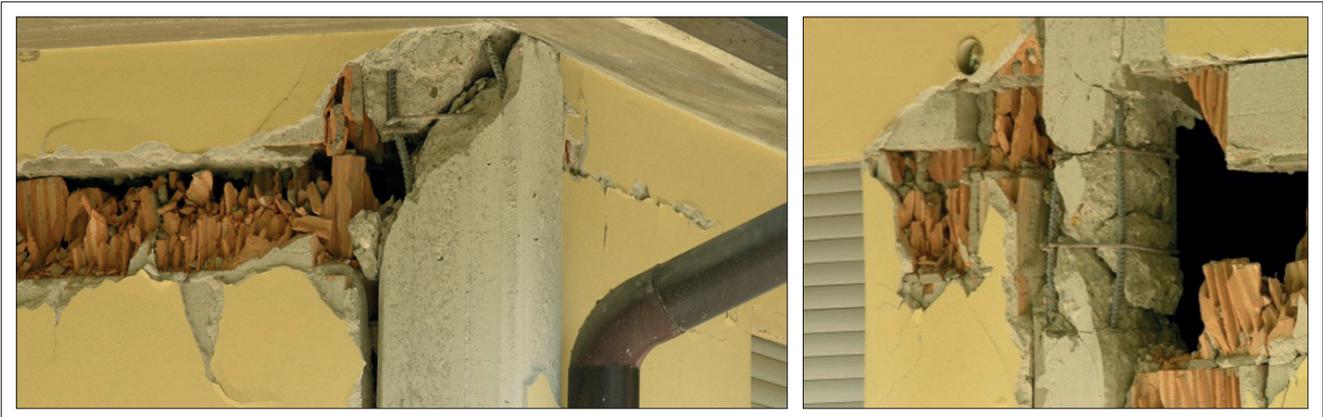
Different damage modes of the columns are worth noticing: shear failure in the column-slab corner joint (Fig. 18) and compressive breaking in the central one (Fig. 19).

**FIGURES 18-19** Failure of RC columns

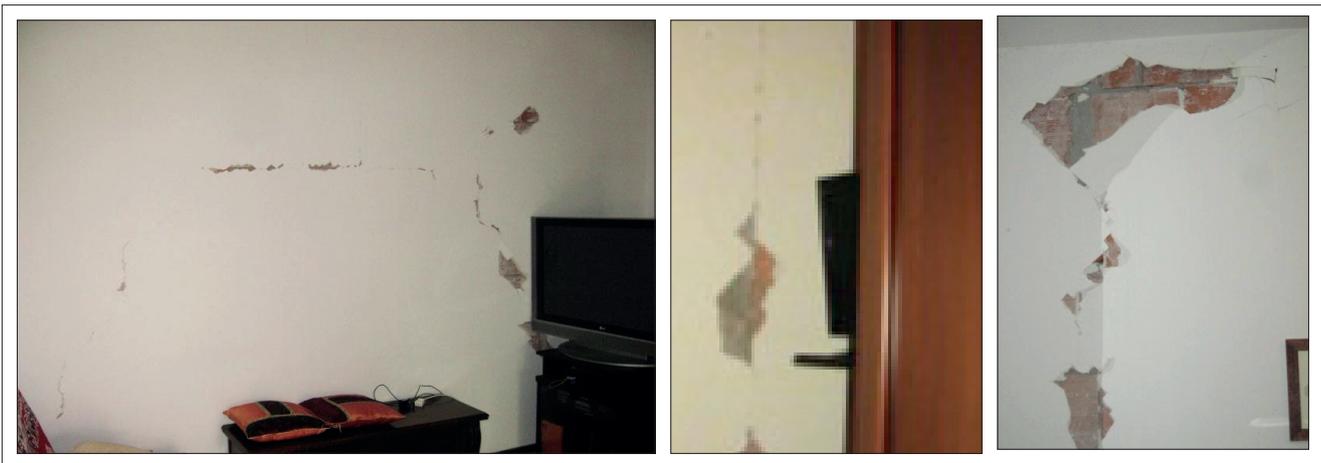
FIGURES 23-24-25 Damage to the partition walls

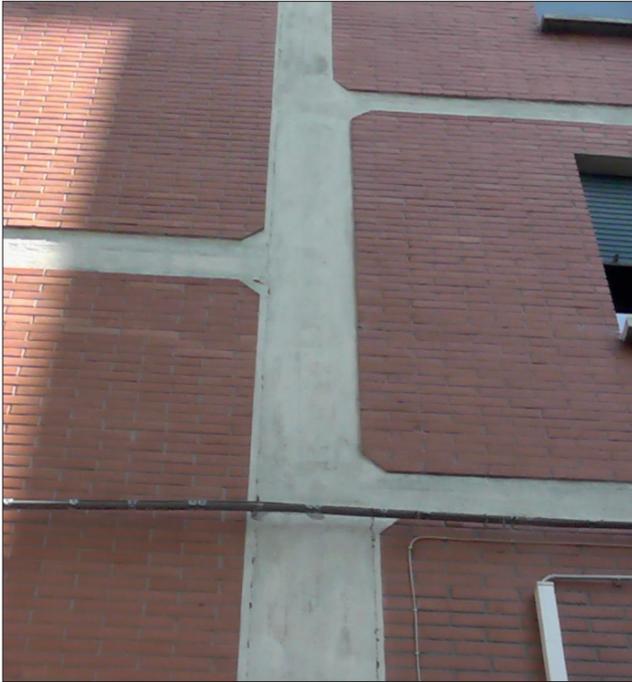
**FIGURE 26** Separation between adjacent buildings

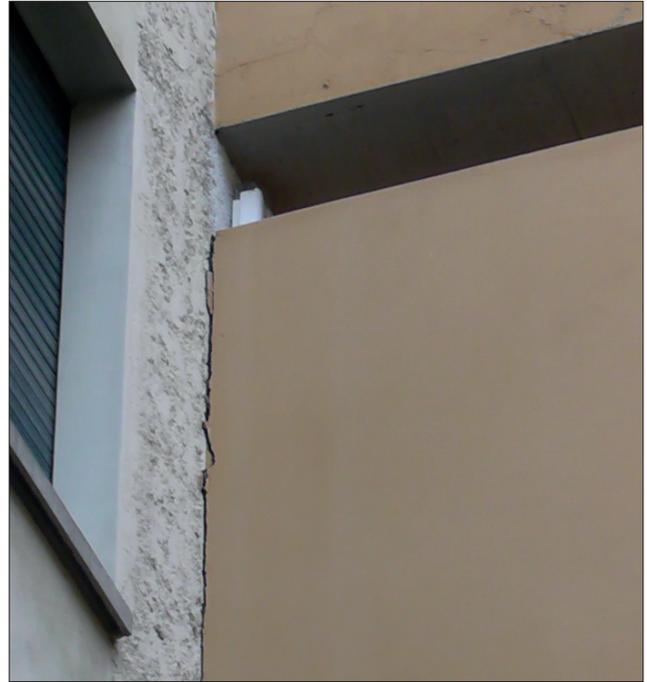
In particular, in the apartments on the first floor of the buildings located at the two ends of the aggregate, the damage to cladding was stronger, making the overturning of the cladding itself possible in case of aftershocks, with consequent danger to the occupants. Some apartments (civic numbers 5, 7 and 17) have also been declared usable after prompt interventions thanks to the separation of the parapet of the balcony.

**FIGURE 27** Detachment of the parapet of some balconies

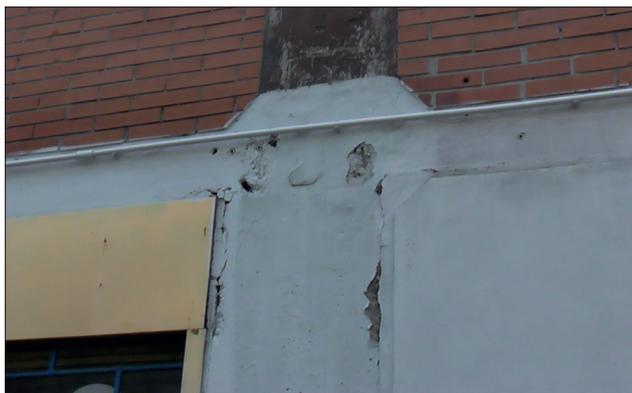
**FIGURE 28** Separation between cladding and structure elements

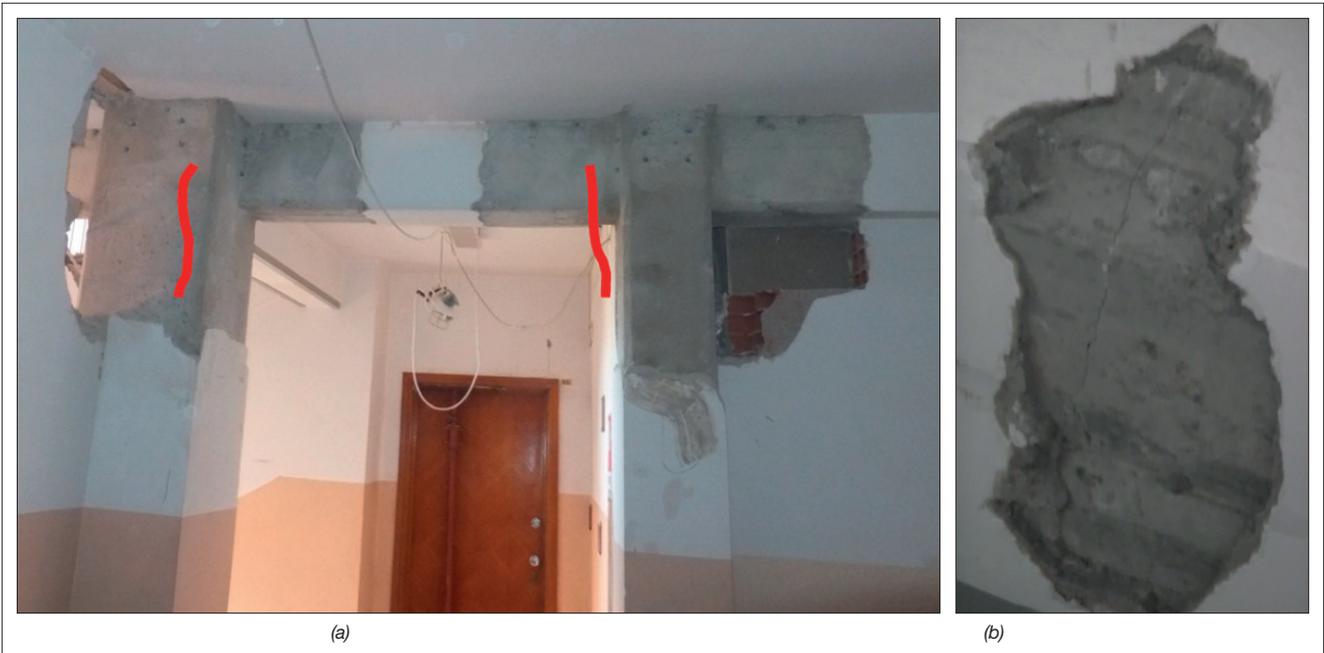
The first pattern consisted of cracks on both sides of all the beams located on the right of the stairs, with reference to the upper direction, at each floor level (Fig. 32a,b). The cracked beams are about 1.90 m long and are present only on one side of the stairs. As a consequence, this is a small element inserted in a rigid body (the stairs), and it can be classified as a stocky beam. The damage has been probably due to the high stiffness of these elements with respect to the adjacent ones. Furthermore, the lintels of the east balcony were cracked almost at all the floors.

**FIGURE 32** Structural seismic damage: a) location of the cracks on the stair beams; b) crack detail

After the survey, a non-usability assessment (i.e., usability only after prompt interventions) has been filled up in the investigation form. In order to permit a quick re-entering of the skyscraper's inhabitants, a rapid and effective local consolidation has been suggested. It consisted in binding the damaged elements (both beams and lintels) with Fibre Reinforced Polymer (FRP) strips. Hence, the plaster was firstly removed from the damaged elements, then the primer layer was applied, and finally the FRP strips were fixed (Fig. 34).

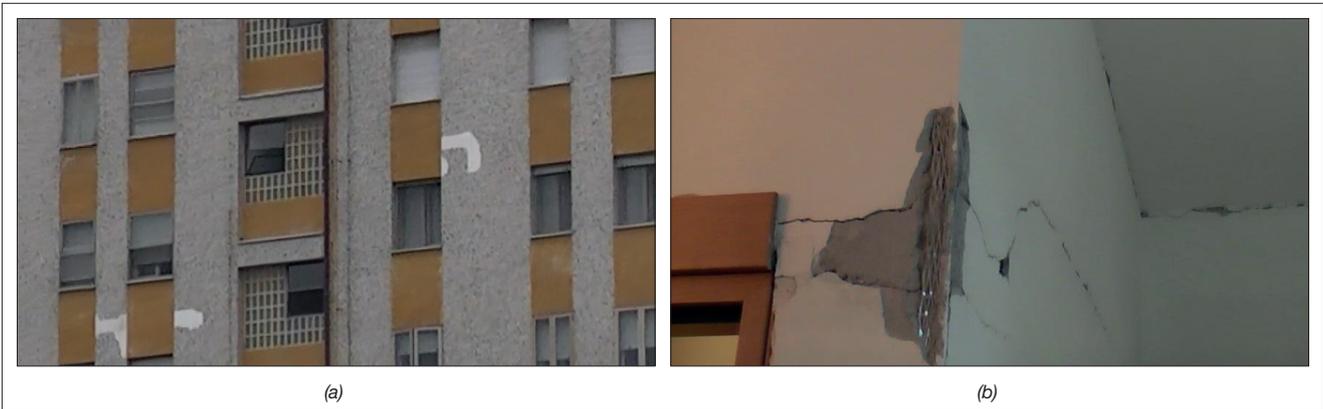
The second pattern was referred to façades, which showed partial fall down of the covering completion layers (plaster and mosaic), in addition to the partition walls cracks (Fig. 33).

**FIGURE 33** Non-structural seismic damages: a) façade covering layers; b) partition walls
