The restoration of the Tower of Montorio, Italy, after the 2003 earthquake

■ Bruno Carpani

■ Bruno Carpani
ENEA, Seismic Engineering Technical Unit

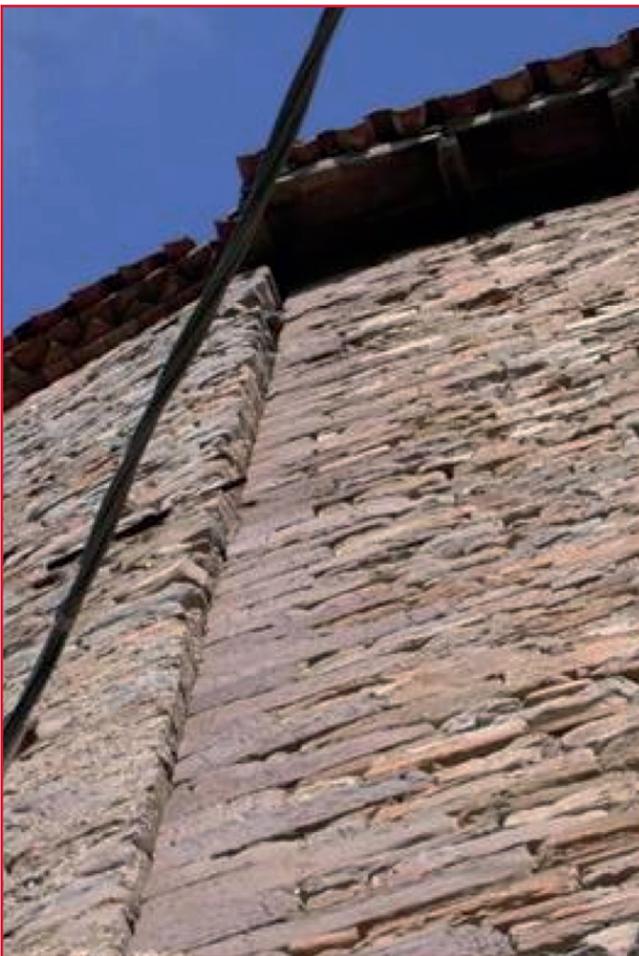
FIGURE 11 Structural discontinuity between adjacent building parts

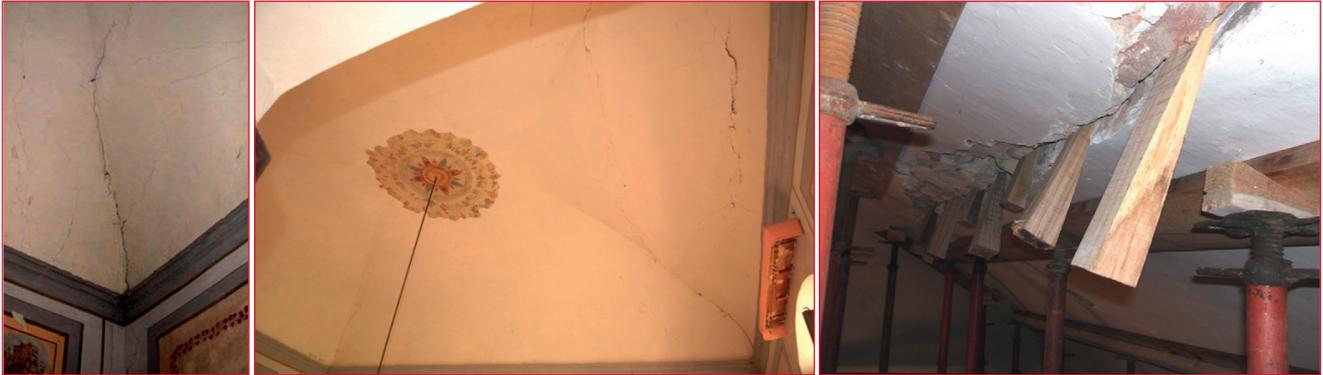
FIGURE 12,13,14 Damage to pavilion vaults

To the former it must be ascribed the damage to the

pavilion vaults (Figures 12-13-14), composite overturning of the walls (Figures 15-16), floor and wall detachments (Figure 17); to the latter, cracks in platbands and architraves (Figure 18), in association with structural discontinuities, detachment of walled up windows built without proper toothings (Figures 19-20).

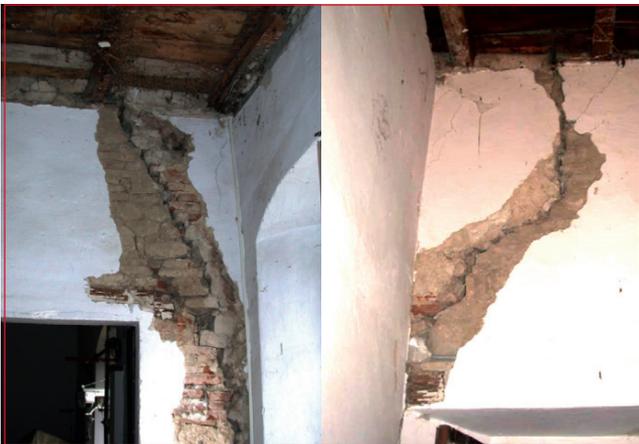
FIGURE 15,16 Cracks due to façade overturning

So, with the aim of improving the structural box behaviour and not to allow first-mode mechanism (overturning of external walls), a widespread introduction of steel ties at each level (in both horizontal directions) has been foreseen (Figures 32); in some cases to connect the floor to the wall, the floor beams themselves were anchored by means of metal plates (Figure 33). In order to reduce the flexibility of floors, double-crossed wooden planks were set wherever possible. The inaccessible area of the garret floor has been reinforced by using a steel stringcourse-tie (Figures 35-36). The roof-to-wall connection was realized with upper stringcourse in reinforced masonry, while the top stone-masonry, due to its degraded conditions, was completely reconstructed in a traditional way according to Giuffrè's proposal (Figures 37-38). In addition to the roof-to-wall connection above described, the thrusting effect of the roof was eliminated to screw the wooden trusses to each other (primary and secondary, Figure 34).

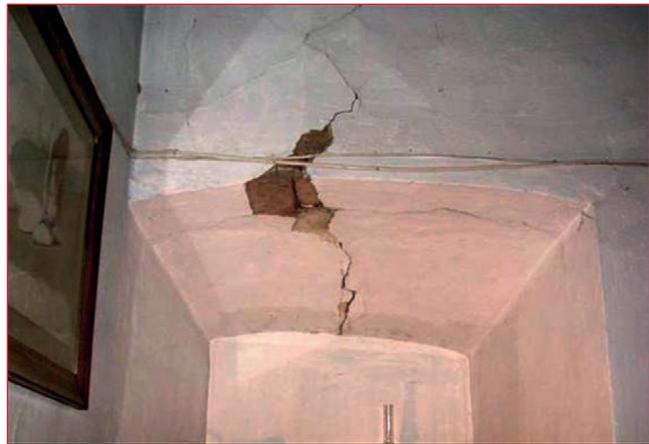
FIGURE 18 Damage to architrave

Regarding masonry, generalized mortar injections were avoided; in case of widespread cracks – most of the ones sited above the windows – only localized injections of compatible mortar were made. Local repairs of inhomogeneous or cracked masonry were conducted

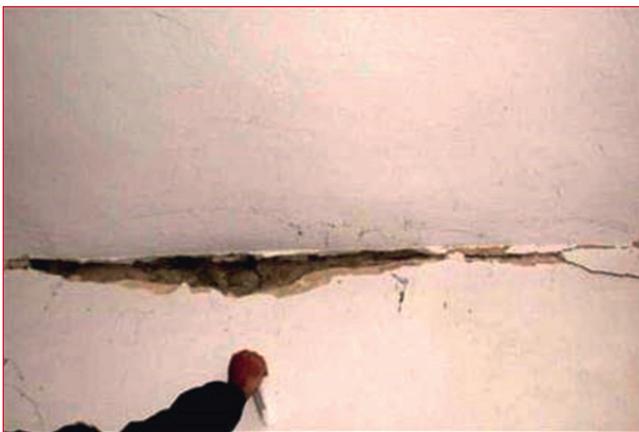
FIGURE 17 Wall-floor detachment

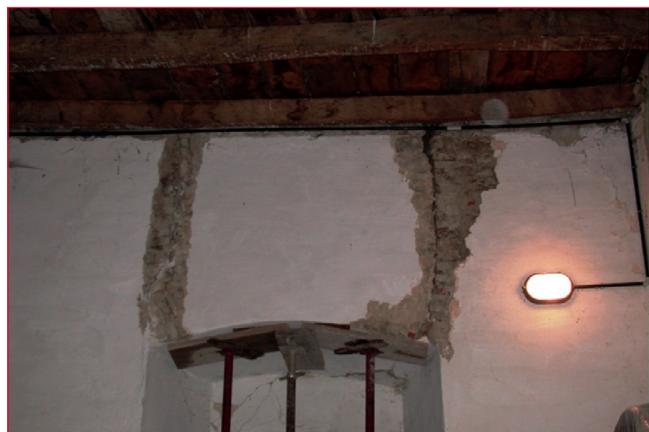
FIGURE 19 Detachment of walled-up window

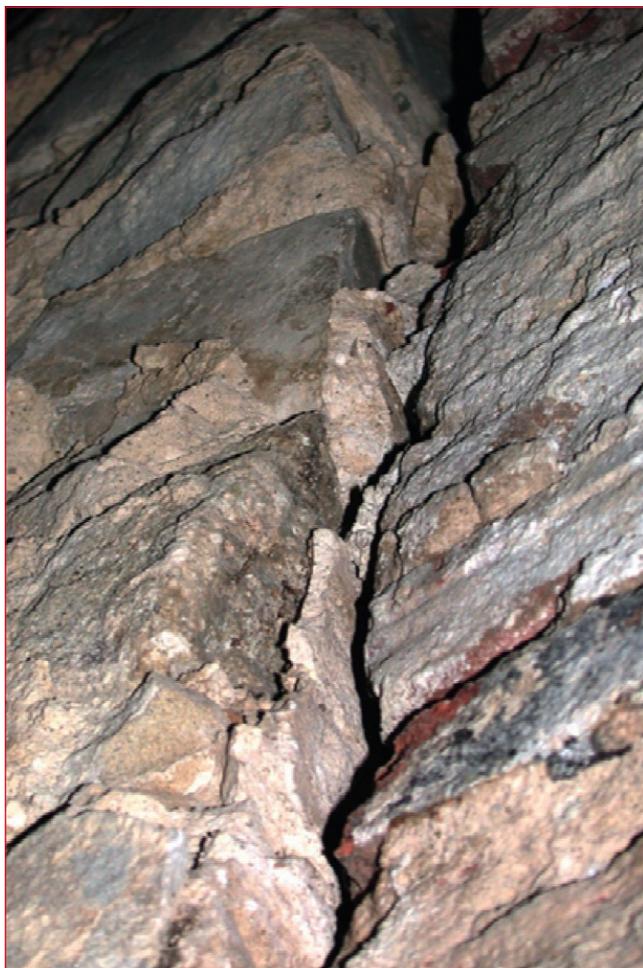
FIGURE 20 Detail from previous figure

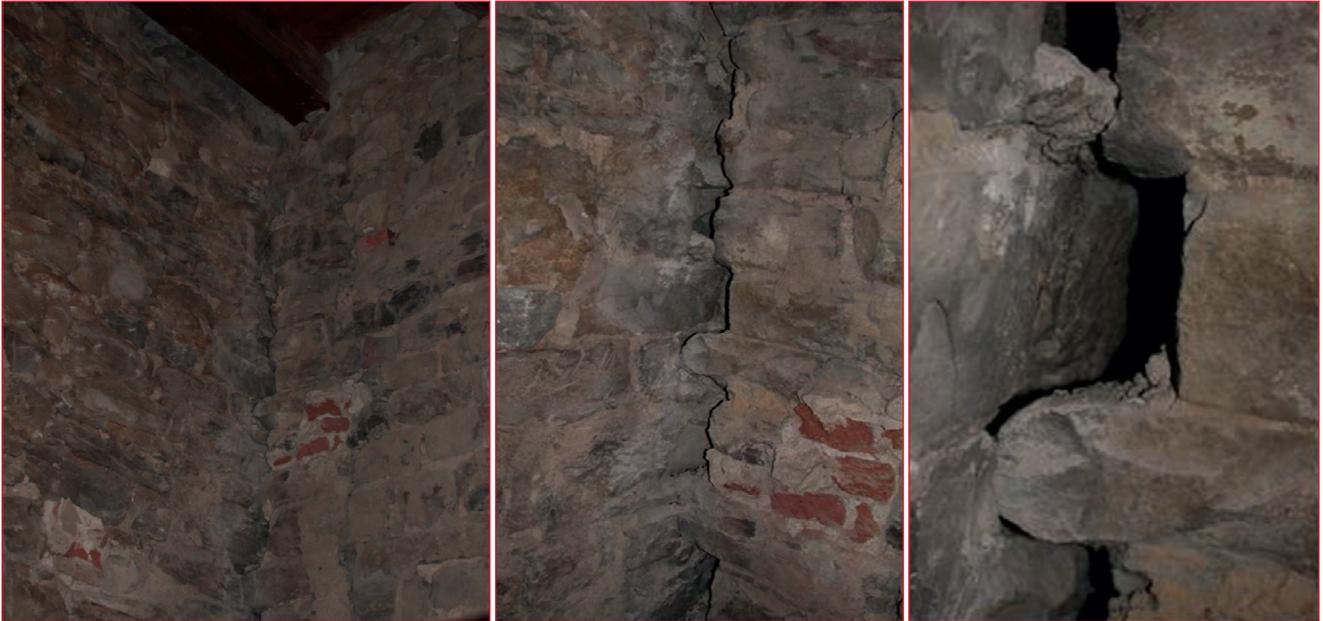
FIGURE 22,23,24 Walls detachment ascribable to 1869 Vergato earthquake

of the 1869 Vergato earthquake (Mw 5,4 I_{max} 7-8), which had considerable effects to the Tower that have been recognised by means of both historical and stratigraphic investigations. Such studies also indicate that earthquakes not only caused significant damage, but also played a decisive role in the evolution of the architectural style of the monument, leading to substantial changes to the floor levels and to the openings layout. It was of special importance discovering the detachment between the orthogonal walls in the tower due to the 1869 earthquake (Figures 22-23-24), clearly proving that a first-mode mechanism took place. At the same time, no serious cracks in the walls associated with that event were detected. This is a damage pattern similar to the

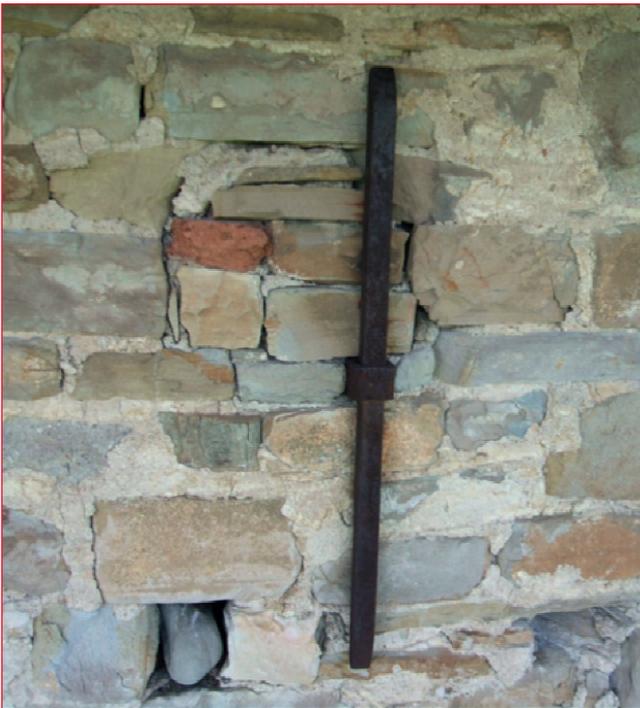
FIGURE 25 Tie rod inserted in breach after the 1869 Vergato earthquake

It is worth noticing that after the 1869 earthquake three metal tie-rods was inserted through breaches in the walls (Figure 25).

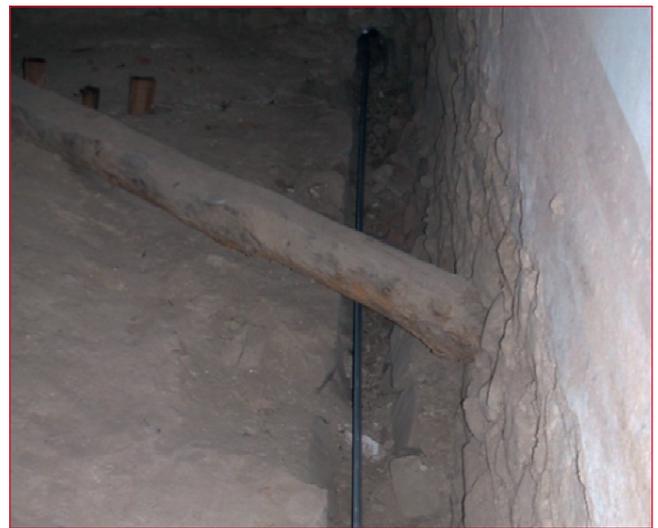
FIGURE 31 Steel tie-rod at the extrados of vault

maintain this structural scheme, replacing the wooden reinforcements with steel ones (Figure 31).

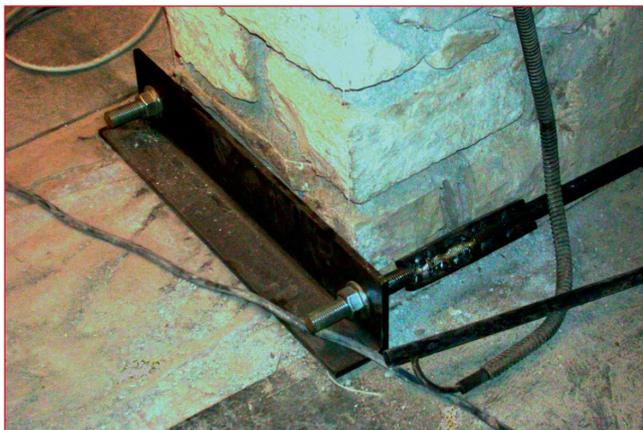
FIGURE 32 Example of internal tie-rod anchorage

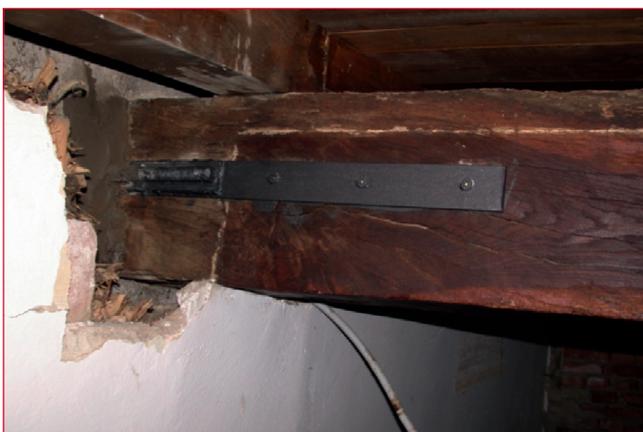
FIGURE 33 Connection floor-wall

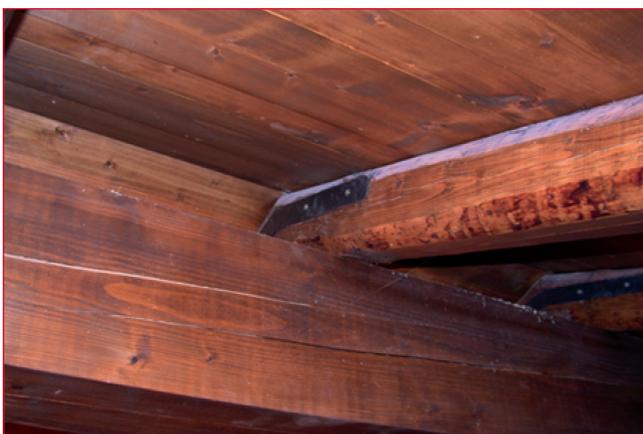
FIGURE 34 Metal connections to roof elements
