THE PIANURA PADANA EMILIANA EARTHQUAKE

Damage and collapse mechanisms in churches during the Pianura Padana Emiliana earthquake

■ Maurizio Indirli, Giuseppe Marghella, Anna Marzo

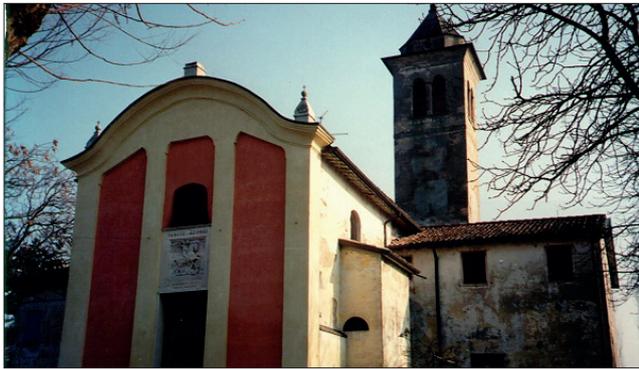
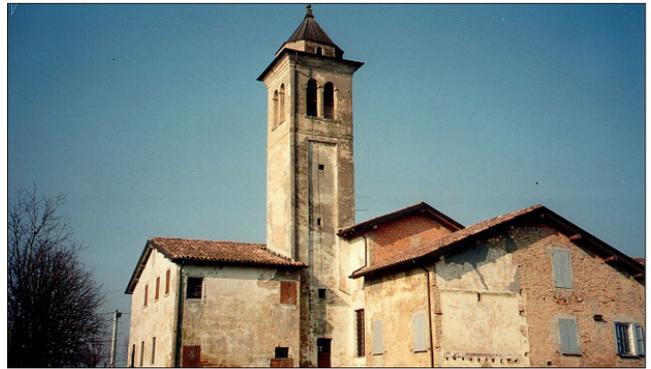
The San Giorgio Church and its Bell-Tower (Trignano, San Martino in Rio, Reggio Emilia, Italy)

Cracks on the Bell-Tower (a, b) and rotation of the upper structure (c, d)

Application of 4 steel tie bars including SMADs: intervention scheme (i); anchorages at the building top (e) and at the foundation (f); SMADs before (g) and after (h) assembling; intervention details (j); bell-tower after restoring (k)

It concerned the experimental dynamic characterization of the church plus bell-tower complex, and its post-earthquake restoration, including the insertion of 4 vertical steel ties in series with Shape Memory Alloy Devices (SMADs), an innovative technique conceived in the framework of the aforesaid ISTeCH project [5-6]. Damage, restoration and intervention schemes are reported in Fig. 4. A subsequent seismic event, with about the same epicentre, occurred at 9:42 on June 18th, 2000 (Mw 4.5, MCS Intensity VI-VII). Immediately after the main shock, the bell-tower was again investigated with great accuracy by the ENEA personnel, but it showed no damage of any type. The 2000 seismic event had been the best verification of the retrofit.

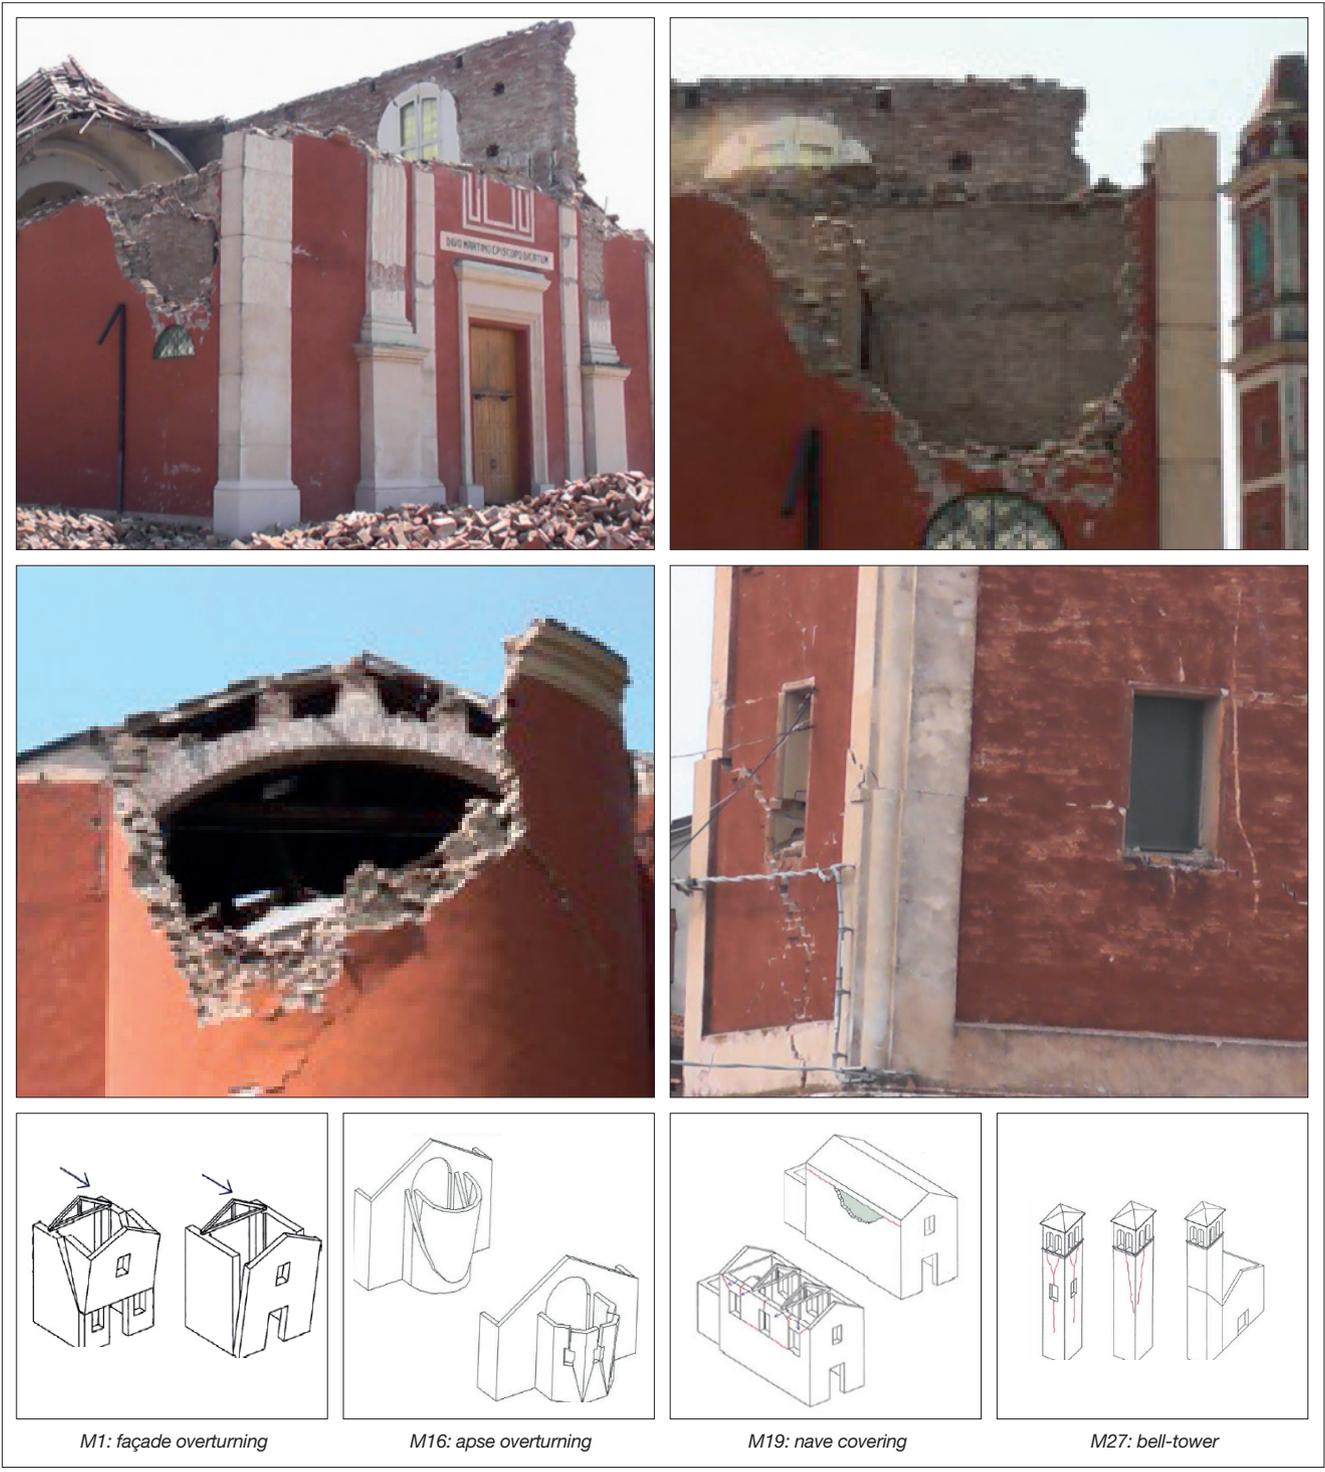
In this first period, an ENEA team (Maurizio Indirli, Giuseppe Marghella, Anna Marzo), operating in the vast territory of the town of Cento (Ferrara), had the opportunity to see directly some cases of damage/collapse of churches and bell-towers. The most impressive general collapse, due to the first shock (maximum May 20th peak ground acceleration, PGA: Mirandola recording station, 0.30g; Medicina recording station, 0.04g) and aggravated by the following ones (maximum May 29th PGA: Cento recording station, 0.30g), occurred in the church of San Martino di Tours (Fig. 5), located in Buonacompra (Cento, Ferrara). The construction probably started in 1399, but it was strongly modified during the XVIII-XIX centuries. A controlled demolition of the bell-tower, cut in at least three portions by the earthquake, was underway at the time of the visit, removing the masonry bricks line by line (Fig. 6).

FIGURE 5 Damage in the San Martino di Tours church and bell-tower in Buonacompra (Cento, Ferrara) and main collapse mechanisms

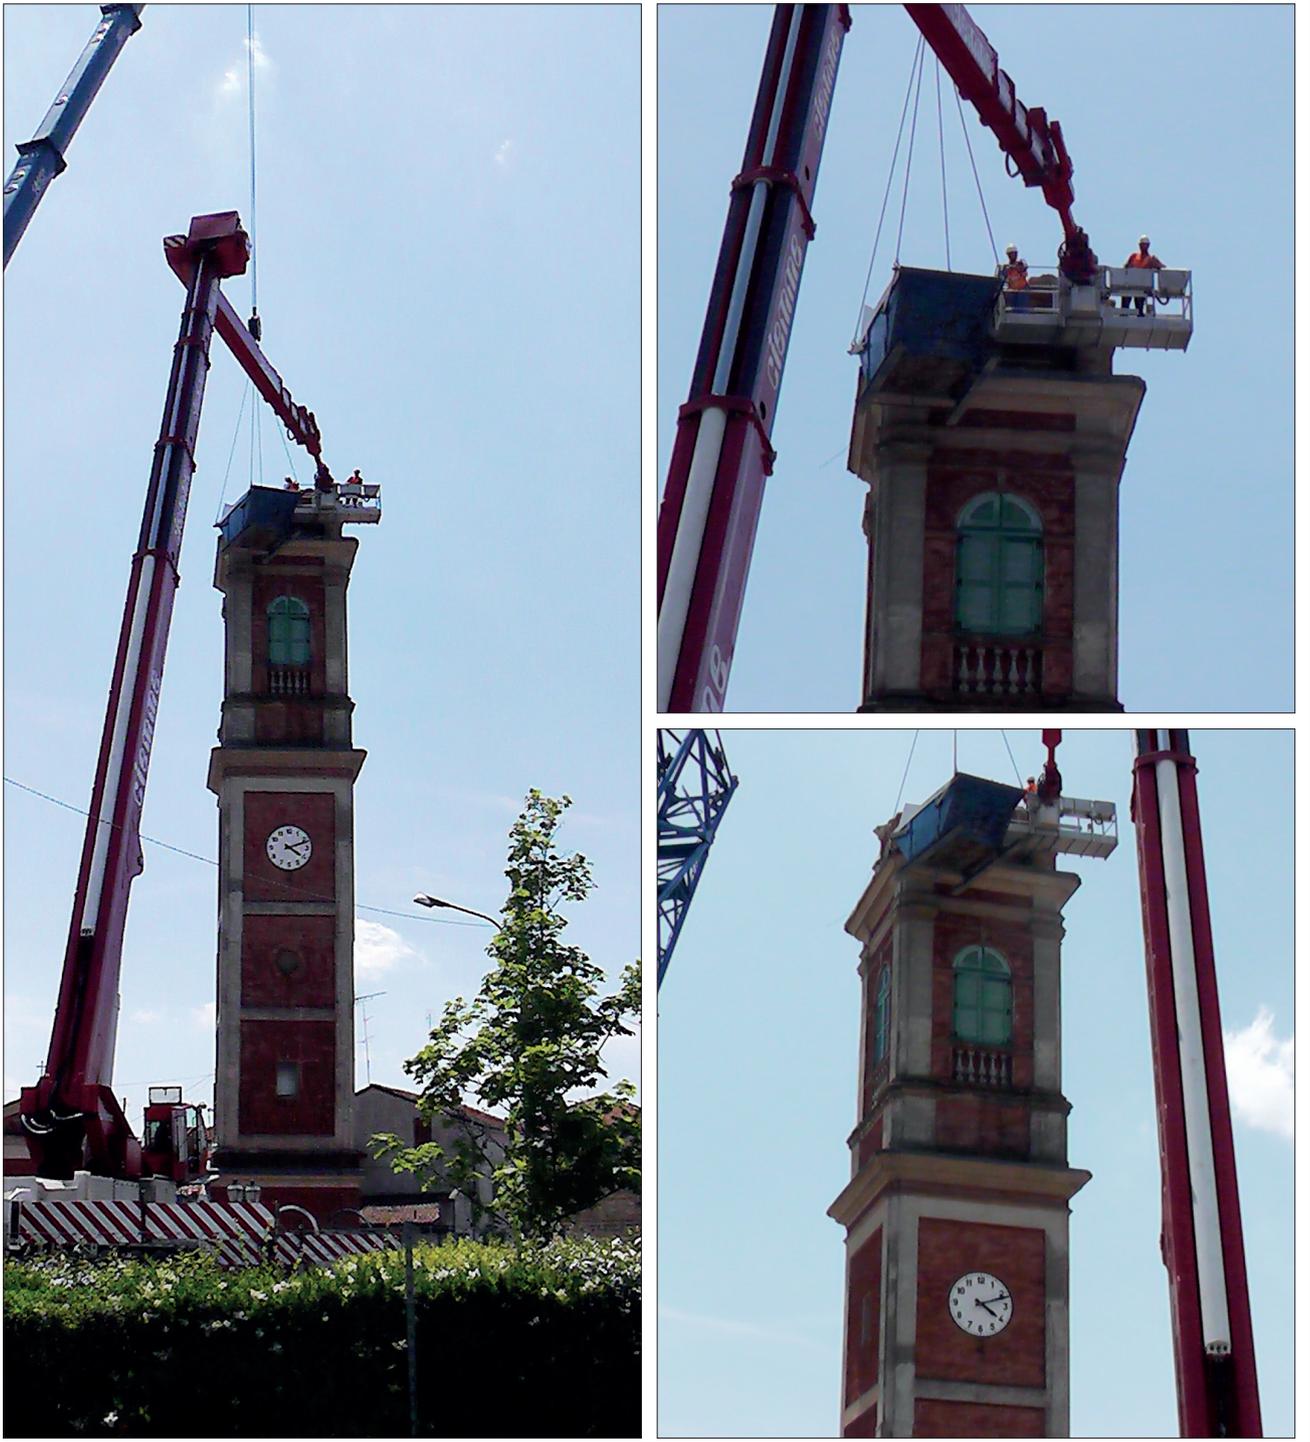
FIGURE 6 Controlled demolition in the San Martino di Tours church bell-tower in Buonacompra (Cento, Ferrara)

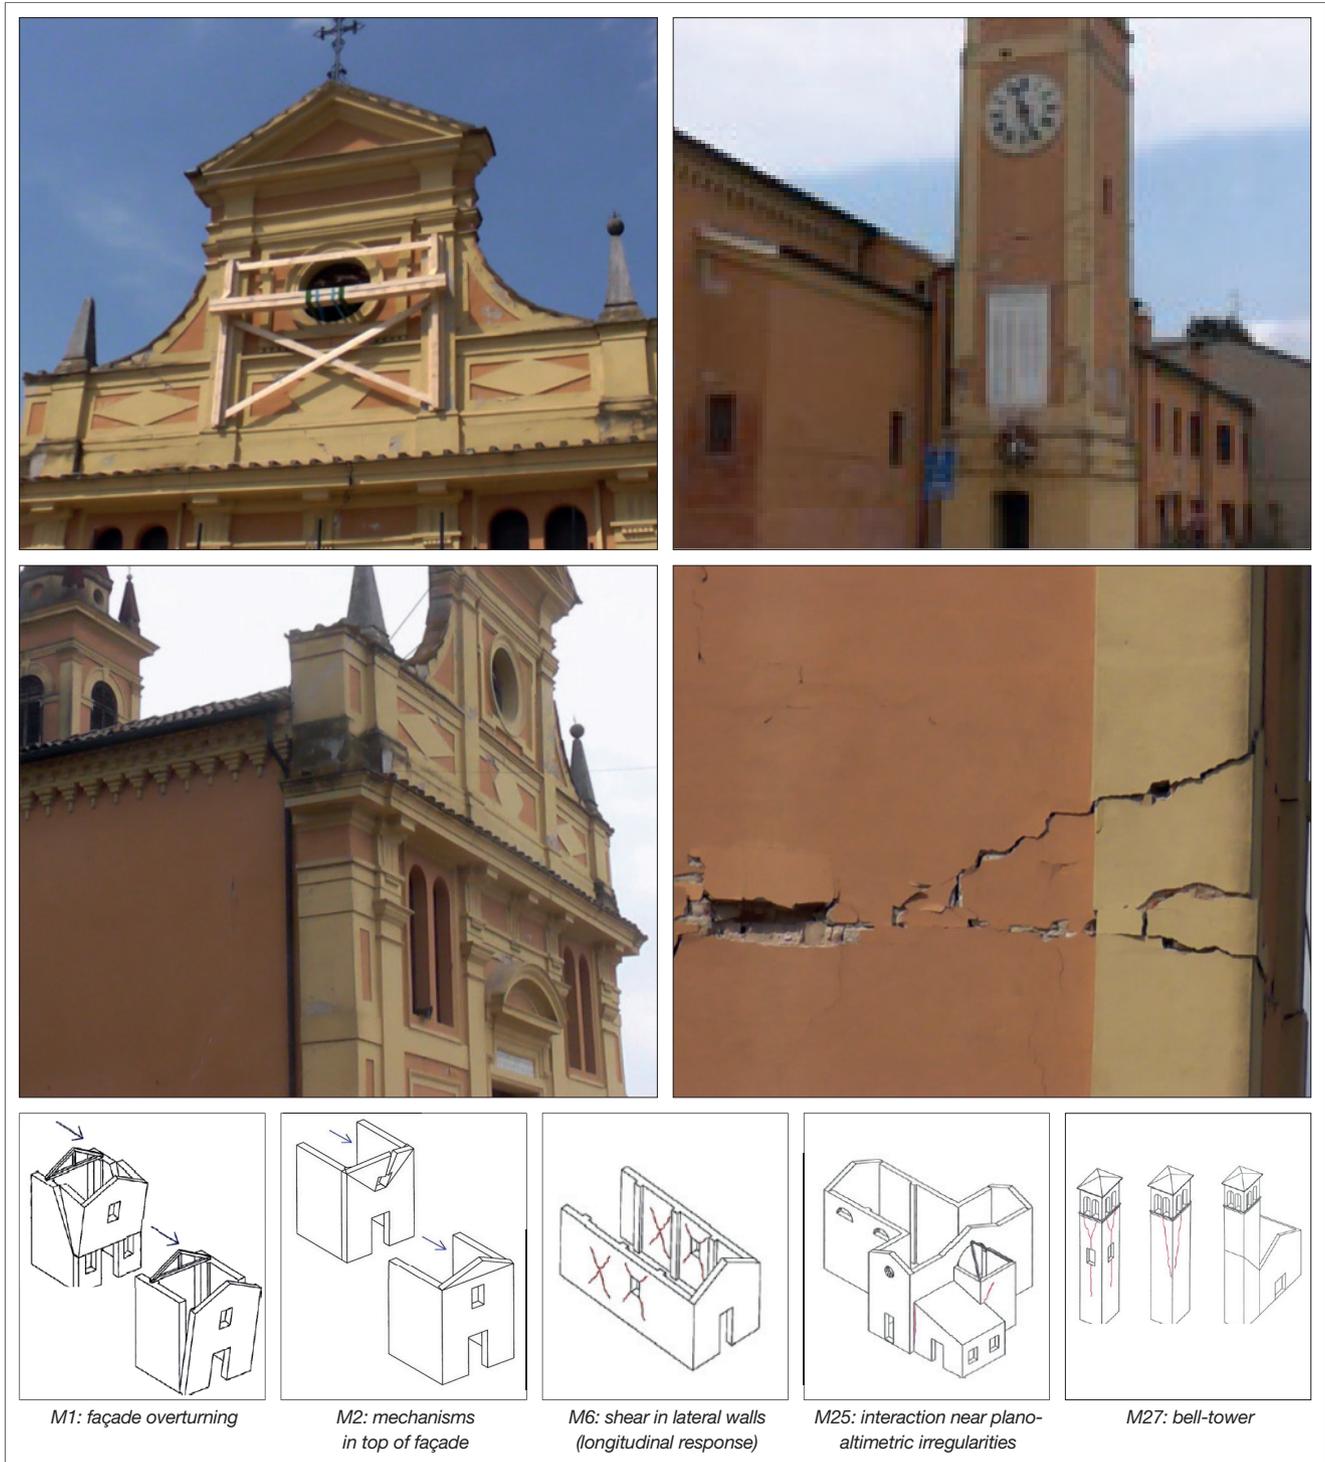
The church of San Lorenzo at Casumaro (Cento, Ferrara) was founded in 1449 by the Bishop of Modena, but many changes were done (together with the bell-tower) during the XVIII-XIX centuries. Immediately after the first shock (the maximum PGA values are the same as the previous case), the church showed a clear out-of-plane detachment in the façade, together with shear cracks in its masonry panels and tympanum overturning; the bell-tower was close to collapse, due to deep cracks originated by bending and torsion movements during the earthquake (Fig. 7).

FIGURE 7 Damage to the San Lorenzo church in Casumaro (Cento, Ferrara) and main collapse mechanisms

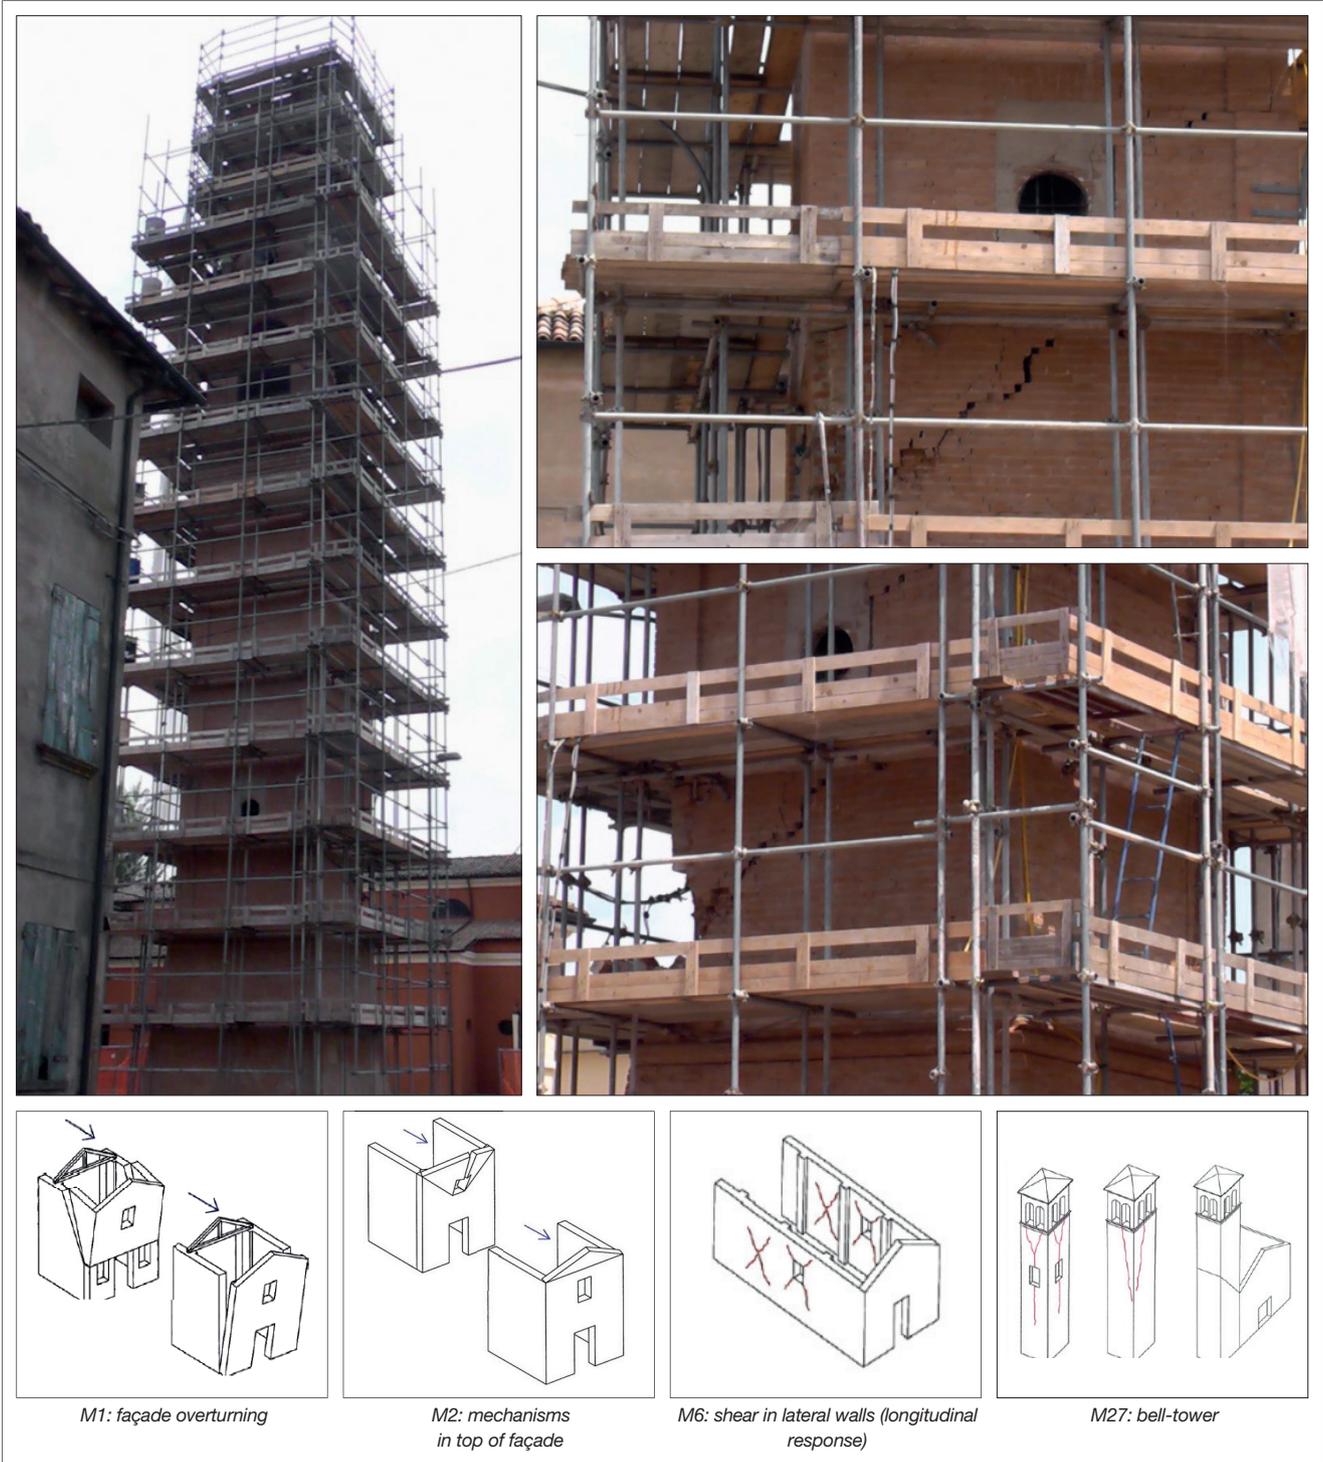
About a similar incipient collapse occurred to the bell-tower of the Sant’Anna church (built in 1772 and subsequently modified in the XIX century) in Reno Centese (Cento, Ferrara, PGAs as before), which has been divided into two portions by the seismic event since the first shake (Fig. 8); after a long discussion between the experts about its possible demolition, the structure has been put in safety through an innovative intervention, spraying jets of mortar and structural fibres in the cracks [7].

FIGURE 8 Damage to the Sant'Anna church in Reno Centese (Cento, Ferrara) and main collapse mechanisms

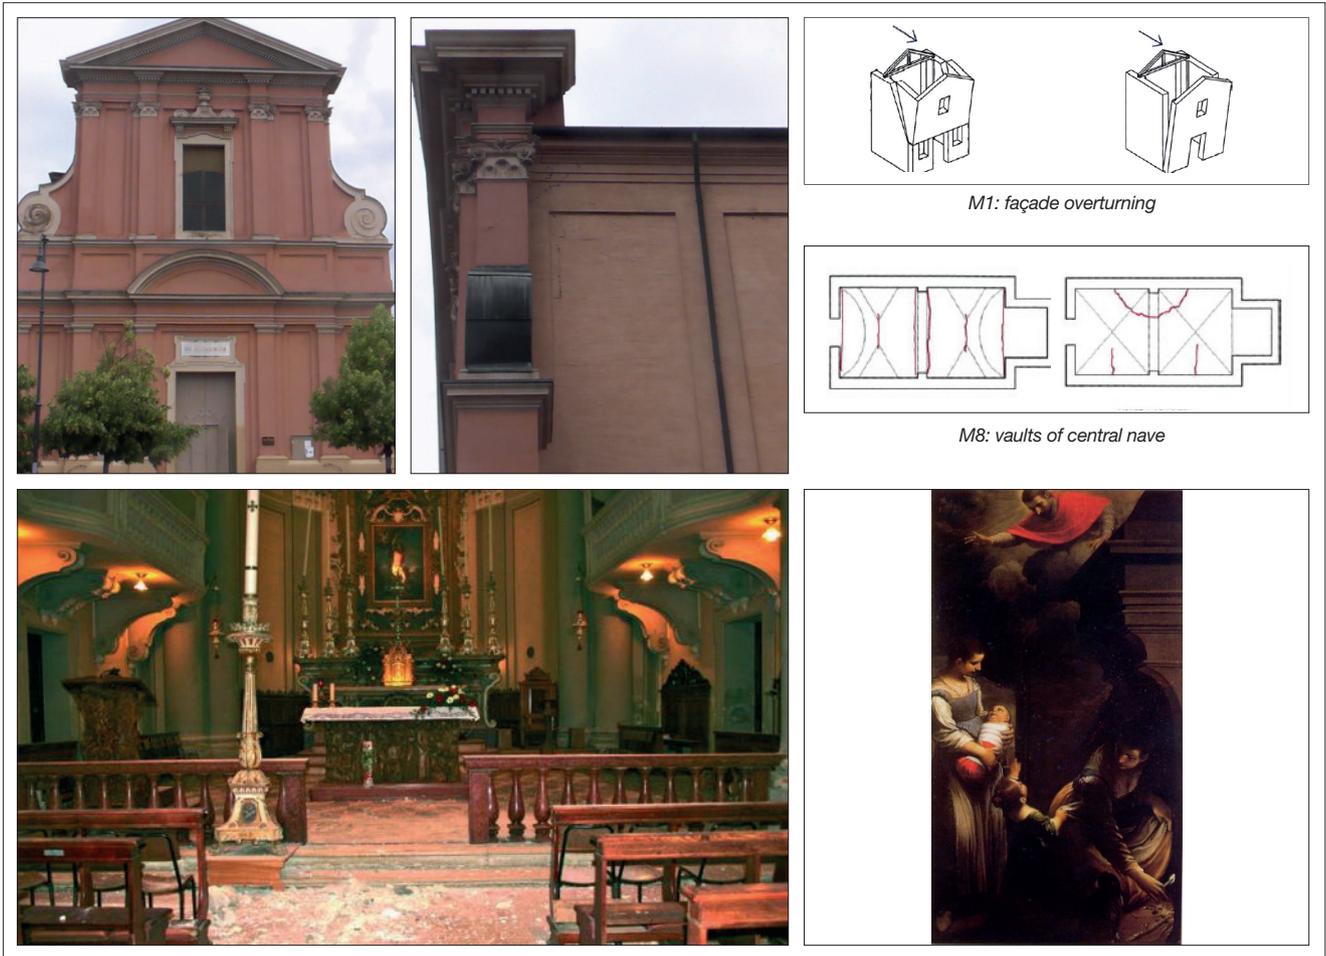
Also the church of San Sebastiano (XV century, modified in the XVIII) in Renazzo (Cento, Ferrara, PGAs as before) was damaged (Fig. 9). Several works of art were removed by the firemen, including a famous painting of Guercino (the miracle of San Carlo Borromeo), put in a temporary safe place.

FIGURE 9 Damage to the Church of San Sebastiano in Renazzo (Cento, Ferrara) and main collapse mechanisms

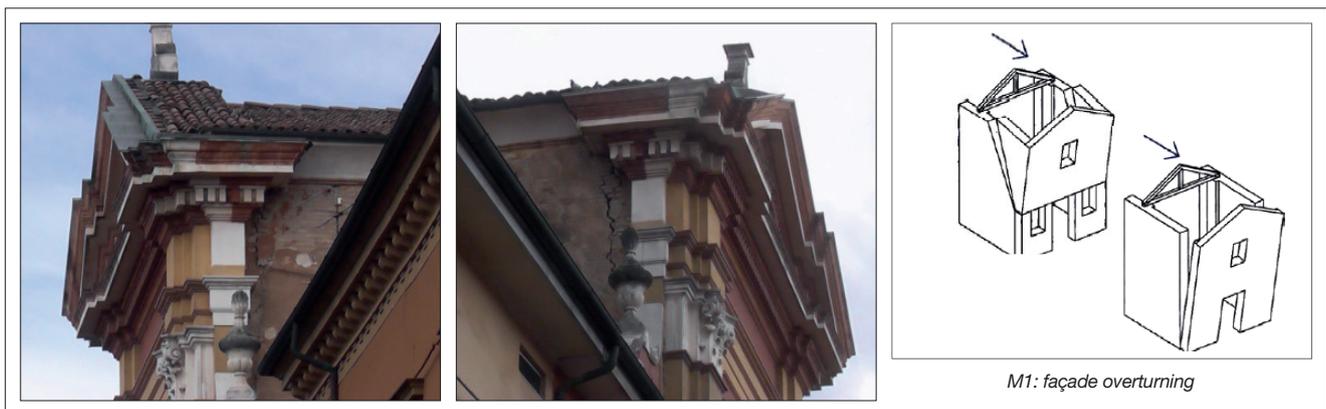
FIGURE 10 Cento (Ferrara) historic centre: the church of San Filippo Neri and main collapse mechanisms

Inside the historic centre of Cento (Ferrara), most of the damage occurred after the shock of May 29th (Cento recording station, PGA 0.30g): Church of San Filippo Neri (detachment of the façade, Fig. 10); Church of San Sebastiano and San Rocco (collapse of the tympanum, Fig. 11); Church of San Biagio (instability of the top part of the bell-tower, Fig. 12); Church of San Pietro (detachment of the façade, Fig. 13); Church of the Rosario (vault collapse, Fig. 14).

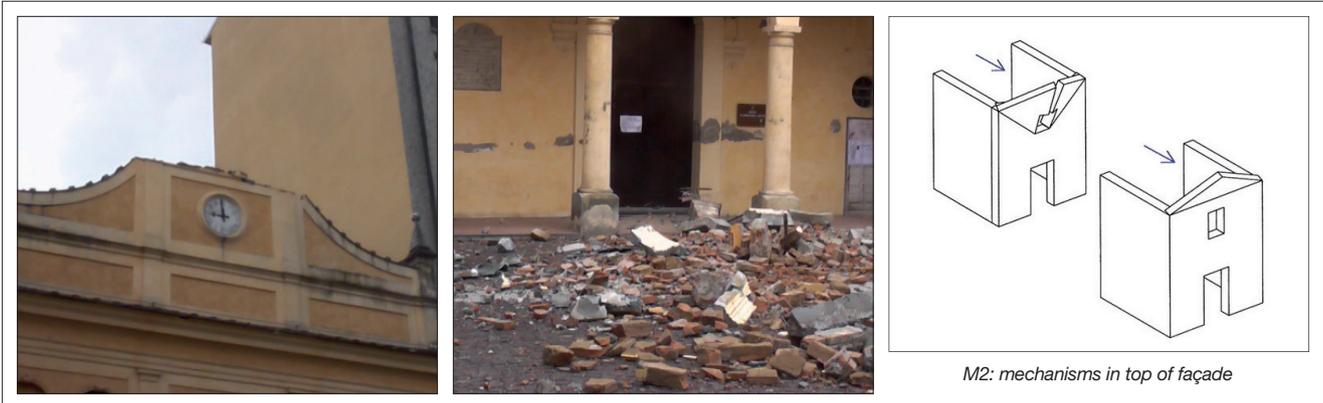
FIGURE 11 Cento (Ferrara) historic centre: the Church of San Sebastiano and San Rocco (Convent of Friars Capuchins) and main collapse mechanisms

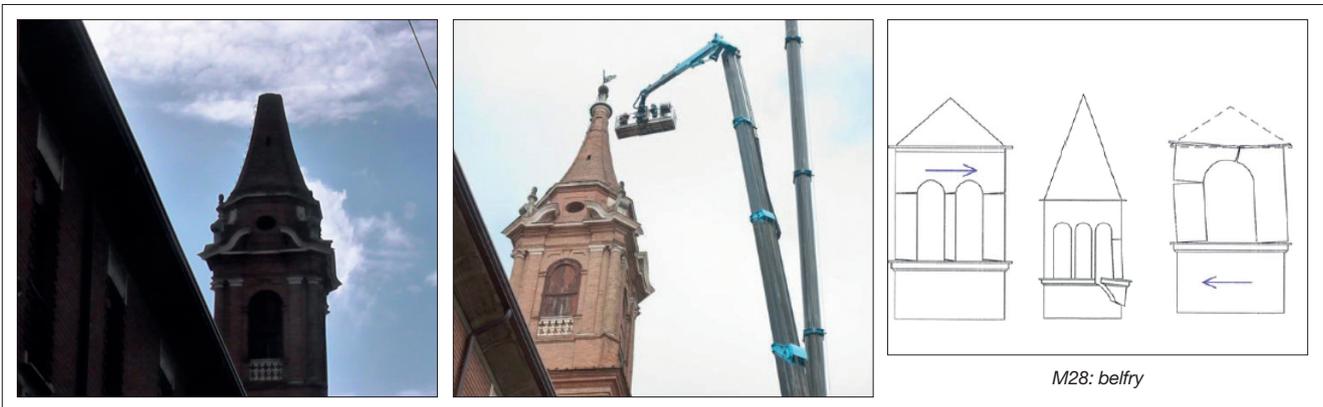
FIGURE 12 Cento (Ferrara) historic centre: the Church of San Biagio and main collapse mechanisms

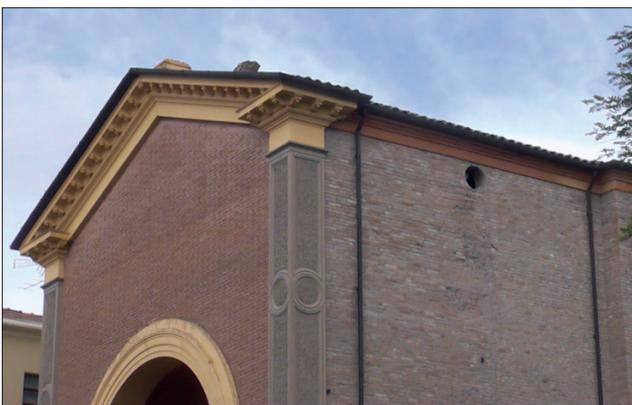
FIGURE 13 Cento (Ferrara) historic centre: the Church of San Pietro and main collapse mechanisms (middle above)

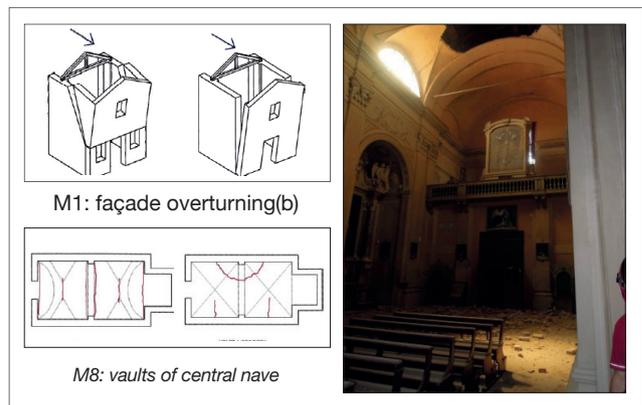
FIGURE 14 Cento (Ferrara) historic centre: the Church of the Rosario and main collapse mechanisms (middle bottom)

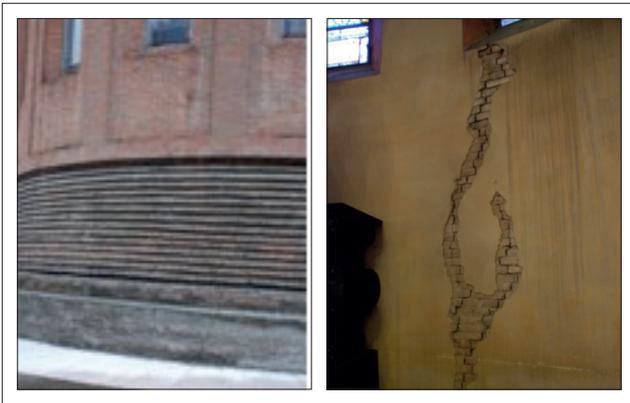
- The survey evidenced damage due to the recent seismic event, but also previous ones. The latter are caused by subsidence, because of different soil mechanical properties.

In particular, the ground under the crypt is more deformable in comparison with the adjacent area; therefore, this part of the construction shows an in-progress sinking mechanism.

The old cracks (Fig. 16) increased with the recent earthquake, which originated new local/global damage mechanisms.

FIGURE 16 Subsidence phenomena: a) external view; b) internal view

Finally, a damage index of about 0.27 has been obtained. Soil geotechnical survey and seismological microzoning is considered mandatory, in order to evaluate how to enhance the foundations.

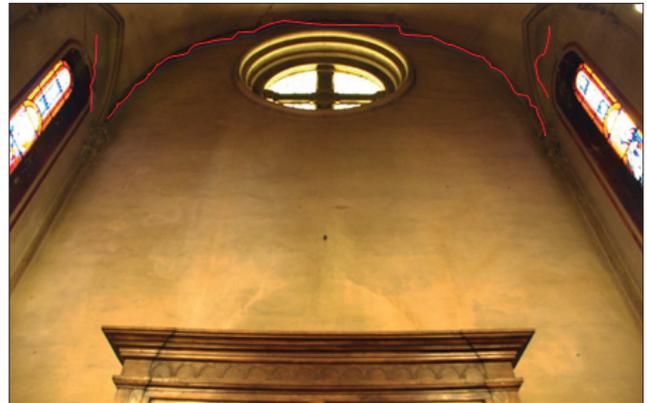
The major cracks of the main façade are highlighted with a red line (Fig. 17), and the mechanisms plotted in Fig. 18. It is worth noticing that the mechanisms related to church lateral apses have been considered as chapel mechanisms (M22 and M23).

FIGURE 17 Façade overturning mechanism (M1), internal view

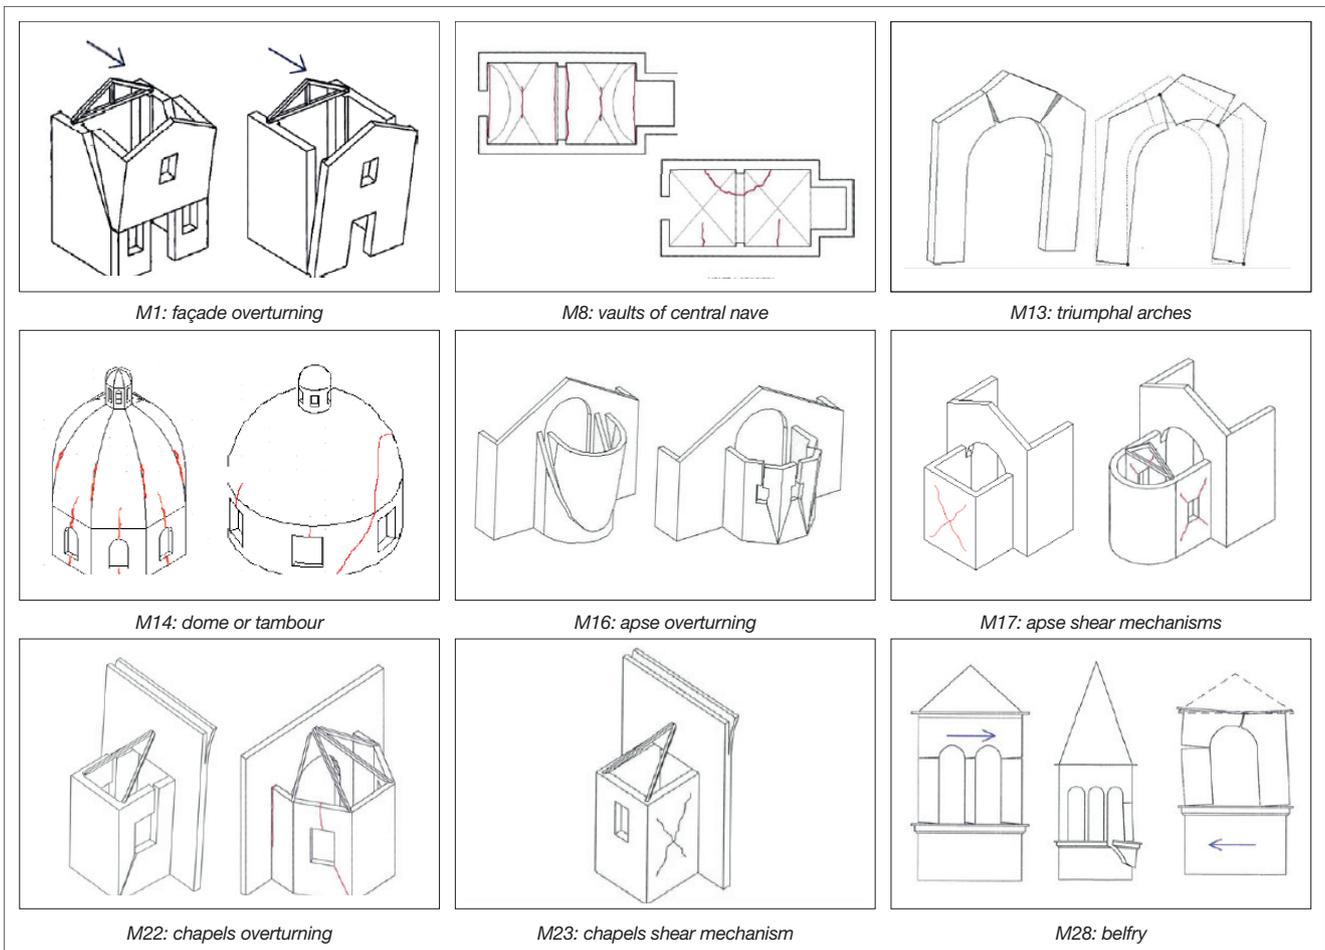
FIGURE 18 Damage mechanisms observed in the Monumental Temple of Fallen (Modena)

Moreover, also extensive material diagnostics and dynamic characterization should be carried out, aiming at a general (conventional and/or innovative) anti-seismic reinforcement. Restoration should regard all the decorative apparatus.

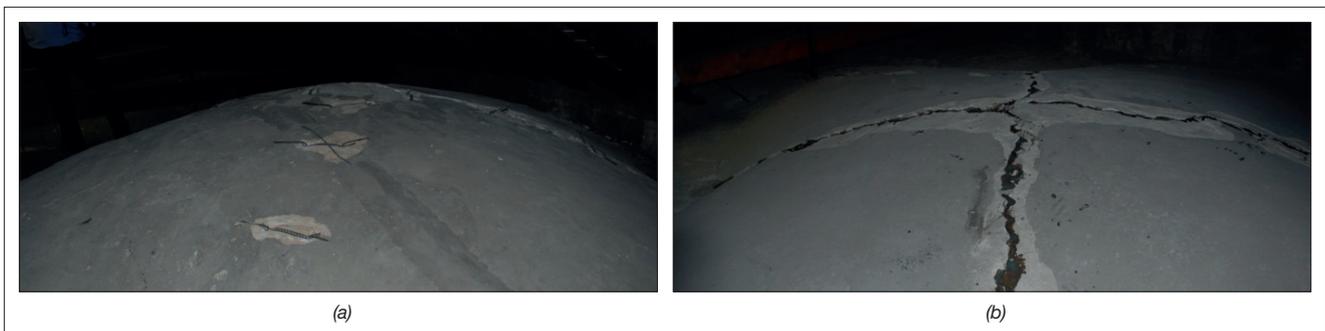
the lateral nave. Cracks along the ribs and falling of bricks were found. Such damage has been repaired through prompt interventions (almost completed at the time of our visit), ringing of the ribs with metallic plates fixed to the vaults (Fig. 23a), and filling the cracks with resin (Fig. 23b).

FIGURE 23 The San Geminiano Cathedral: a) ringing of the vault ribs; b) filling of the cracks

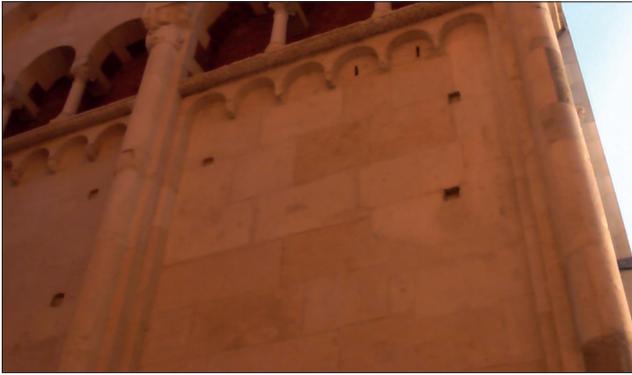
In addition, the main façade showed a potential overturning mechanism, slightly triggered, highlighted with a black line in Fig. 24. Moreover, the opening of the transversal walls (corresponding to the lateral nave) from the longitudinal one has been observed (Fig. 25), due to the variability of the mechanical properties of the soil foundation.

FIGURE 24 The San Geminiano Cathedral: potential overturning of the façade

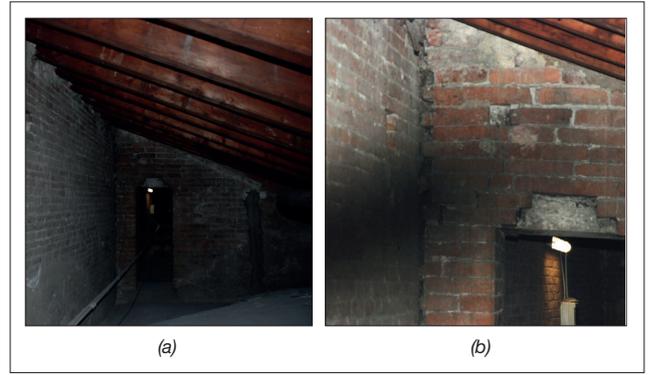
FIGURE 25 The San Geminiano Cathedral: overturning of the lateral transversal walls

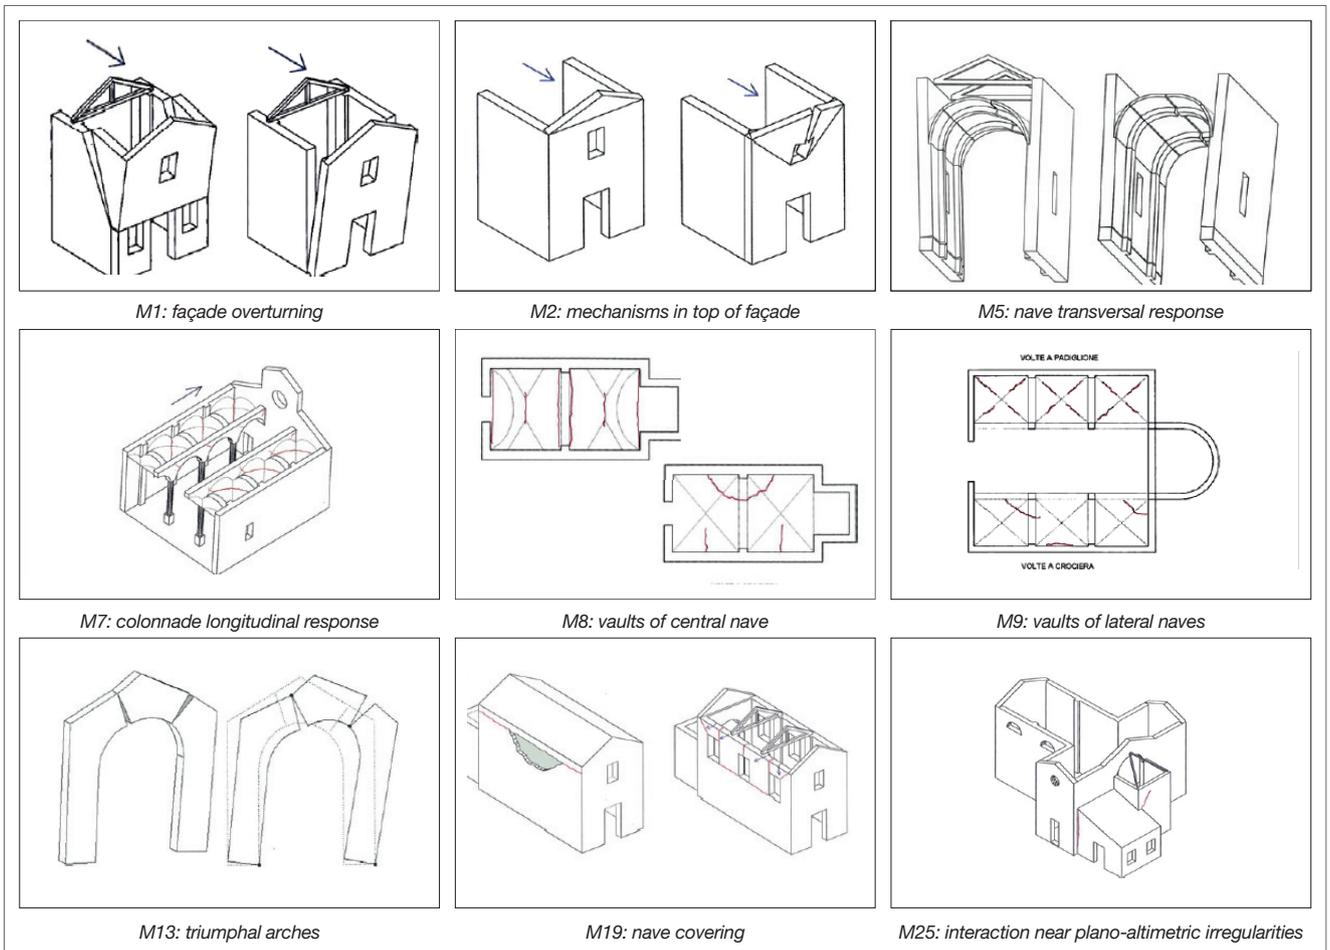
All the detected main mechanisms are summarised in Fig. 26 (Cathedral, global damage index equal to 0.16) and Fig. 27 (Ghirlandina, global damage index equal to 0.27), respectively.

FIGURE 26 Damage mechanisms in the Cathedral of San Geminiano (Modena)

The following several interventions were suggested after the investigation: structural re-establishment of damaged vaults, arches, ribs and unconnected wall portions. The implementation of the monitoring system – for a deep and permanent dynamic characterization of the whole complex, evaluating in particular church/tower interactions – is considered necessary and propaedeutic to complete the existing strengthening systems, in both the Cathedral and the Ghirlandina.

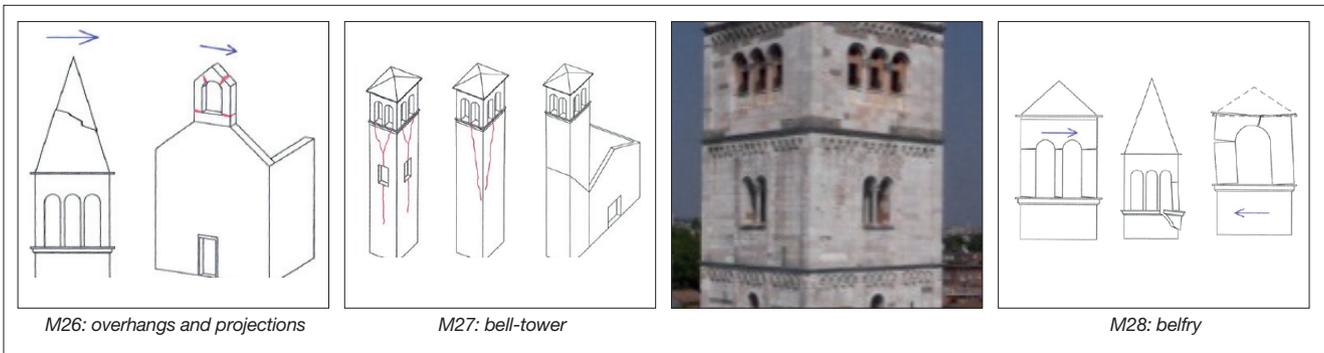
FIGURE 27 Damage mechanisms in the Ghirlandina Tower (Modena)

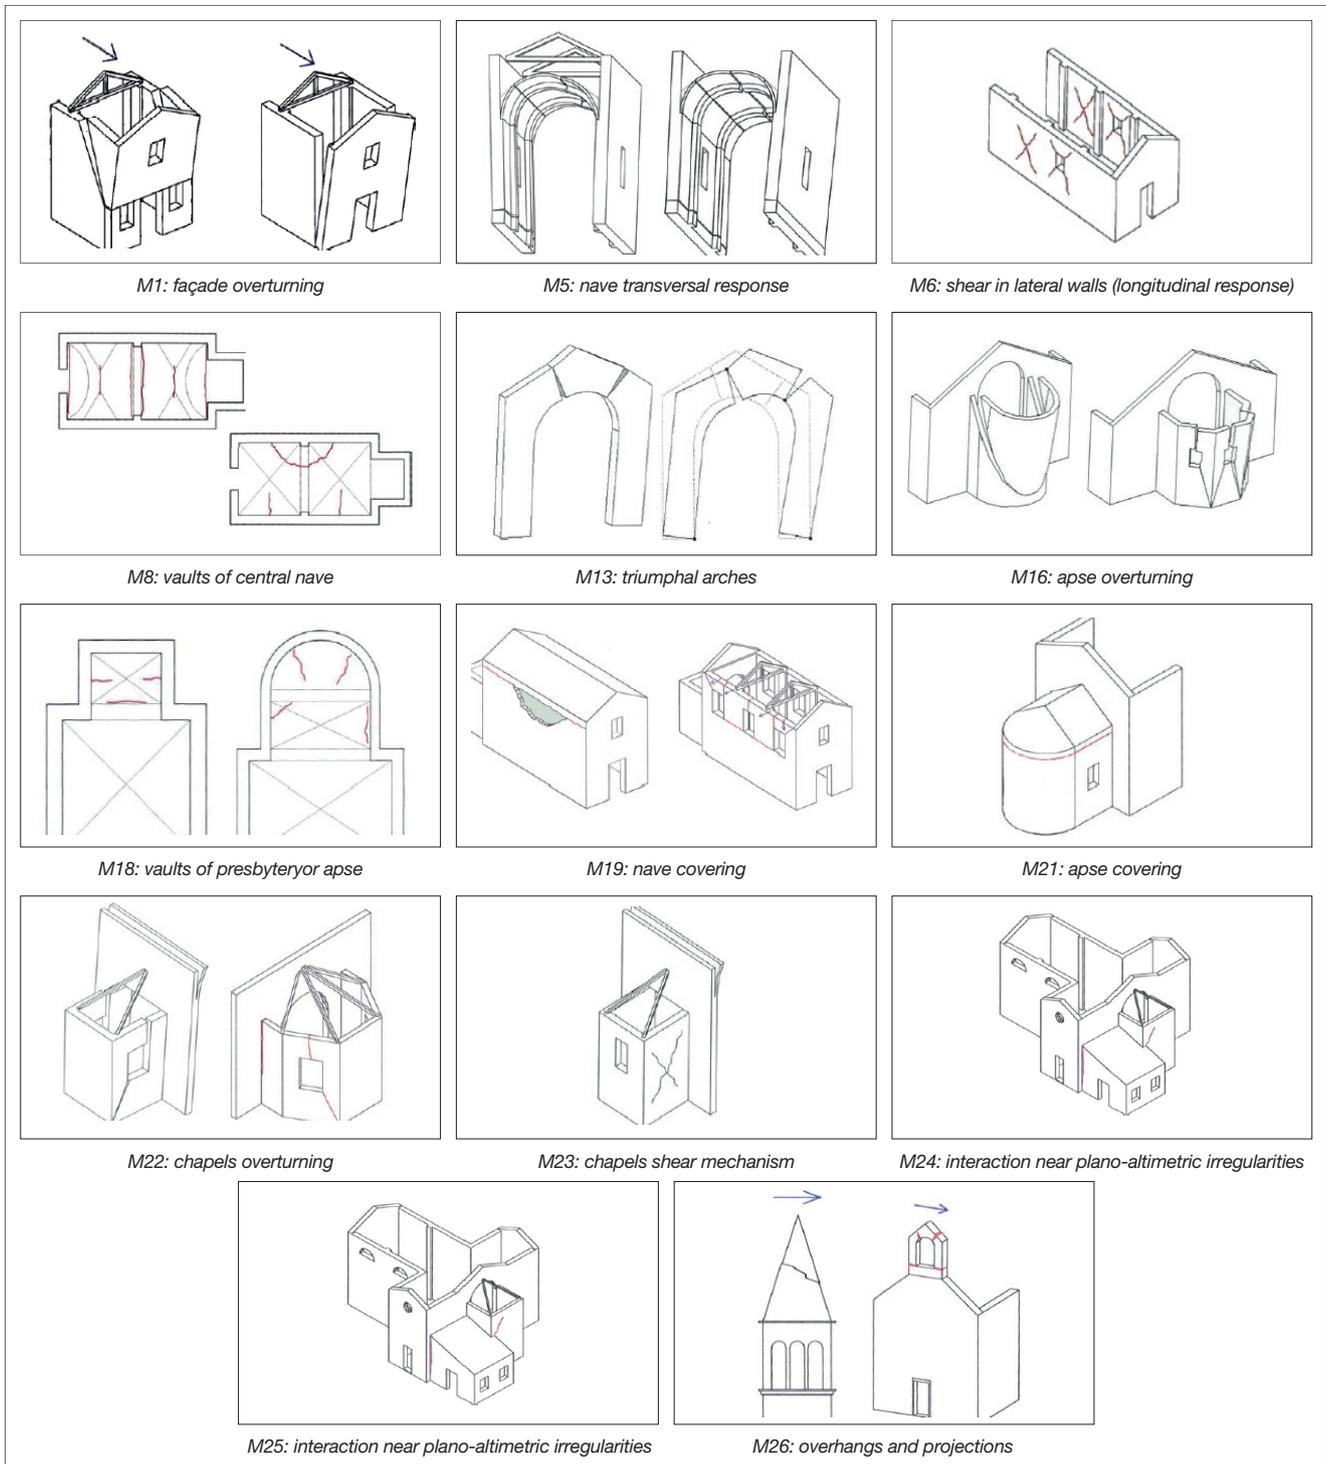
Damage survey and observed mechanisms - The church was bombed during the Last World War and the original bell-tower collapsed. Never completely restored, at the time of our visit it showed a generalised previous damage in walls, vaults and arches, worsened by the earthquake (Fig. 29). The main mechanisms are reported in Fig. 30, corresponding

to a global damage index equal to 0.16. During the May 2012 seismic events, the church experienced a PGA maximum value of 0.040g (Medicina recording station). After the survey, it was considered safe, but the maintenance poor (previous cracks, humidity due to rain). Tying enhancements of nave and tympanum have been suggested.

FIGURE 30 Damage mechanisms in the Parish of San Giovanni Battista in Triario (Minerbio, Bologna)

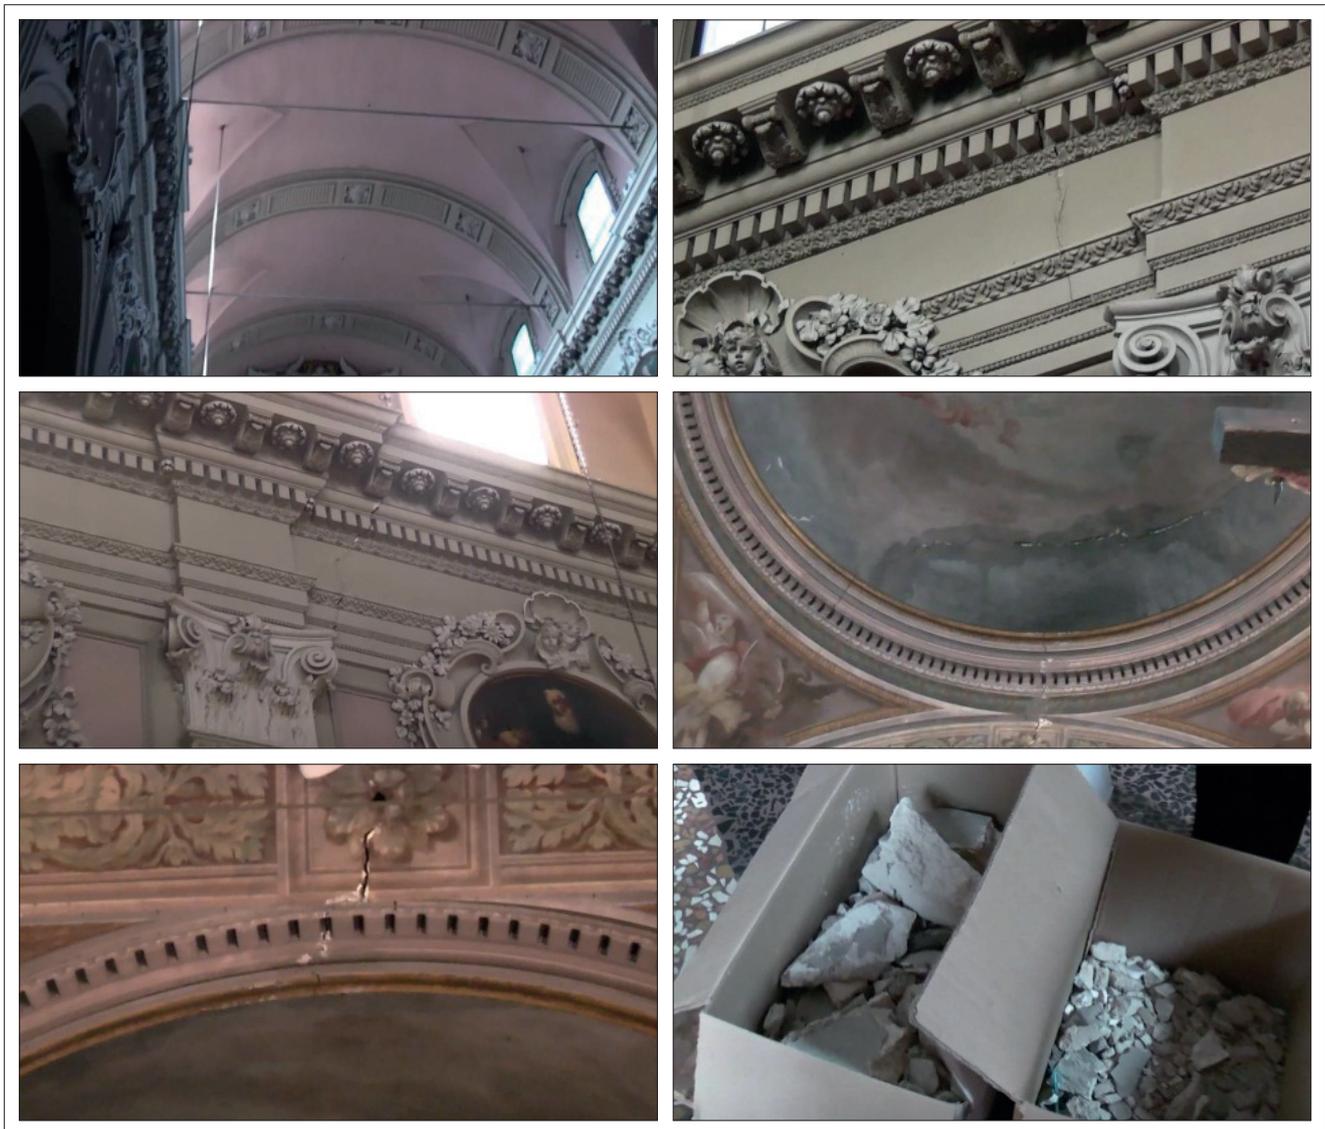
Damage survey and observed mechanisms - The observed damage in the church was clear enough: in the dome, in the triumphal arches, in the central nave (vaults and colonnade); in the vaults of the lateral naves; in the apse vaults (Fig. 32). Probably, the construction moved with a longitudinal response, because steel ties were present only in the transversal direction. Many stucco pieces detached from the rich

FIGURE 32 Damage to the Church of San Lorenzo (Budrio, Bologna)

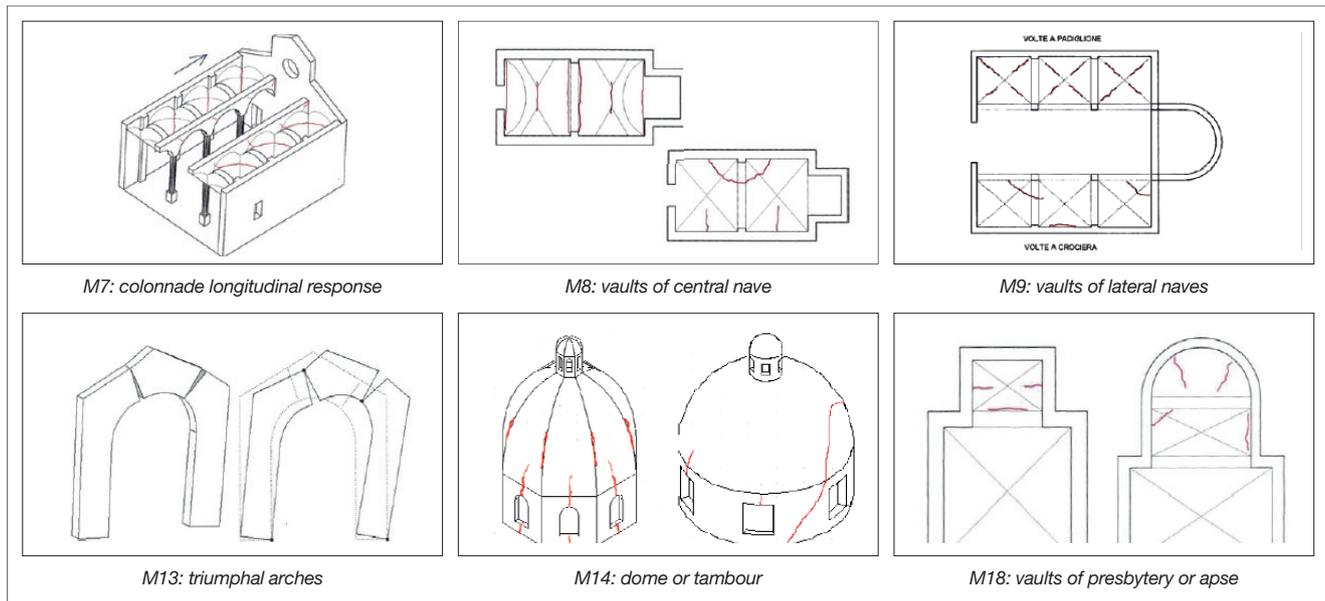
decorations and were collected by the church personnel. The fresco of the dome was also injured. The main mechanisms are reported in Fig. 33, corresponding to a global damage index equal to 0.13. Together with an overall restoration of the harmed parts, a strengthening intervention is recommendable, in particular in the nave longitudinal direction, anticipated by an accurate dynamic characterization of the structure.

FIGURE 33 Damage mechanisms in the Church of San Lorenzo (Budrio, Bologna)
