Lessons from the Tōhoku earthquake

■ Giovanni Bongiovanni, Paolo Clemente, Vladimiro Verrubbi

ENEA, Technical Unit for Environmental Characterization, Prevention, and Recovery

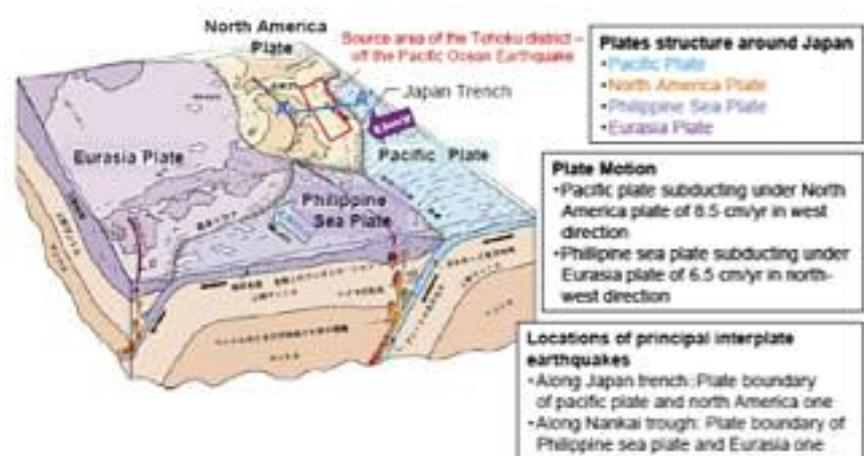
FIGURE 1 Tectonic of the earthquake area

The main event of the seismic sequence that affected the northeast coast of Japan began on 11 March 2011 at 14:46 (Japan local time) in an area where the Pacific Plate plunges under a strip of North American plate, which is wedged between the Pacific and the Eurasian ones (Figure 1). From the hypocenter, at about 130 km from the coast and at a depth of about 24 km, the rupture propagated both to the North and to the South, affecting an area

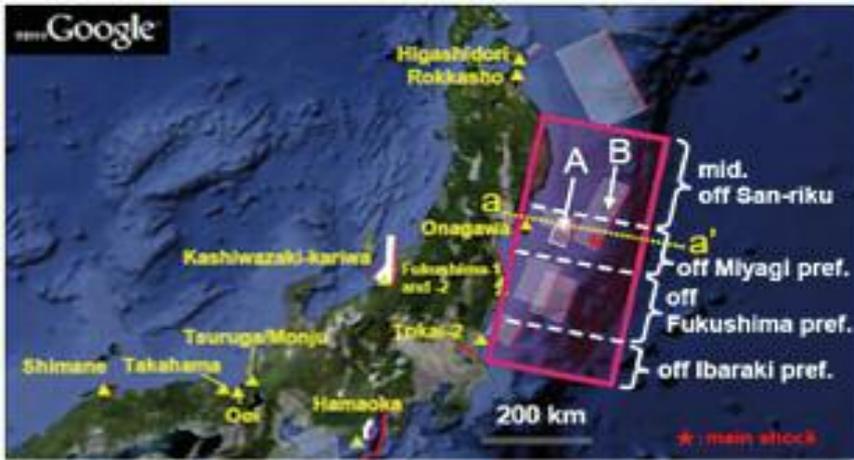
FIGURE 2 Area affected by the rupture

over 400 km long and 200 km wide (Figure 2). The moment magnitude was estimated to be 9.0. The earthquake generated a

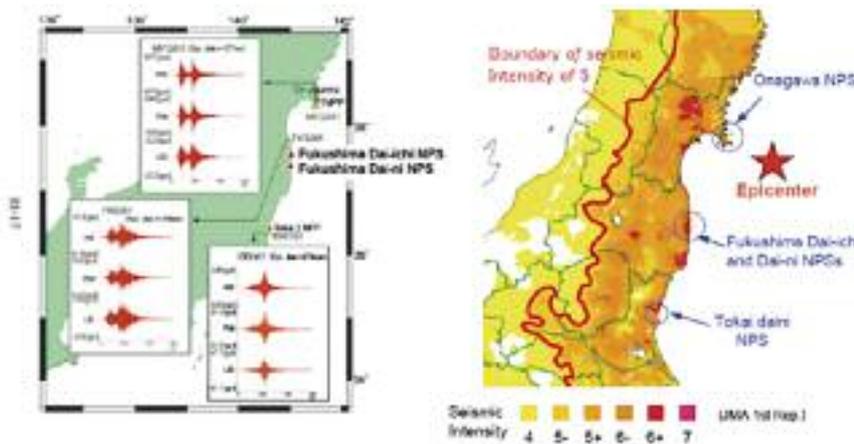
FIGURE 3 Shindo JMA intensity (right), accelerometric recording close to NPP (left)

The devastating effects of the earthquake and, mostly, of the tsunami in terms of lives lost and in terms of destruction of the area are well known, here we only report the description of the physical effects measured, with particular reference to nuclear plants. Figure 3 shows, on the right, the seismic intensity measured on the Shindo scale of Japan Meteorological Agency (JMA), and on the left the accelerometric recordings in the vicinity of nuclear installations. It should be pointed out that the Shindo intensity is provided directly from gauges located throughout Japan. The amplitude of the waves of tsunami was measured by a network of buoys (Figure 4) that transmit real-time measurements to a central and constitute part of the early warning system. In general, the first arrival of the waves occurred just minutes after the seismic event, while the maximum height occurred after about one hour. In Figure 4, a complete record of a buoy is also reported, which shows the sequence of tsunami waves that continued for several hours. The maximum height measured by buoys reached about 10 m; it must be said, however, that in many cases the buoys did not work properly, so the waves may have been much higher. The run-up, *i.e.*, the height reached by the wave (relative to sea level) on the mainland, was far greater than the height measured by the buoys. Figure 5 compares the run-up achieved in this earthquake with those of two San-Riku historical earthquakes of

available. From a comparison between **Figure 3** and **13** it appears that Japanese hazard maps, although produced with enormous wealth of resources, failed their purpose. Although outside the scope of this work, it is still worth noting

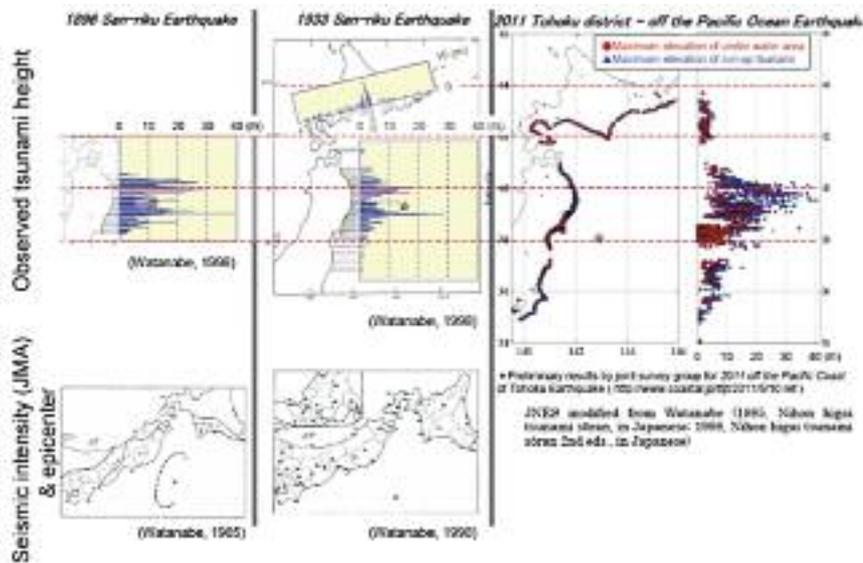
FIGURE 5 Comparison of the today run-up to those of the San-Riku earthquakes of 1896 and 1933

1896 (magnitude 8.5) and 1933 (magnitude 8.4), respectively. It is clear that, in the most severely affected area, events of lower magnitude happened in the past, which led to run-ups comparable with those of the 2011 earthquake.

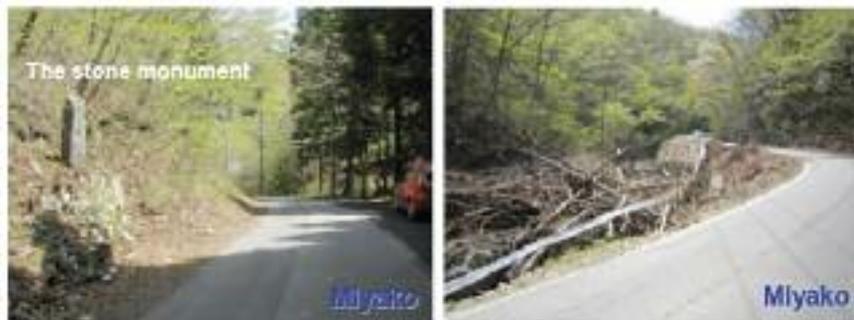
FIGURE 6 a) Stone monument seen from the village; b) Effects of tsunami approximately 100 m downstream of the stone monument

Figure 6 provides a confirmation of occurrence in the past in the same area of tsunami with higher run-ups. In Figure 6a, we see a stele called “stone monument”, near the village of Aneyoshi, indicating the limit reached by previous tsunamis, beyond which it is suggested not to build; the picture in Figure 6b, taken about 100 m above the stele to the coast, shows the effects of the recent tsunami. The run-up in this site was about 40 m. The stele (Figure 7) is one out of hundreds in Japan: obviously someone did not believe in the truthfulness of these historical documents.

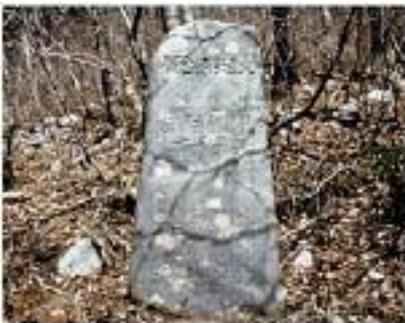
FIGURE 7 Stone monument

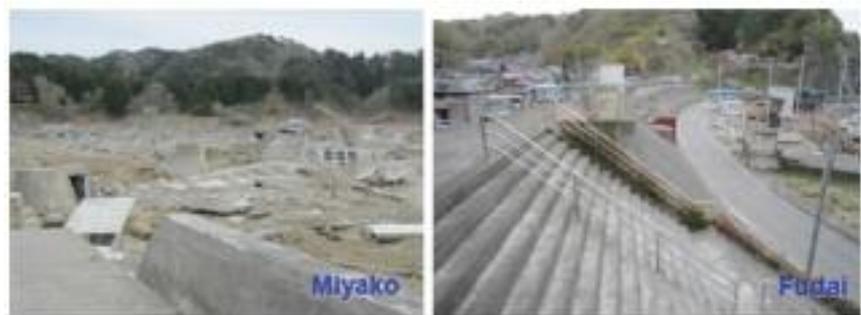
FIGURE 8 a) Protective wall in Miyako destroyed by the tsunami; b) Protective wall in Fudai

Figure 8 shows that while Fudai administrators learned from the experiences of the past with the construction of protective walls 15.5 meters high, enough to deal with the tsunami, in Miyako 10 m high walls were completely inadequate.

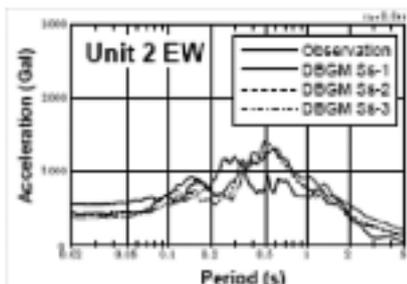
FIGURE 9 Comparison between observed spectrum and the corresponding response of DBGM

The nuclear plant in Fukushima Dai-ichi had 53 triaxial seismometers on structures and on the ground. The ground motion was recorded in 29 points and records were stopped between 130 and 150 s from the beginning, due to malfunction (elsewhere records have durations of 300 s). The acceleration measured at the basement reached peak values in the WE direction up to 0.55 g, against the expected response values equal to about 0.45 g, according to the DBGM Ss (Design Basis Ground Motion Seismic standard). Figure 9 shows the comparison between the response spectrum of the observed motion and the response spectra of DBGM Ss.

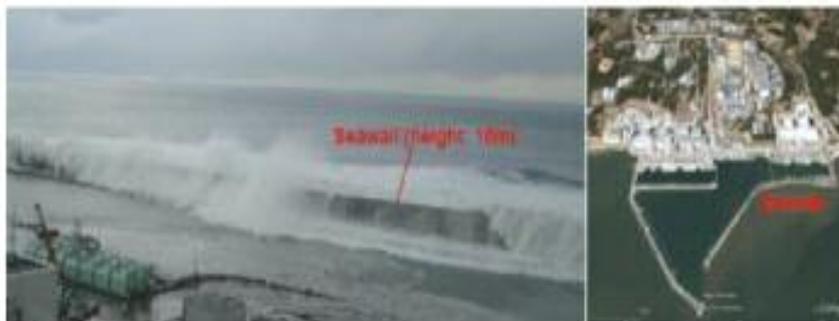
FIGURE 10 Maximum wave arrival at the site of Fukushima Dai-ichi

As well known, the damage to the system was due to the tsunami. Figure 10 shows the maximum wave arrival on the plant.

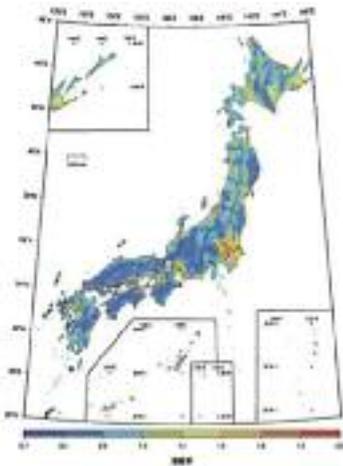
FIGURE 11 Amplification factors of the soil surface layers

Figures 11 and 12 report, respectively, the distribution of the amplification factors of the surface layers of the soil and the distribution of subduction zones and the 98 major faults where ERCJ as-

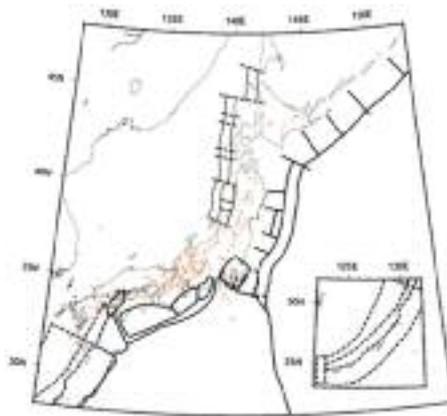
FIGURE 12 Subduction zones and 98 major faults

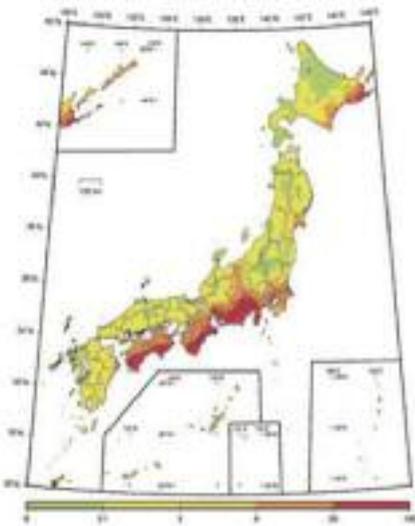
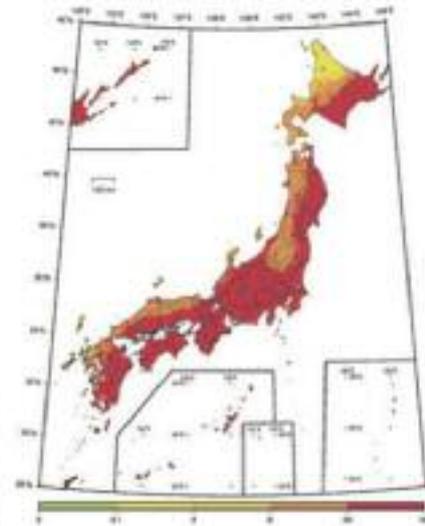
FIGURE 13 Probability of exceeding (a) the JMA 6-low e (b) the JMA 5-low in 30 years

essed the probability of occurrence of earthquakes. **Figure 13** shows the distributions of probability of exceedance in 30 years (from January 2005) of the intensity 6low and 5low. **Figure 14** reports scenario maps for areas where detailed information was
