Structural analysis of historic constructions: Some notable examples

The preservation of historic constructions passes through the analysis of the actions that can affect the structure and a suitable structural modeling. This is based on the knowledge of the geometrical and mechanical characteristics, also with reference to foundations and soil. Past experiences are good lessons for future studies

by **Farhad Ansari**, *University of Illinois at Chicago*,
Giovanni Bongiovanni, **Giacomo Buffarini**, **Paolo Clemente**, **Guido Martini**, **Fernando Saitta**
and **Sandro Serafini**, *ENEA*

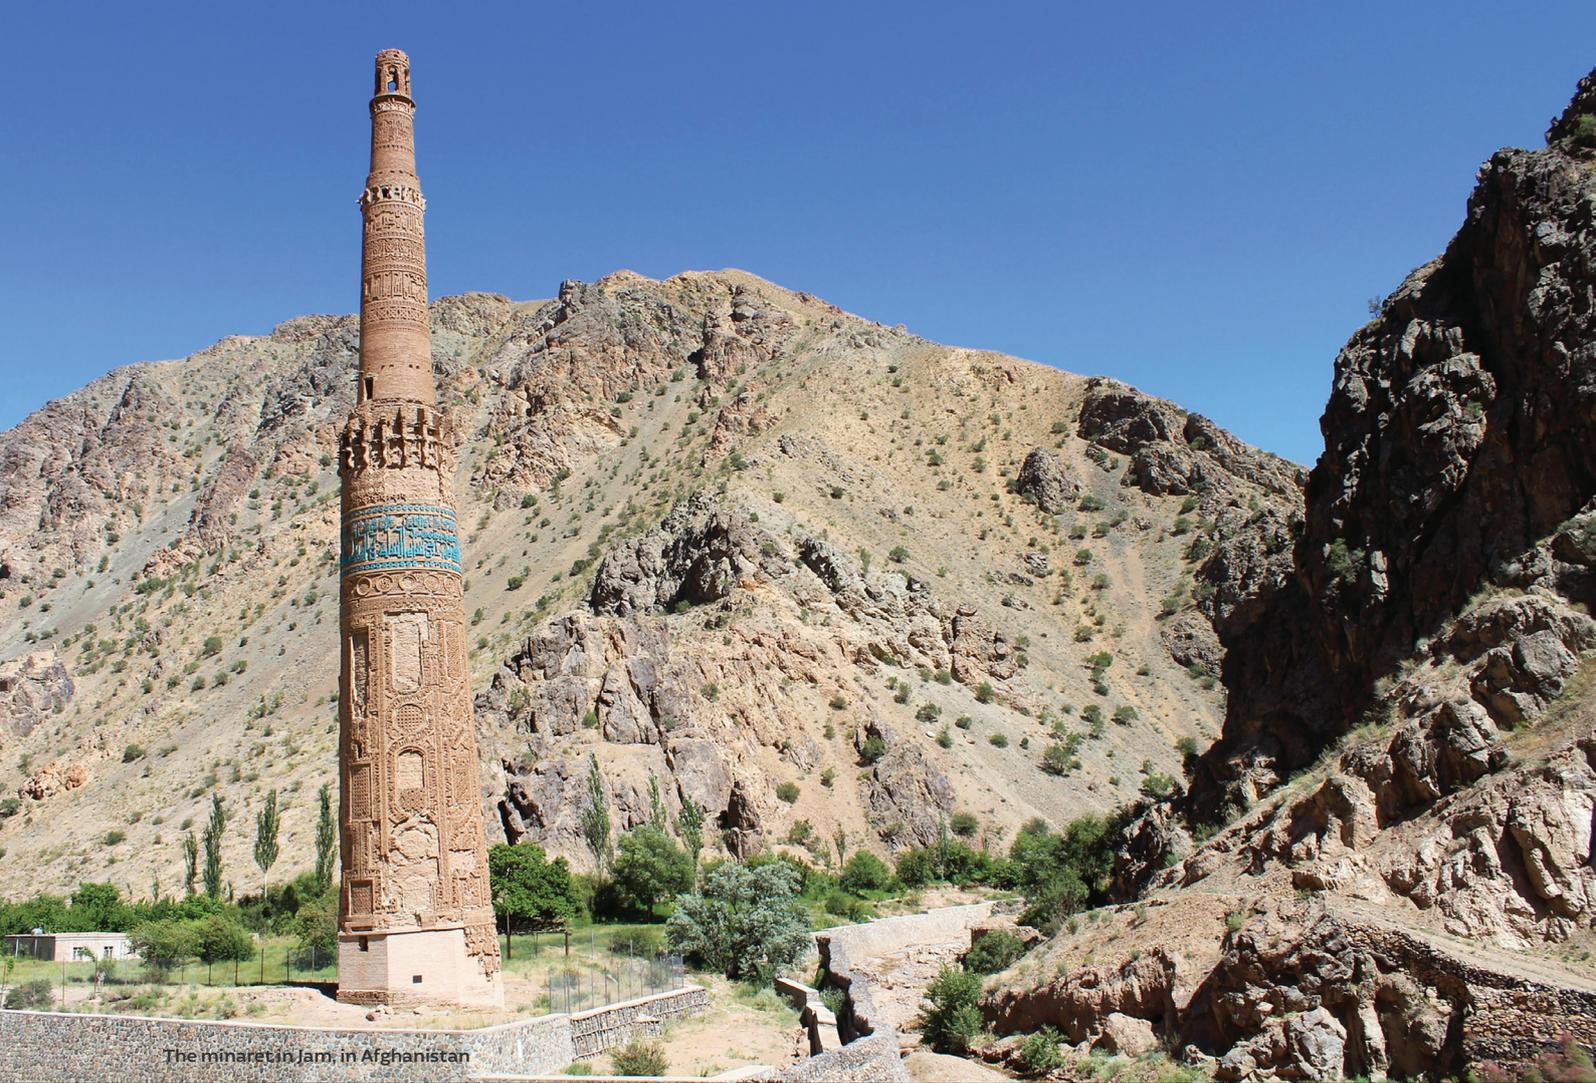
The minaret in Jam, in Afghanistan

The leaning Minaret of Jam, one of the tallest in the world, was declared as the Afghanistan's first World Heritage Site by UNESCO in 2002. The global stability analysis of the tower against soil collapse was evaluated in its present configuration, in the hypothesis of increasing bending moment at the base section, assuming an elastic-perfect plastic behaviour for the soil. Then a finite element model was set up and used for the modal analysis and then for the seismic push-over analysis, based on both single and multi-modal approaches, assuming an elastic-perfect plastic behaviour in compres-

The study showed that Minaret is stable under dead loads. However, the stability check is very sensitive to soil properties, which should be investigated in more detail, as well as the foundation depth. If the soil strength would be lower than the assumed value, a wide portion of the soil under foundation could be yielded. This implies that the structure could be closer to the collapse point than it appears.

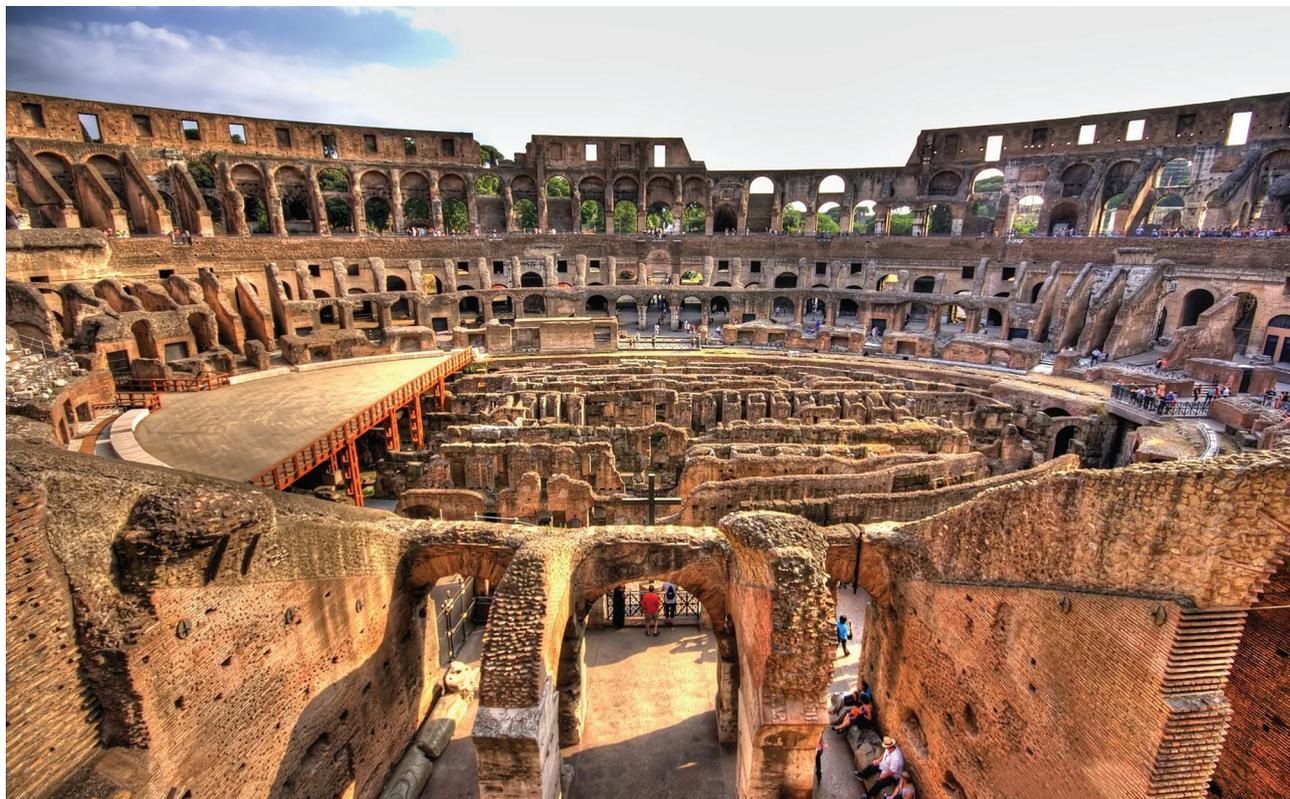
theater ever built (Fig. 1). Concentric annular walls connected by a series of radial walls and vaults compose the structure. The outer wall is 48 m high and is composed of travertine blocks, originally connected by iron pins and cramps without mortar. The foundation consists of an elliptical ring, approximately 13 m thick, composed by a paving of about 1 m and two concrete layers with different characteristics, of about 6 m each.

Fig. 1 The Colosseum, in Rome

The Colosseum was one of the monuments in Rome investigated by ENEA in the mid-'80s. The structure was instrumented to study the effects of the traffic-induced vibrations at different times of the day, as well as the vibrations from the near underground, and to determine its dynamic characteristics. The results

allowed to point out the vibration amplitudes at different locations in the monuments as well as some of its resonance frequencies. More recently, in 2014, another experimental campaign was carried out, which interested the northern wall and also the hypogeum. The results pointed out some interesting features of the foundations.

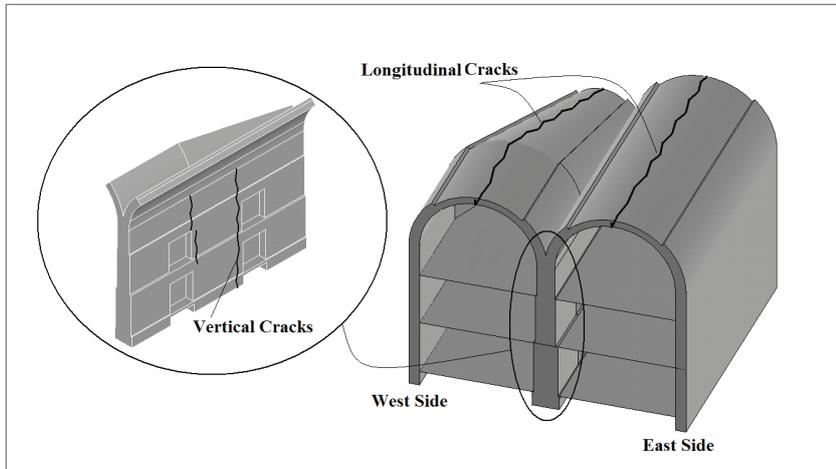
Fig. 2 Longitudinal cracks in the vaults and the supporting wall of the Brooklyn Bridge approach structures

bridge was constructed, the caissons used in the construction of the towers, the hybrid suspension/cable-stay system, and the air spinning of the suspension cables were innovative in size and method. Its span was also twice longer than any other previously built suspension bridge in the world (Talebinejad et al., 2011). A routine investigation of the approach structures that consist of masonry double vaults with span lengths of 10 and 10.5 m revealed large crown cracks covering the entire lengths of these cylindrical vaults (Fig. 2).

The cracks were large, with a nominal width of 1.5 to 2 cm. It seemed that these cracks took many years in making. From the structural point of view, crown cracks in arches are generally developed due to support movements. The question was why the cracks had occurred in these vaults, since the near surface bedrock on the Manhattan side of the bridge provided a very rigid foundation for the vaults. Subsequently, a structural health monitoring approach based on fibre optic Bragg Grating (FBG) sensors was employed in order to

investigate the problem (Ansari, 2007). The FBG sensors consisted of tilt meters, displacement, crack, and temperature sensors. The tilt meters were placed along the height of the wall supporting the two vaults in order to detect the wall movements. The crack and displacement sensors were used along the length of the vault cracks for monitoring the crack movements. Temperature sensors were placed next to the other sensors. The structure was remotely monitored over a period of 12 months. While the structure did not indicate any significant daily and or weekly movements, the results of the investigation revealed that the over the twelve months period of study, the wall and vault crack movements were in direct correlation with the seasonal changes in temperature, i.e. winter through summer. The long-term monitoring results depicting the crack opening displacements and the thermal variations are shown in Fig. 3. It was concluded that the vaults had gone through thermal cyclic fatigue since the time of their construction in 1883, result-

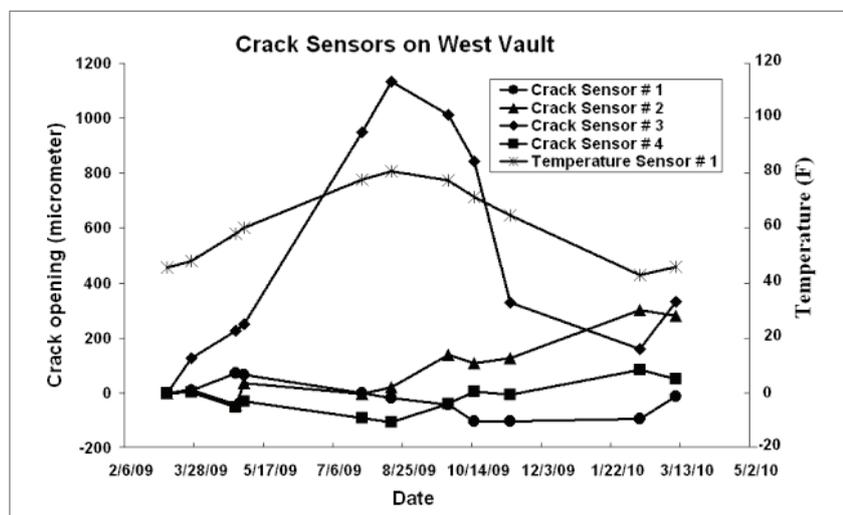
Fig. 3 The crack temperature and sensor readings, west vault
Source: University of Illinois
