The 6TH April, 2009 L'Aquila Earthquake: Restoration Choices and Pathways

■ *Luciano Marchetti*

*Former Director General - Ministry for Cultural Heritage,
and Vice-Commissioner for reconstruction at L'Aquila*

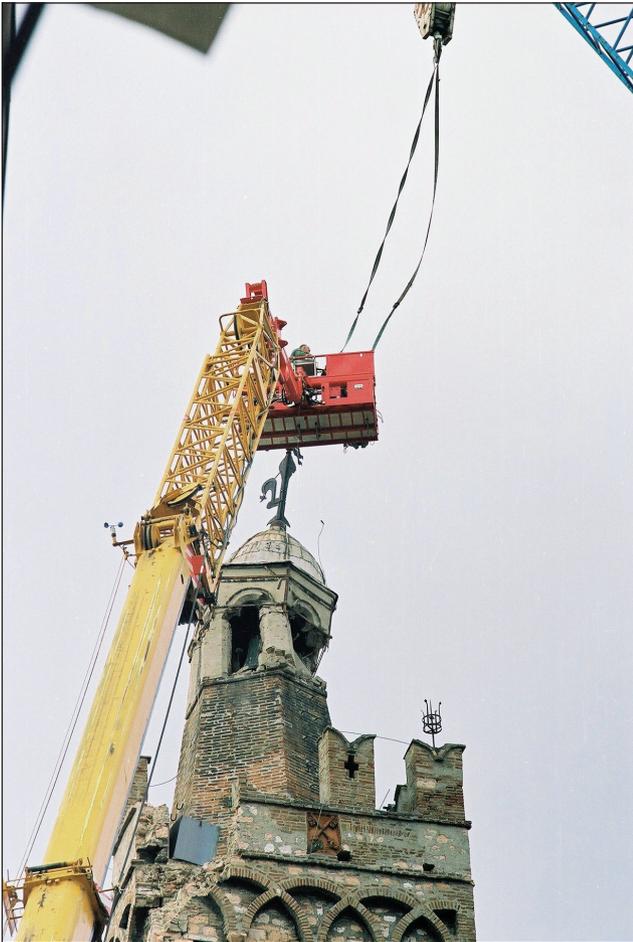
FIGURE 3 Securing the Torrino in Foligno, following the 1997 earthquake
 Source: Author's personal archive

In Umbria, a mixed criterion correlated to the actual damage was opted for, so as to make interventions as much accurate as possible; nevertheless, should this not be possible due to collapse, intervention of mere actual reconstruction could be envisaged. Typical examples of the kind are the above-mentioned "Torrino" of the Municipal Palace in Foligno (where

only the belfry collapsed, whereas the actual medieval tower was saved thanks to the protection facilities), the Civic Tower in Nocera Umbra (severely damaged and then restored and partially reconstructed), or the Upper Basilica in Assisi (where the vaults, partially collapsed, have been reconstructed with techniques and materials similar to the original church, providing an anti-seismic consolidation system for both the surviving and the reconstructed parts, so ensuring that the complex has an effective, homogeneous seismic response; the decorations of the vaults with frescoes of the greatest value have undergone a massive restoration campaign, based on the strict compliance with the Brandian restoration criteria, and completed with the in-situ repositioning of the restored parts and the neutral (“a neutro”) treatment of those remaining. Following the Umbria emergency, the first securing measures were implemented over the whole damaged territory, allowing to begin the following restoration in a very short time and in a functional and fruitful way, thanks mostly to the optimal architectural conservation methodology and to the consequent opportunity to set-up many building sites at a time, without any interference with one another.

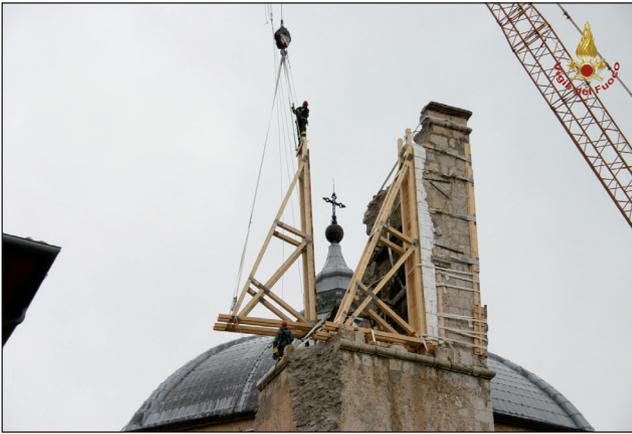
FIGURE 5 Securing the bell gable of the Basilica di S. Bernardino in L'Aquila, following the 2009 earthquake
 Source: Author's personal archive

The Vice-Commissioner Office, with the support of VVF squads mainly, ensured that the law-protected and particularly important heritage was made safe, intervening on the severely damaged structures whose collapse could have caused them further damage. Some examples are the recovery of the remains of San Bernardino in the convent of the same name, and the securing interventions to the belfry and the dome of the Basilica dedicated to the saint, directly borrowed from the interventions made in Umbria after the 1997 earthquake. By other means yet by the same technique that led to the private housing projects, the stability of the most ancient part of the XVI century Castle was ensured by tying the internal double-lodge structure (almost overturning on the court) with the robust external masonry of the fortress by way of stainless steel tie beams and metal partition structures placed on the internal façade, also affected by some collapses on the second floor.

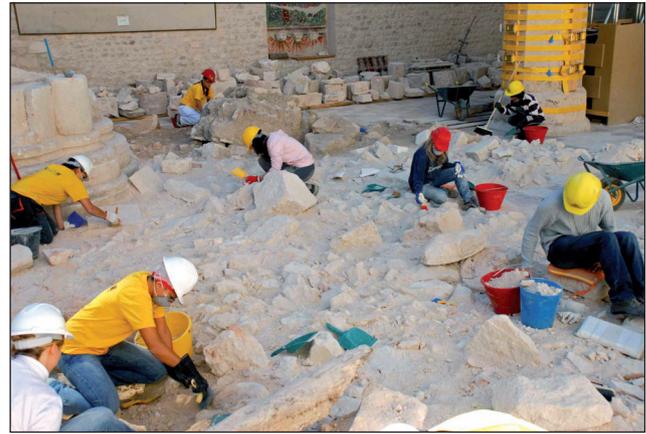
FIGURE 6 Restoration and screening of the ruins in the Church of S. Maria di Collemaggio in L'Aquila, following the 2009 earthquake
 Source: Author's personal archive

Another intervention with a very remarkable effort was that made on the Basilica di Santa Maria di Collemaggio, which consisted in recovering the remains of Pope Celestine V, securing the whole complex (by selecting the collapsed materials, retrieving the gravestone elements and saving the pipe organ), and setting-up and installing a massive metal roofing structure, allowing to re-open the Basilica for Christmas 2009. The provisional works were inspired by several different technologies, as shown by the synthetic-belt ringing of the columns of the naves, the steel wires to avoid the possible overturning of the side walls, the centering of the arches most at risk and installing on the transept a light translucent roofing, supported by steel trusses standing on reticular metal bases. Besides fast re-opening the Basilica to the public, the intervention allowed retrieving, with archaeological methods, all the fragments from its interiors, thus also enabling to fully recompose the decorations in the choir of the organ (a valuable high-age piece made of carved and gilded wood) and the related sound-amplifying apparatus.

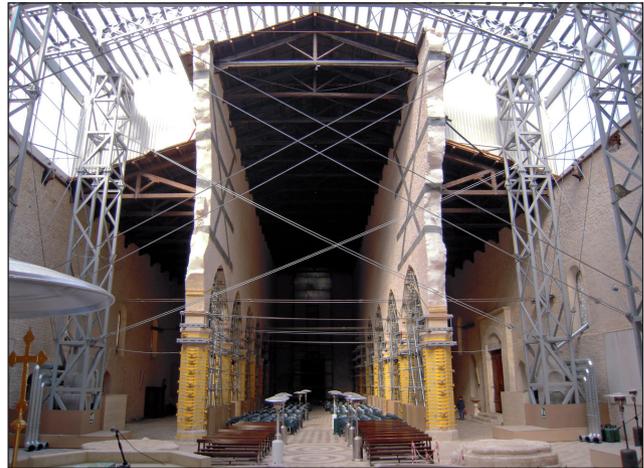
FIGURE 7 Securing and roofing the transept in the Church of S. Maria di Collemaggio in L’Aquila, following the 2009 earthquake

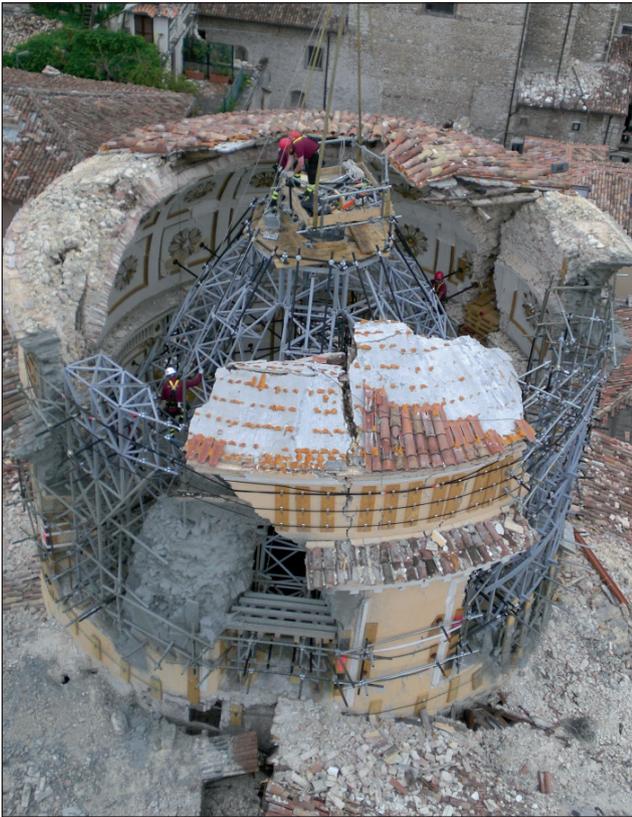
FIGURE 8 Securing the dome of the Church of S. Maria del Suffragio in L'Aquila, following the 2009 earthquake
 Source: Author's personal archive

In the framework of assessing the damage to cultural heritage, the Church of Santa Maria del Suffragio (or delle Anime Sante, built following the 1703 earthquake in memory of the casualties) drew a particular attention, mainly for the very severe conditions of its dome, a valuable architectonic element attributed to Giuseppe Valadier, mostly collapsed and for this reason to be

necessarily secured to ensure its correct restoration. The intervention was characterized by many dangerous aspects both for the reiterating quakes and for the precarious situation of the artifact remains. Using a sophisticated laser-scanner to survey the damaged structures was fundamental to design the system of provisional works required to ensure the complex stability. Besides providing very-high-precision measurements, the laser-scanner device allowed the technical staff to investigate the dome in complete safety, since the overall operation was carried out with automatic-control mobile machines transported on site by a remote-control mechanical shaft.

The laser-scanner survey allowed to define a securing intervention to be carried out in more phases and times: firstly an outringing to prevent the stump from overturning; then the prefabrication of three metal structures: two of them allow to restore the tambour continuity interrupted by the collapse, and the third one acts as internal contrast element allowing to avoid the implosion of the whole structure (remaining parts of the dome and the tambour). The laser-scanner investigation also allowed to make proper simulation to fine-tune the times and modes of operation, and to schedule a specific training of the VVF squads responsible for the intervention.

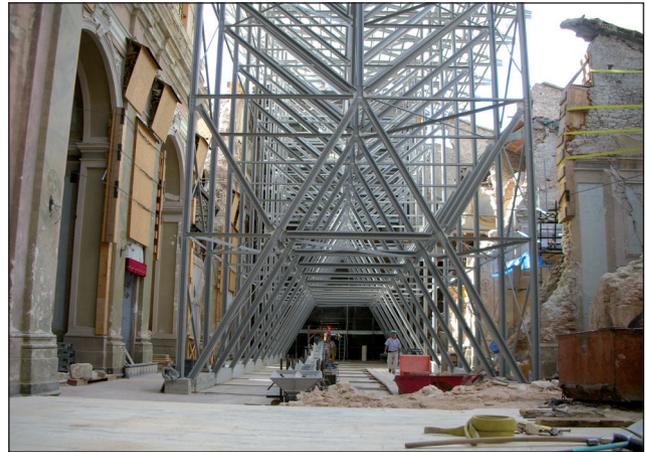
FIGURE 9 Securing and roofing the Church of S. Maria di Paganica in L'Aquila, following the 2009 earthquake
Source: Author's personal archive

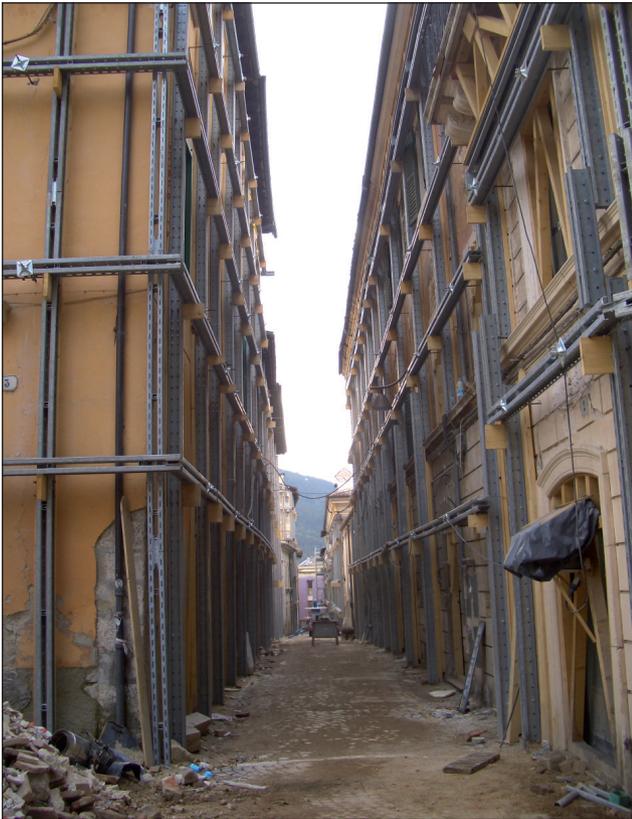
FIGURE 11 Securing historical palaces in the historical centre of L'Aquila, following the 2009 earthquake
Source: Author's personal archive

In the light of the above, and urged by the need to avoid that the provisional works could hamper the reconstruction phase, an intervention design criterion was defined, aimed at restoring the vertical load-bearing capacity of masonry buildings by using vertical elements capable of ensuring the plane stability of the perimeter walls (along with opening ringing, filling of the collapsed portions, etc.), devices ensuring the good cohesion of the external walls (wooden or iron beam grids on the external surfaces), and systems of metal tie beams properly tightened between the walls so as to ensure that the structure had a "box" behaviour. Specific completion facilities (provisional roofing, rockfall protection structures, etc.) were provided wherever needed.

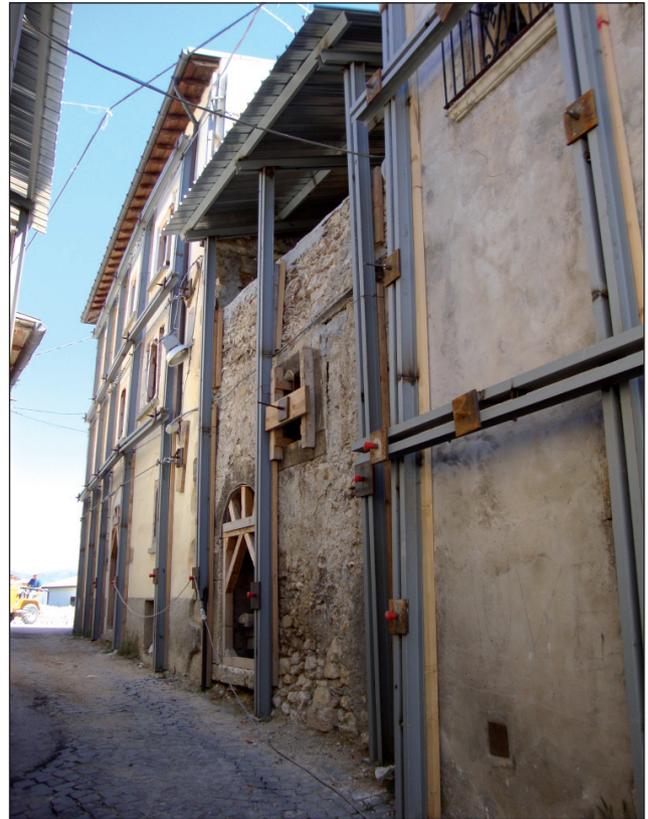
FIGURE 12 Securing historical palaces in the historical centre of L'Aquila, following the 2009 earthquake
Source: Author's personal archive
