# Seismic Preservation of the Archeological Site of Pompeii. Preliminary Analyses

The seismic preservation of archaeological sites should certainly be targeted at the conservation of the historical and artistic values but cannot prevent these sites from being visited by a high number of tourists daily. A complete study should include the analysis of the seismic hazard in the area and of the seismic local response at each site, in addition to the analysis of the health status and the seismic vulnerability of structures. The site of Pompeii, recently interested by collapses, is probably the most interesting case in the world. The Soprintendenza Speciale per i Beni archeologici di Napoli e Pompei, in collaboration with ENEA, is organizing a study for the evaluation of the health status and the seismic vulnerability of some of the most diffused structural typologies in the archaeological site. The preliminary analysis pointed out the need for a detailed vulnerability analysis based on a comprehensive experimental investigation on both structure and site

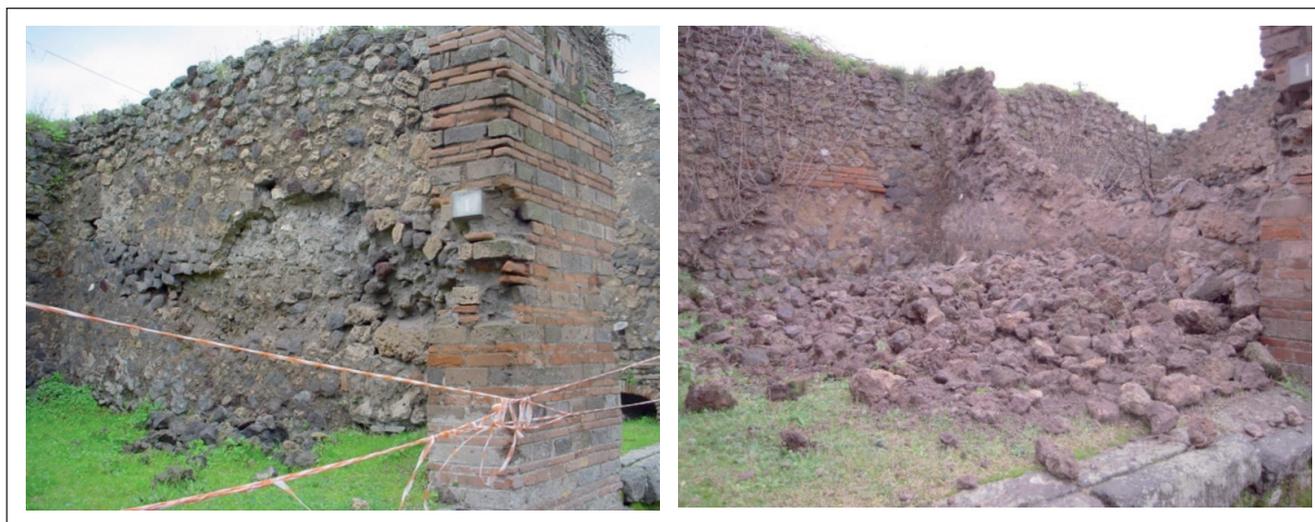
**FIGURE 1** Wall in Regio VII (Insula 2, No. 1), (a) before and (b) after the collapse  
Source: Soprintendenza Speciale per i Beni Archeologici di Napoli e Pompei

Fig. 1 shows the walls of the *Termopolio* of P. Paquius Proculus, a commercial building excavated in 1943-1944. The partition wall that separated two adjacent workshops had a total thickness of 40 cm, a length of 5.0 m and a height of about 3.0 m, and the two opposite faces are N-W and S-E, respectively. Its collapse pointed out the absence of internal cohesion. In fact, the collapsed portion is completely disaggregated, the mortar is pulverized and the stones scattered on the ground look like those of a drywall.

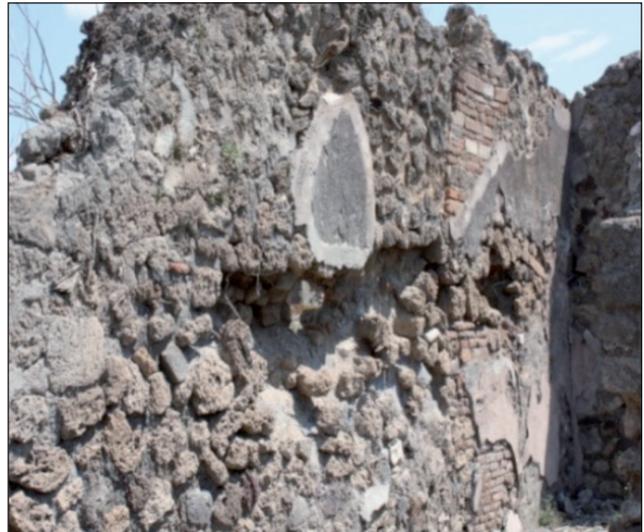
**FIGURE 3** Regio VII (Insula 12, No. 34)  
Source: Soprintendenza Speciale per i Beni Archeologici di Napoli e Pompei

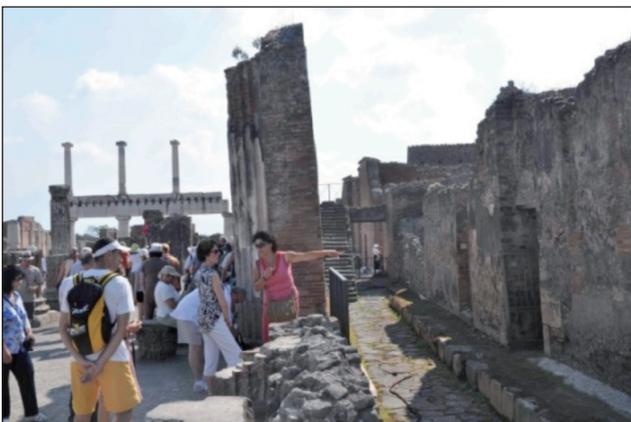
**FIGURE 4** The Forum area: free standing colonnades (in the back)  
Source: Soprintendenza Speciale per i Beni Archeologici di Napoli e Pompei

small settlements could determine instability and collapse (Figs. 4 and 5).

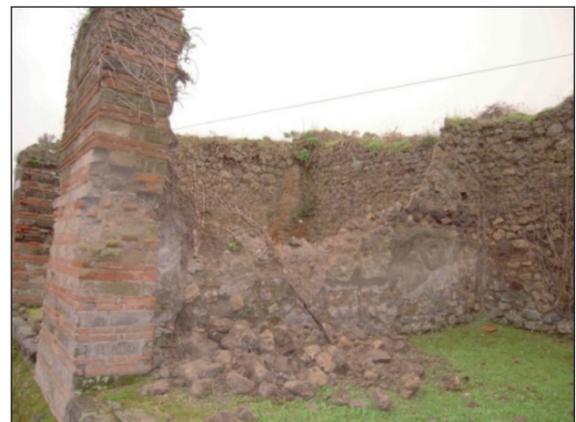
**FIGURE 5** Walls showing different structural behaviors and resultant damage  
Source: Soprintendenza Speciale per i Beni Archeologici di Napoli e Pompei

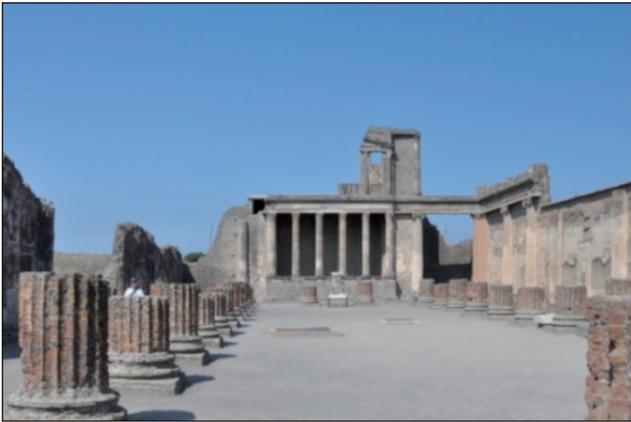
**FIGURE 6** Colonnade of the Basilica  
Source: Soprintendenza Speciale per i Beni Archeologici di Napoli e Pompei

Different types of vertical structures are present in the Pompeii excavations. Among these, the ruins of colonnades in the Forum area and the Basilica (Fig. 6) deserve particular attention. Besides, there are very common vertical structures in opus quadratum forming the jambs of the shops along the main roads. These are composed by the superposition of large blocks of gray tuff, having size of 100\*70 cm and thickness equal to 40 cm. All these structures are very dangerous for visitors due to their position and size. Moreover, they show diffused cracks and significant degradation processes (Fig. 7). It is necessary an in-depth study of the stability of these structures, by carrying out the analysis and evaluation of mechanical characteristics of masonry, and understanding its texture and quality. Furthermore, foundation features and lying, as well as possible past structural interventions which could affect both static and dynamic behaviour should be investigated [10].

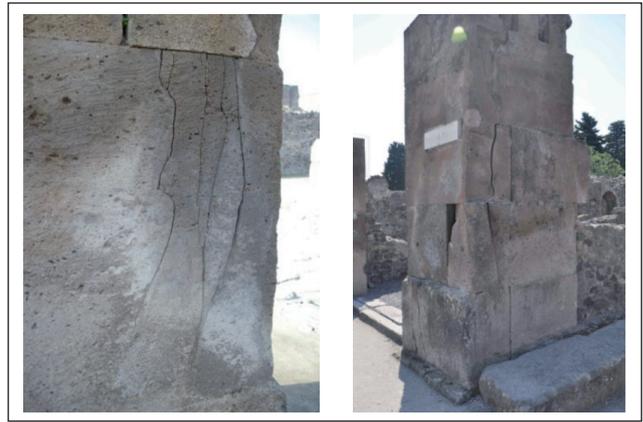
**FIGURE 7** Blocks in grey tuff in Regio VIII (Insula 5, No. 19)  
Source: Soprintendenza Speciale per i Beni Archeologici di Napoli e Pompei

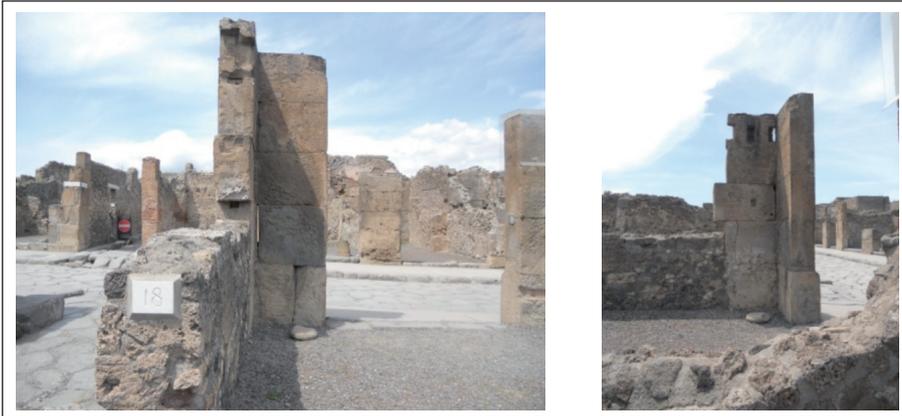
**FIGURE 8** Stacked blocks of tuff for the case study  
 Source: Soprintendenza Speciale per i Beni Archeologici di Napoli e Pompei

A case study related to the seismic reliability of the stacked blocks shown in Fig. 8 is analysed in detail. The blocks constituted the angular elements of the perimeter walls in a building ruin in Pompeii, largely collapsed.
