Behavior of response controlled and seismically isolated buildings during severe earthquakes in Japan

■ T. Saito

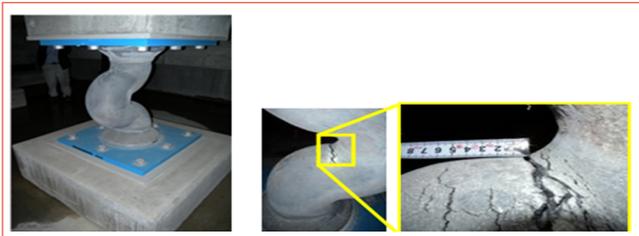
PHOTO 1 Crack on the surface of a lead damper

After the 2011 Great East Japan Earthquake, the Japan Society of Seismic Isolation (JSSI) conducted a questionnaire survey for 327 seismically isolated buildings including 19 detached houses. It is reported that superstructures of all seismically isolated buildings suffered almost no damage even under strong shaking with JMA intensity 6 plus. It proved the excellent performance of seismically isolated buildings. On the other hand, various damages were observed in seismic isolation devices (Saito 2013). For example, many cracks were found in lead dampers (Photo 1) which might be increased by the aftershocks. Loose of the bolts, peeling off the paint and residual deformation were observed for steel dampers (Photo 2). Minor damage to expansion joints between SI floor and superstructure was found extensively (Photo 3).

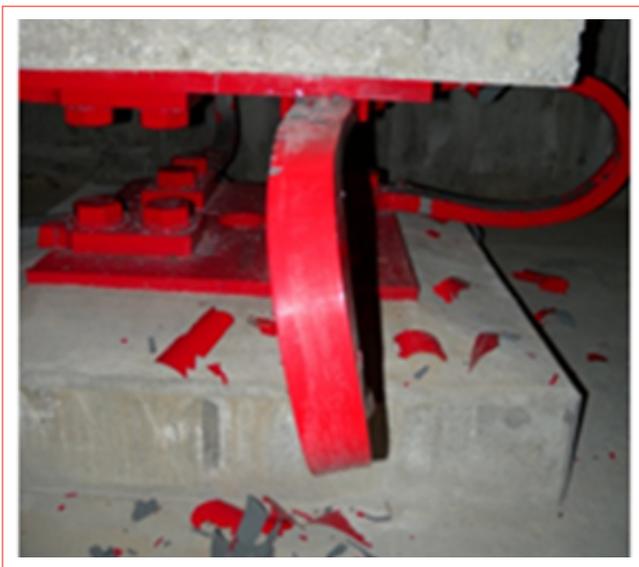
PHOTO 2 Deformation of U-shaped steel damper

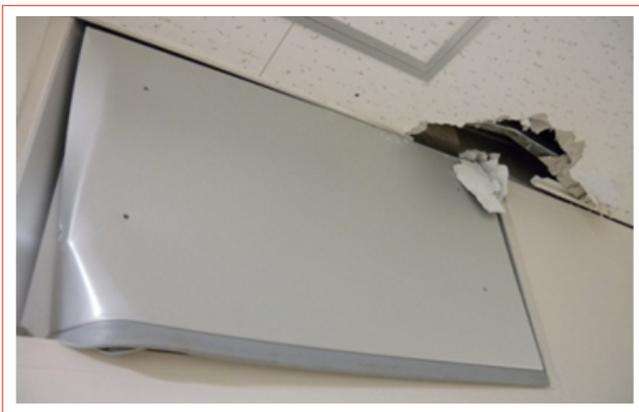
PHOTO 3 Damage to cover panel
