4-5/2012 - Parte II

**The Pianura Padana
Emiliana Earthquake**

58 Damage to religious buildings due to the Pianura Padana Emiliana earthquake

105 Damage mechanisms in some residential building typologies during the Pianura Padana Emiliana Earthquake

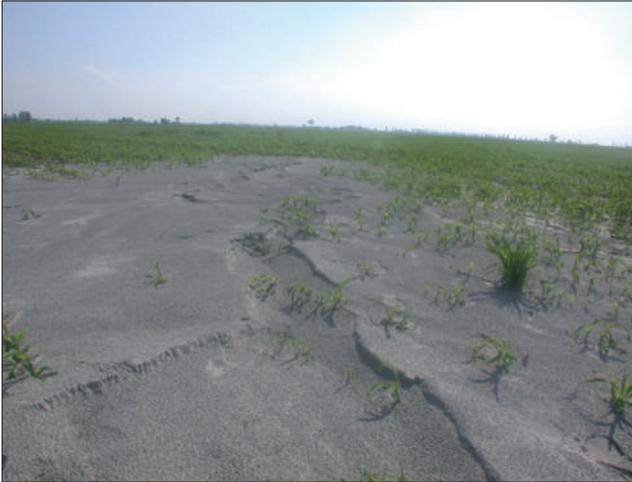
FIGURE 9 Soil liquefaction near Bondeno
Source: ENEA

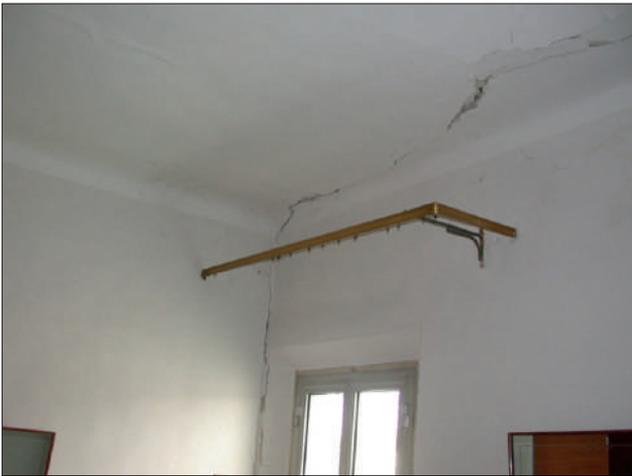
FIGURE 10 Bondeno: damage of grade 2-3
(EMS98 classification)
Source: ENEA

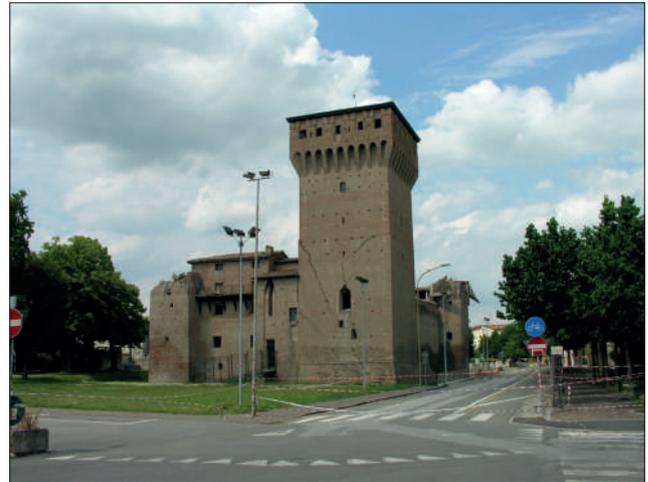
FIGURE 11 The damaged fortress of San Felice sul Panaro
Source: ENEA

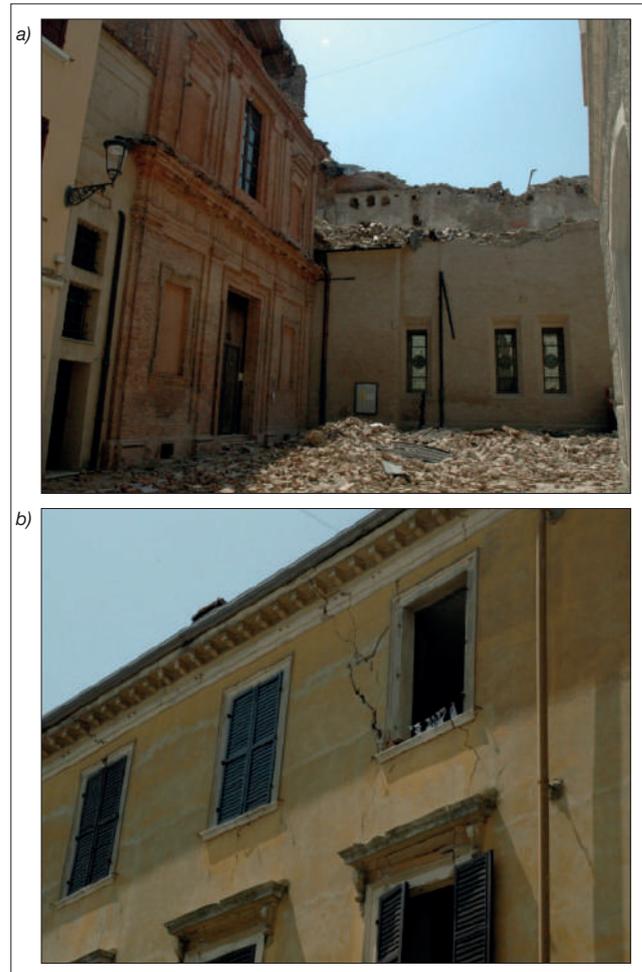
FIGURE 12 Mirandola. Damage in the historical downtown
Source: ENEA

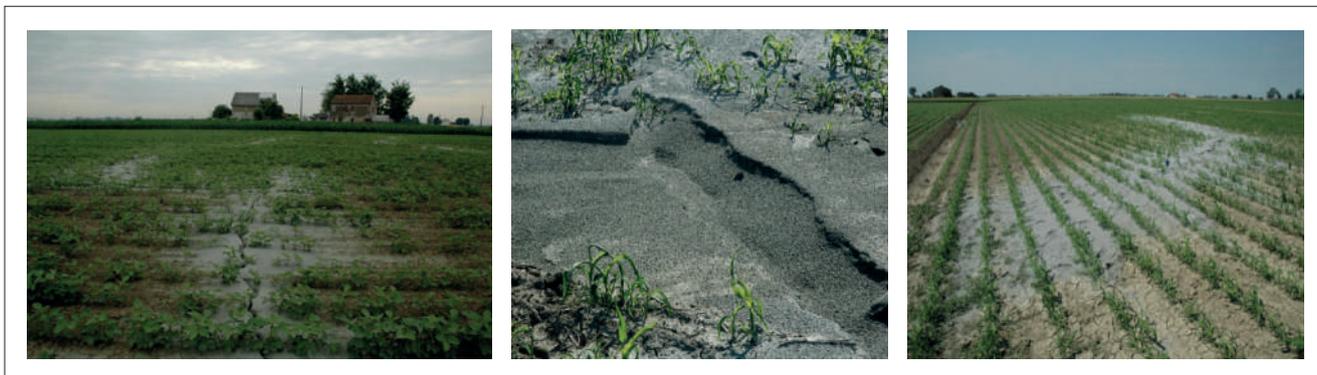
FIGURE 5 Sand liquefaction phenomena within an agricultural area

The phenomenon of sand release has manifested a series of en echelon iso-oriented fractures, that despite the modest extension (usually around meters) are expression of local environmental geo-tectonics. From the geomorphology point of view, the structures are characterized by large sandy plateau with a central ridge along the fracture line and with very light slopes to the outside (Figs. 5-6-7).

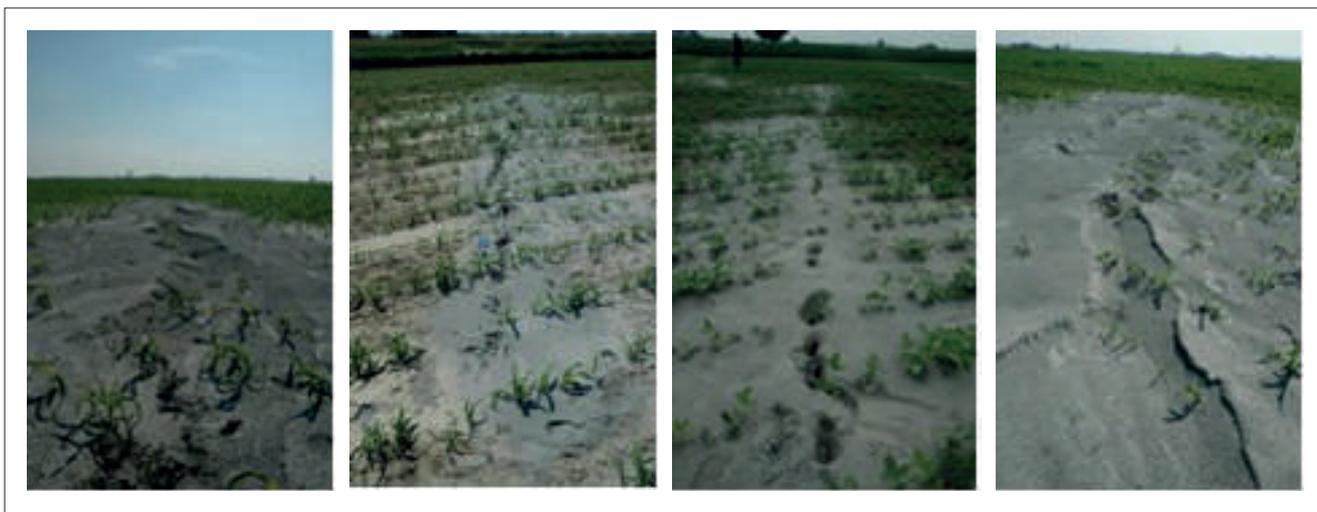
FIGURE 6 Morphological structures of casting sand

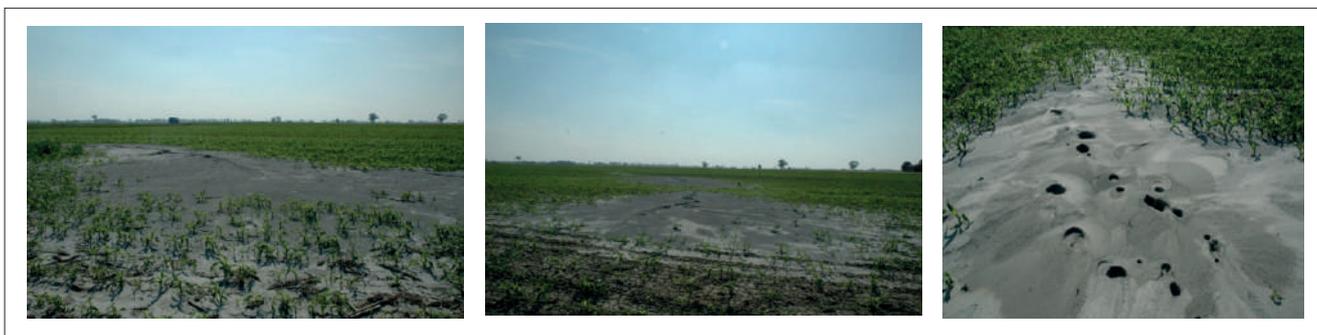
FIGURE 7 The structures are characterized by large sandy plateau

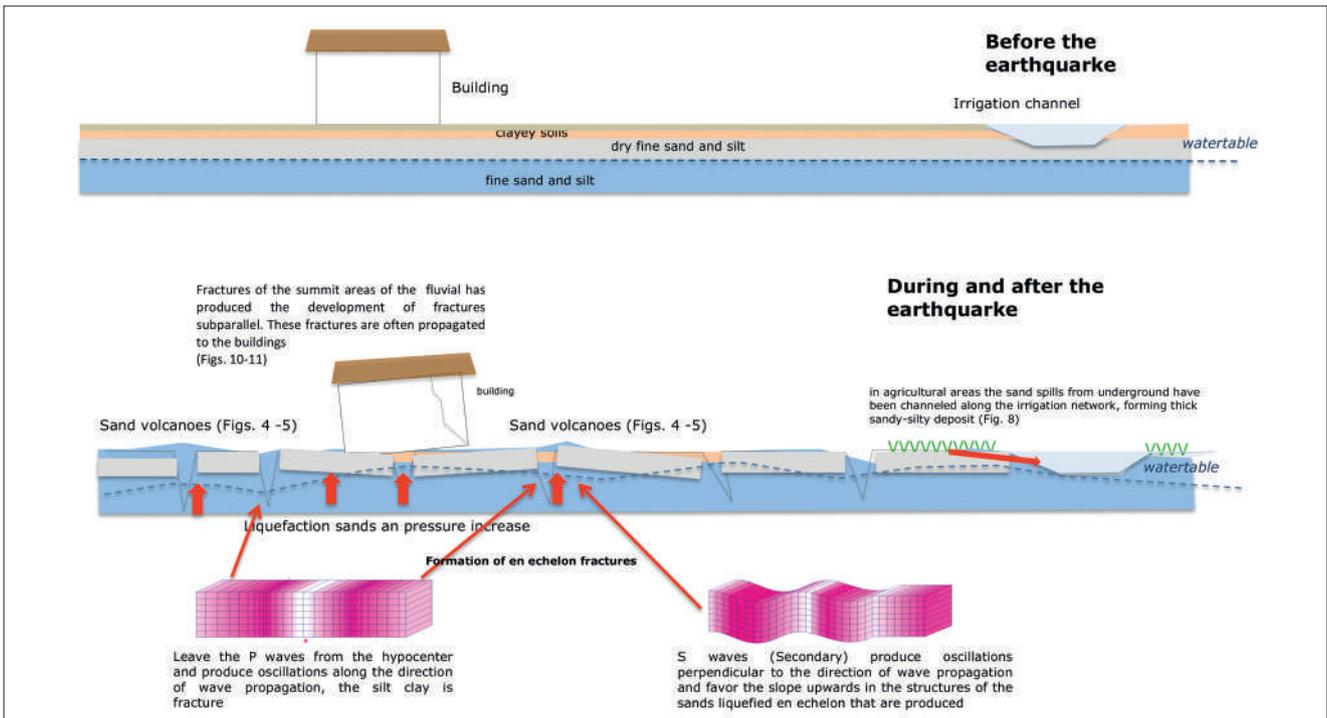
The release of the sands occurred in agricultural areas is often used as a way of escape for irrigation wells, in the cases occurred on the inside of buildings, the sand probably formed escape routes followed by human intervention. Figure 9 shows the effects of the sand liquefaction phenomena on the

FIGURE 9 Soil liquefaction and effects on the stability of man-made structures: up) before the earthquake; low) during and after the earthquake
 Source modified from: *Institution of Professional Engineers of New Zealand* [10]

can slide sideways on the liquefied soil towards the streams; this is called lateral spreading (Fig. 9); this could be the cause of the damage to several rural settlements and can severely damage a building. It typically results in long fractures and cracks occurring in the soil surface and they resemble a classic fault line. Not every foundations of a building can be affected by liquefaction, as the affected area may shrink or be pulled sideways by lateral spreading and can seriously damage the building.

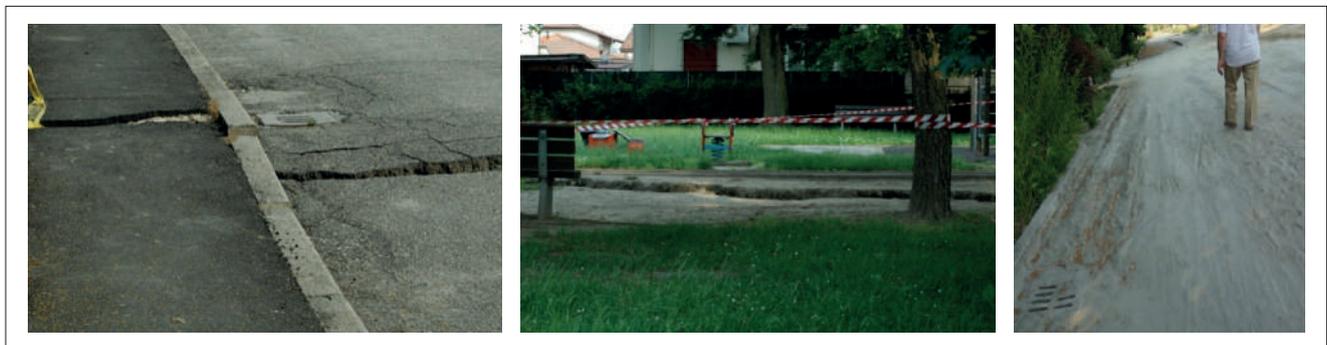
The phenomenon is most evident in Sant’Agostino, particularly in the urban area of San Carlo (Fig. 10), the most damaged by the May 20th earthquake, where a great fracture has affected the city centre. During the

FIGURE 10 Sant’Agostino Municipality: one of the most damaged town by the earthquake of May 20th

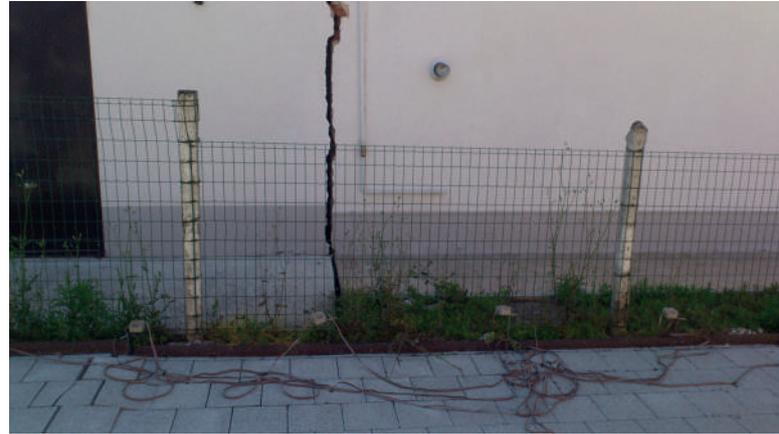
The test site (1 in Fig. 1), represented by a residential building that was affected by surface ruptures (Fig. 3), is situated in Via Argine Postale, 57 (south-western part of the village centre). In this site we accomplished several 2D GPR and seismic reflection profiles. Details regarding the employed techniques can be found in specific literature¹. Concerning the GPR application for the investigation of seismically-induced fractures, we came across

FIGURE 3 Side view of the investigated building with structural damage. The residential building is situated in Via Argine Postale, 57, Mirabello village (Italy). Near the fence, the seismic cables with geophones can be seen

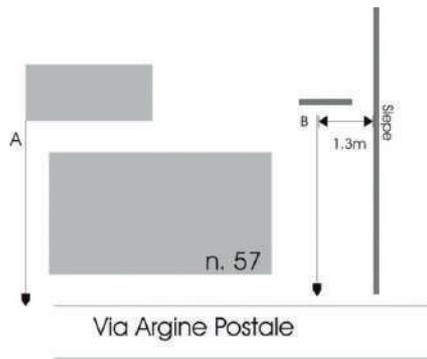
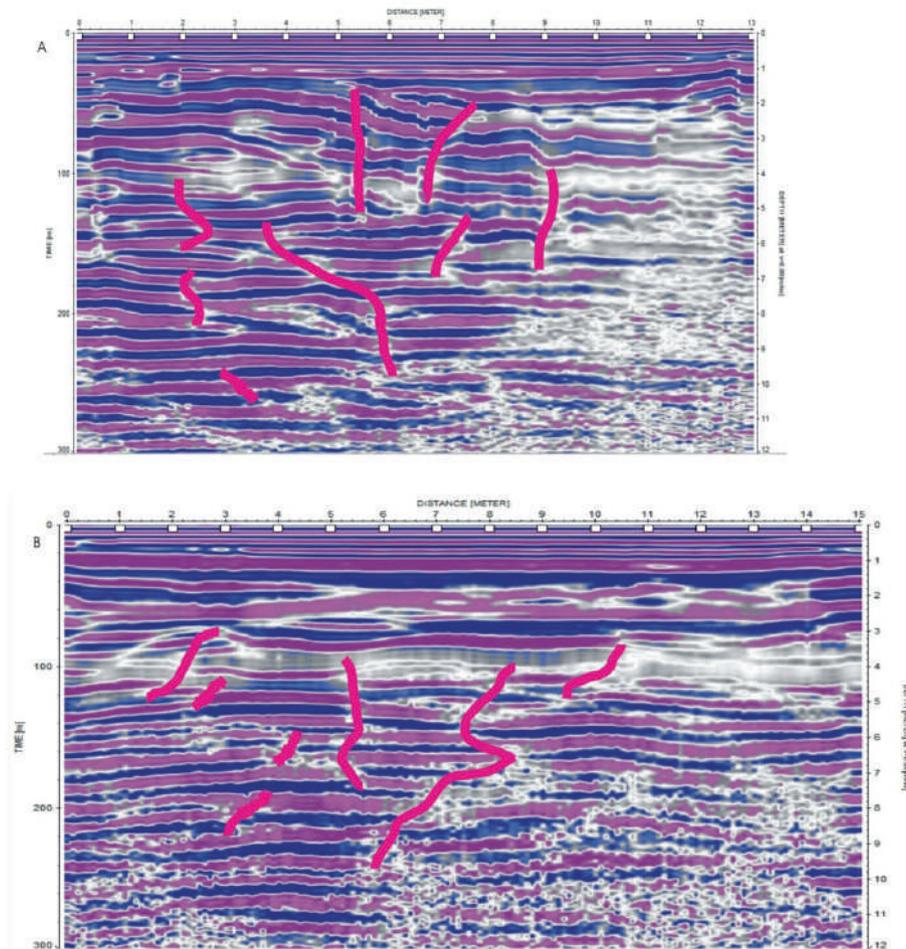
The interpretation of processed sections shows the presence of reflectors characterized by several horizontal unconformities and phase changes that could be associated to fractures or infiltration of sand (red lines). Reflectors associated to clay/sand interfaces are in general not parallel to the surface but show undulated geometries, probably associated to alternances of paleo erosion and sedimentation surfaces. It could also refer to the sediments used in the construction of the embankments. For the transformation of time sections to depth, a velocity of 8 cm/ns – typical of this type of soil (relative dielectrical permittivity “ ϵ_r ”: 14-15) –, has been applied.

It is worth mentioning that, upon request of the National Civil Protection Department and the Geological Survey of the Emilia Romana Region, pre-earthquake GPR sections have been compared⁵. Both radar images were similar, with the only difference that vertical unconformities are present in our data. These features are characterized by phase changes associated to seismically-induced fractures such as those reported in Fig.5.

FIGURE 5 Example of GPR sections, 100 MHz, recorded on the side of building in via Argine Postale 57 at Mirabello. Possible fractures and/or sand intrusions are highlighted in red. The upper left insert shows the position of the GPR and seismic profiles with respect to the building. A and B: GPR sections. Thick vertical line: seismic reflection profile

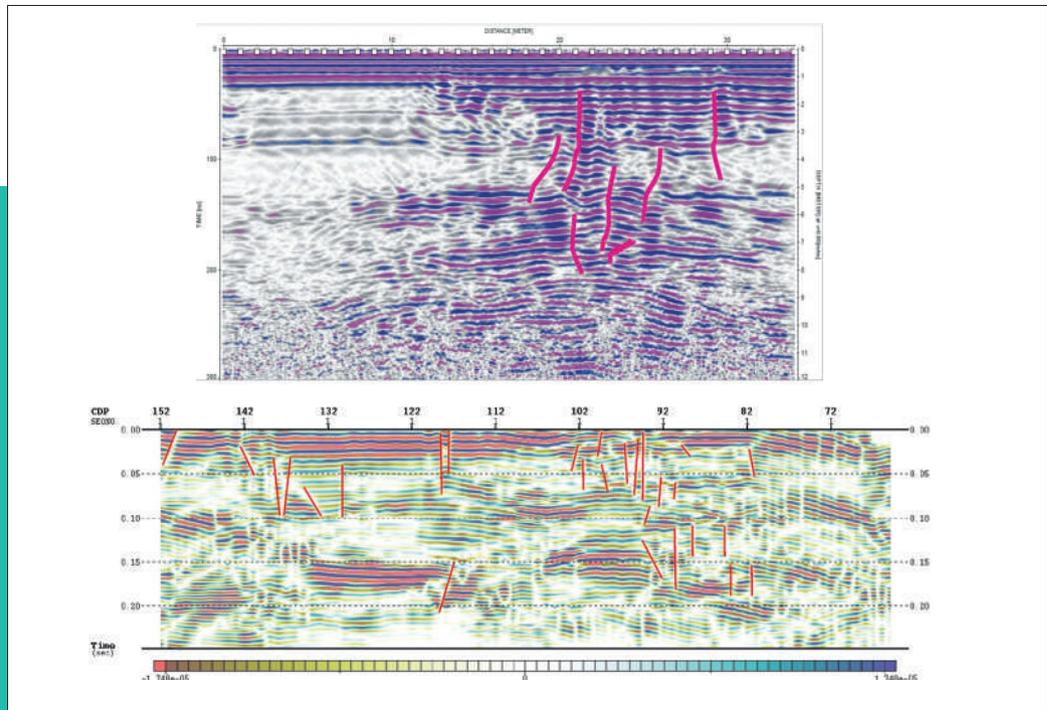
FIGURE 6

a) GPR (100 MHz) and
b) seismic reflection
section. Fractures and
sand intrusions are
highlighted in red colour

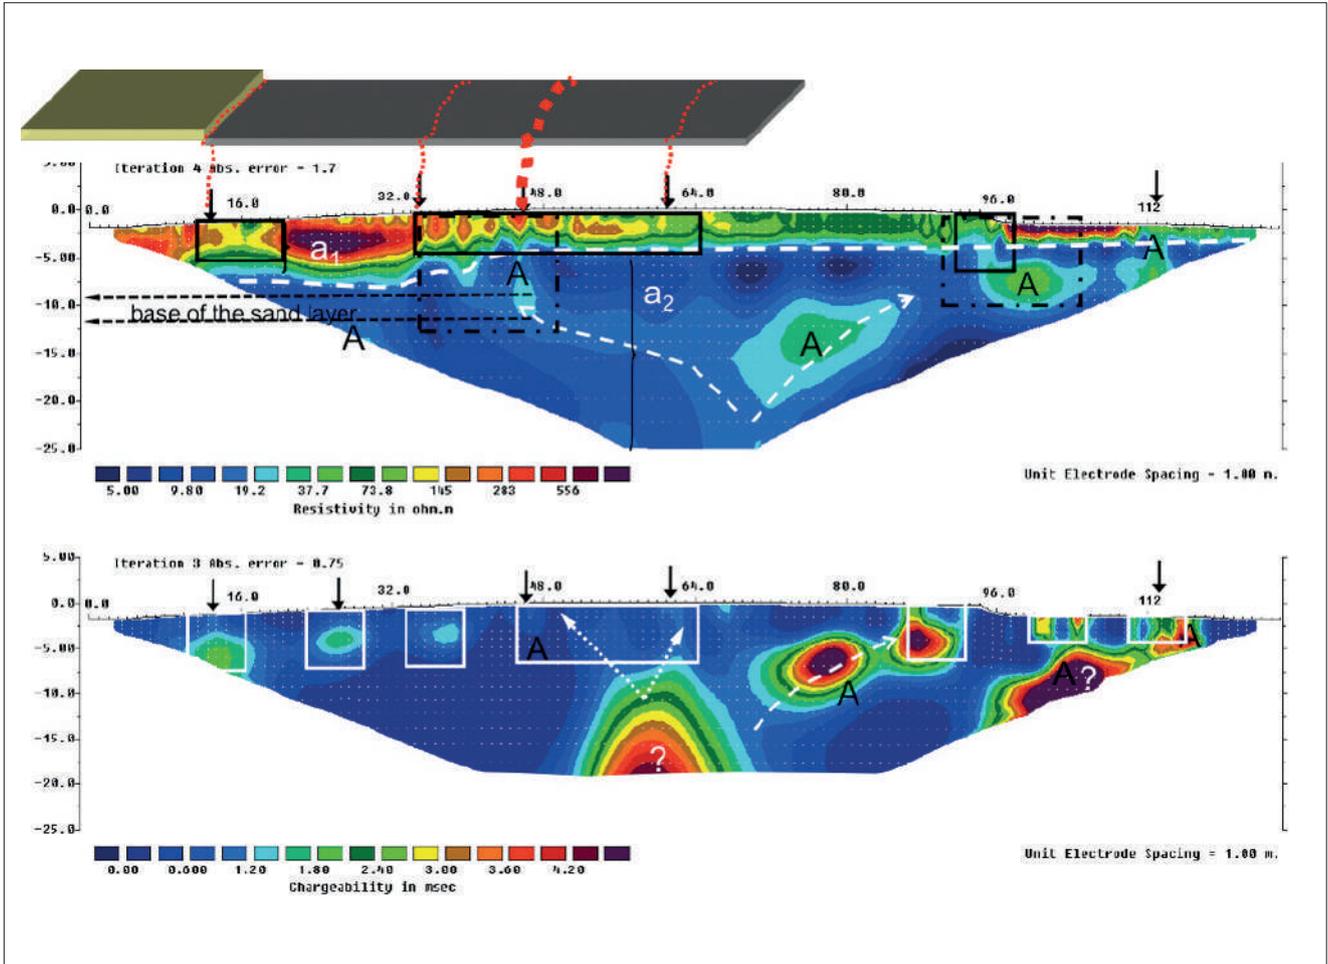
FIGURE 4 2D inverted resistivity (upper) and chargeability (lower) models. a1: resistive horizon and a2: conductive horizon. A: resistivity anomaly due to lithologic variation (silt and fine sand). Dashed white line: possible paleo-soil surface representing the old right embankment of the Reno River. The two shaded areas indicate the extension of the industrial warehouse with respect to the profile. The left one is related to the extreme western portion of the building that was severely damaged and subsequently demolished. ?: further analyses are needed to reveal the nature of these IP anomalies

As regards the first level, the resistivity model suggests the presence of lateral heterogeneities at the following chainages: 12 m, 35-65 m, and around 96 m. These are believed to be associated with subsurface fractures whose traces were visible on the surface at the moment of data acquisition. One of these main fractures (chainage: 35 meters) has caused major damage to the industrial nearby building located some 25 meters off the resistivity profile

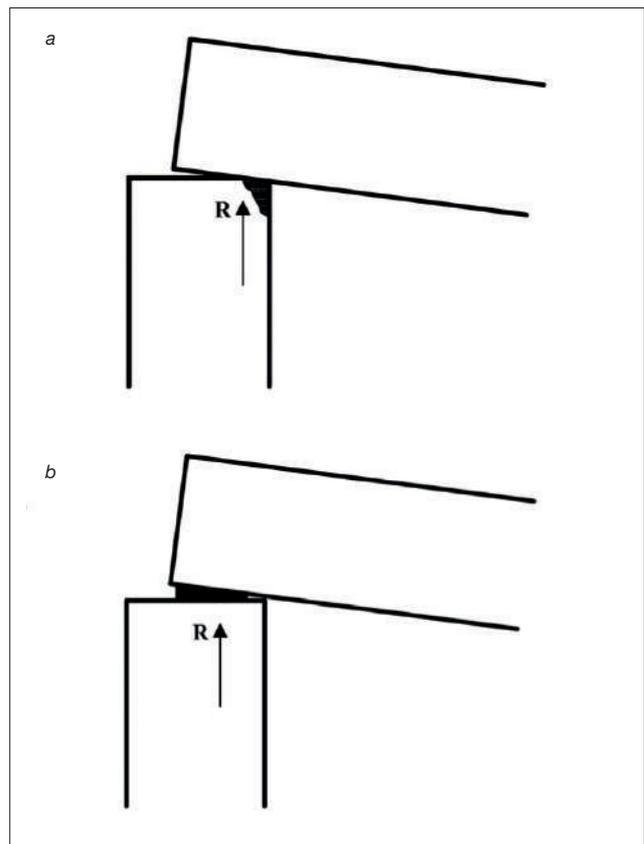
The bending rotation of the beam creates a stress concentration at the top of the pillar, with possible spalling of the concrete (Fig. 4a). This suggests the interposition of a bearing pad (Fig. 4b). If a horizontal force overcomes the friction force, the beam can lose its bearing. A steel dowel or a reinforcing bar can prevent this kind of collapse (Fig. 5).

FIGURE 4 Bending stresses and concrete spalling on the column, avoided by means of the interposition of bearing pads
Source: ENEA

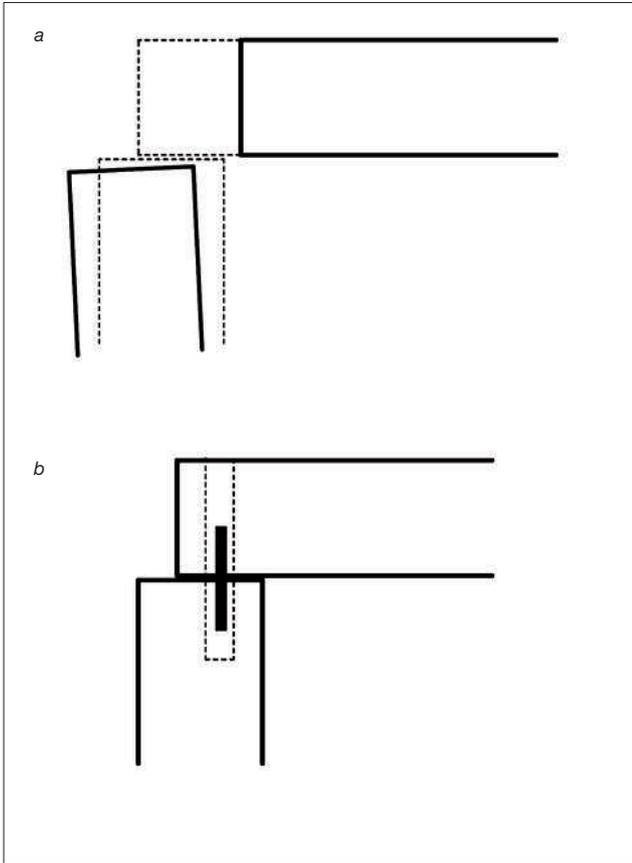
FIGURE 5 Possible relative displacement induced by external forces and insertion of a steel dowel to increase the shear resistance
Source: ENEA

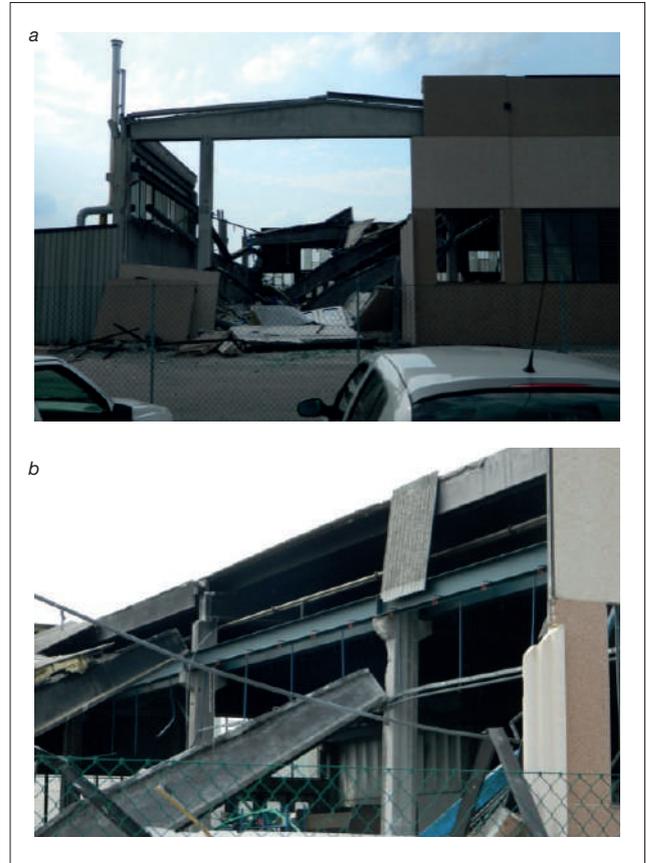
FIGURE 6 Longitudinal toppling of beams for displacement limit
Source: ENEA

The observed damage in industrial buildings was mainly due to the following reasons: loss of bearing, pillar damage, collapse of external cladding panels, instability of steel shelves. Figs. 6 and 7 show some examples of loss of bearing. In many cases, the length of the bearing was too short to allow the beam-support relative motion under the seismic action. Each portal, from a structural point of view, can be depicted schematically as in Fig. 8, where the static equilibrium exists only if the horizontal forces acting on the beam do not overcome the friction forces. Some general considerations can be made for the in-plane behaviour of the roof. To guarantee a good transfer of the horizontal actions to the vertical ele-

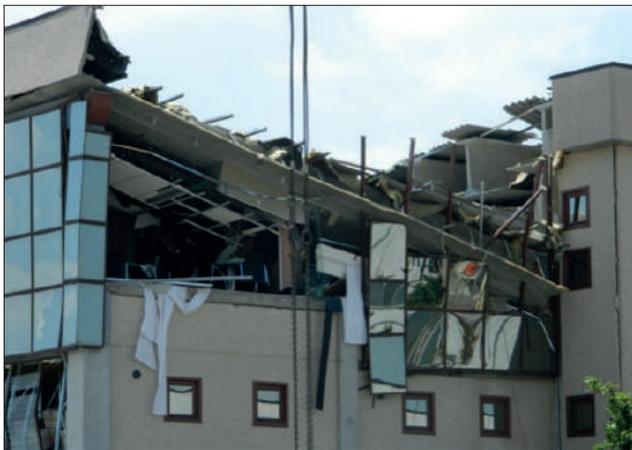
FIGURE 7 Longitudinal slipping of the roof beams
Source: ENEA

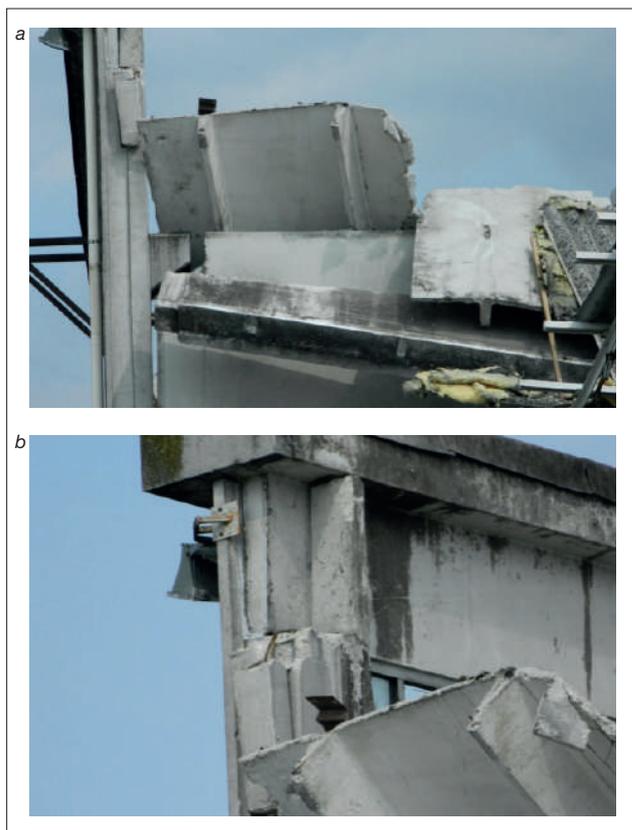
FIGURE 10 Lateral toppling of the beam
Source: ENEA

In some cases the beam toppled down laterally, as shown in Fig. 10, after the failure of the lateral restraint present at the top of the columns, unable to resist to horizontal actions. Clearly, the failure mechanism depended also on the prevalent direction of the seismic motion. Different types of damage to columns are shown in Fig. 11.

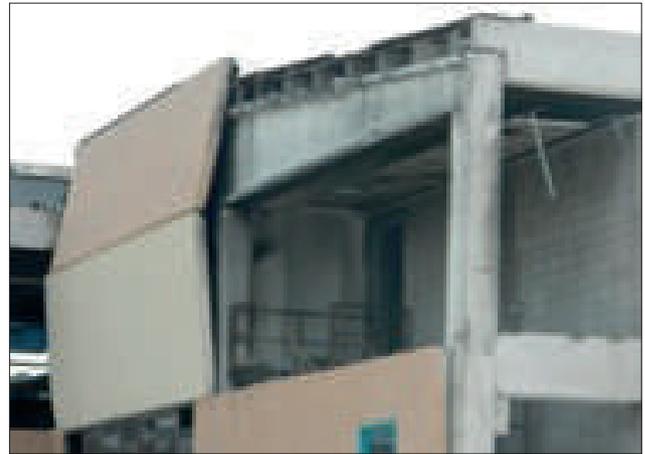
FIGURE 13 Detachment of the external wall
Source: ENEA

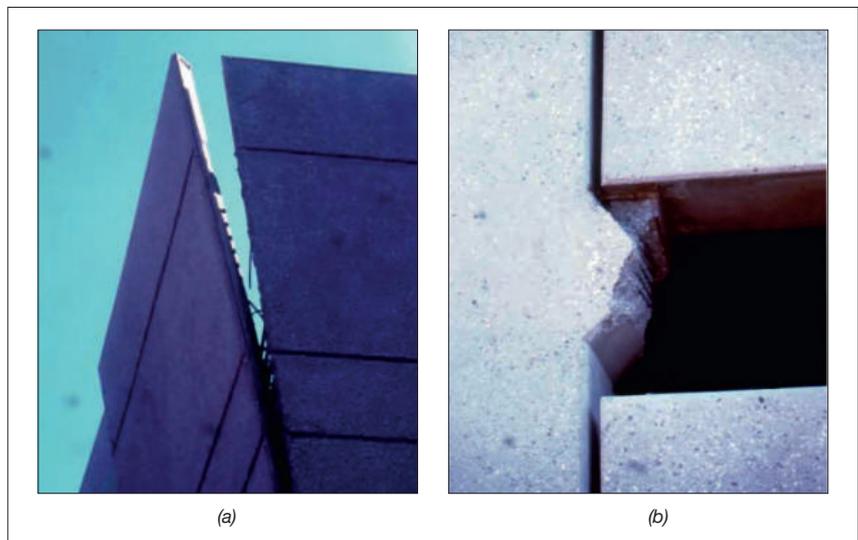
For example, after the January 17th, 1994 Northridge earthquake (California, USA, $M_w=6.7$), several parking lots suffered widespread damage or collapse [6]. Among others, a typical example was the Cigna Garage, a multi-storey assemblage of precast and cast in-situ elements (Fig. 15), located at a distance of

FIGURE 15
Cigna Garage damaged by the 1994 Northridge earthquake [7]

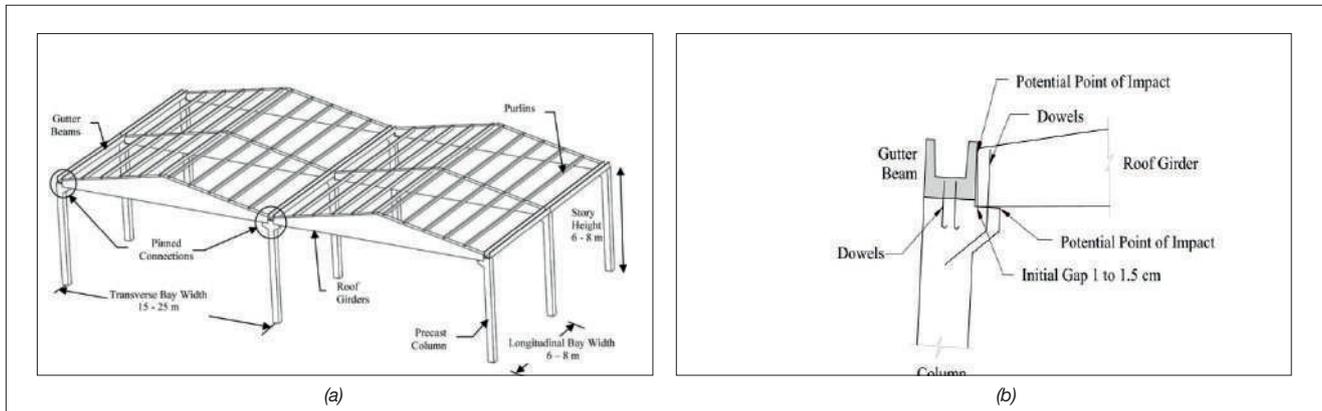
FIGURE 16 A Turkish typical configuration of one storey precast construction near Kocaeli and details [11-14]

hand, collapse and extensive damage was concentrated in pre-1981 r.c. and steel stock. Some typical one-storey industrial pre-cast structures (Fig. 16), located in the epicentre area of the August 17th, 1999, Kocaeli earthquake (Turkey, $M_w=7.4$), didn't show good results, while others remained undamaged (Fig. 17) [10].

The collapse was mainly due to poor design, detailing, and construction, leading to the lack of diaphragm action caused by the inadequate connections (pinned or dowel, simple to realize by the prefabricators) between columns and beams. In addition, buildings under construction were susceptible to collapse when the roof girders rotated off their supports.

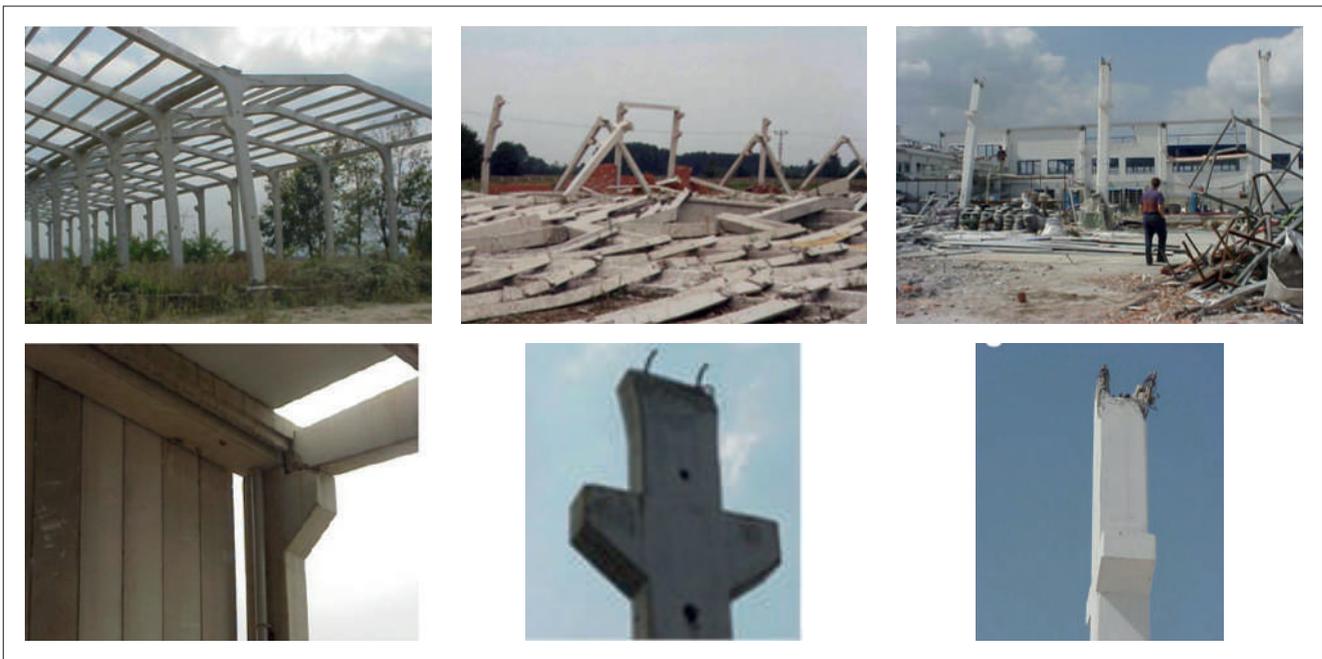
FIGURE 17 P/p. r.c. structures, with different stages of construction and seismic behaviour, located in the epicenter area of the Kocaeli earthquake, and details of the connections [11-14]

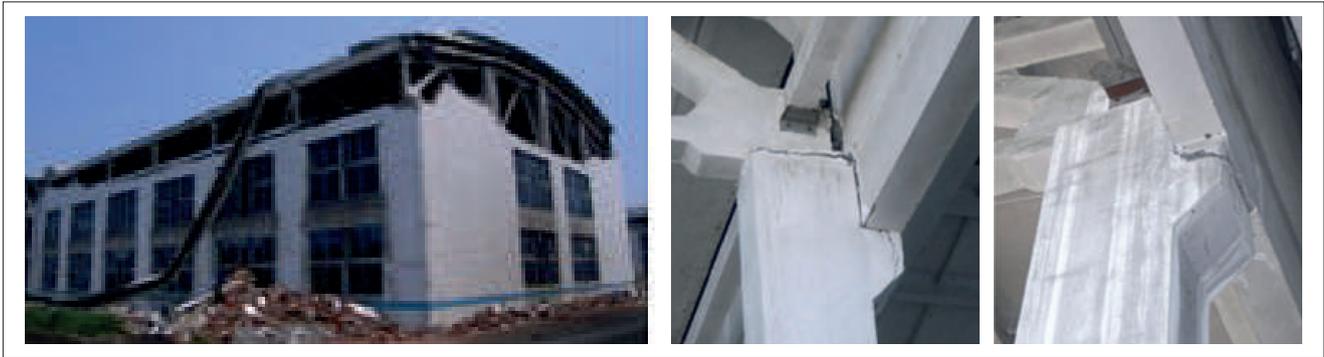
FIGURE 18 Damage and partial collapse of the Xiting Package Ltd. Factory complex in Mianzhu City, Wenchuan, China [15]

Also after the May 12nd, 2008, Wenchuan earthquake (China, $M_w=7.9$), industrial buildings and facilities in the area near the fault rupture were severely affected, as shown in Fig. 18 [15].

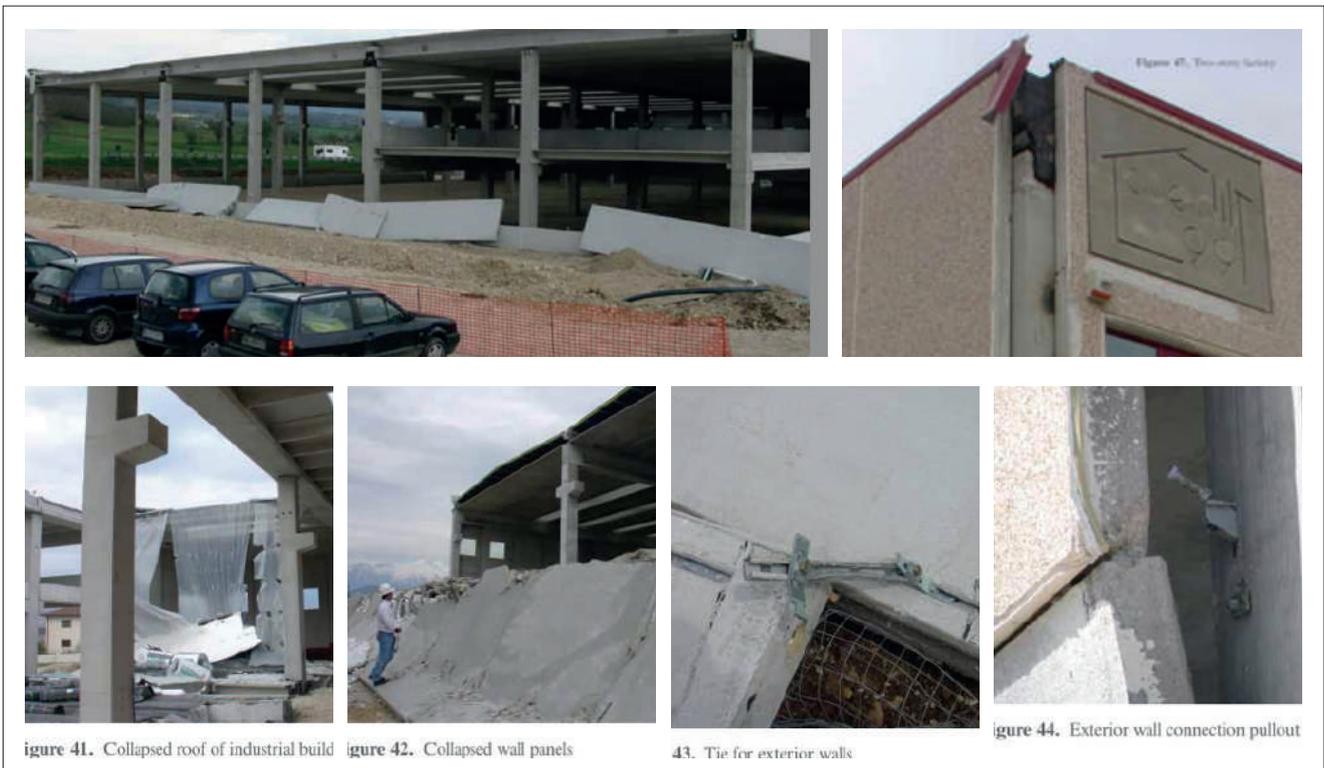
FIGURE 19 Collapse due to lack of adequate anchoring in p/p. r.c. structures in L'Aquila [17]

The April 6th, 2009, Abruzzo earthquake (Italy, $M_w=6.3$) again seriously affected some p/p. r.c. buildings, generally unanchored or inadequately braced [16, 17]; taking into account the relatively new vintage and the

existing seismic classification of the area before the event, the level of damage was surprising (Fig. 19).

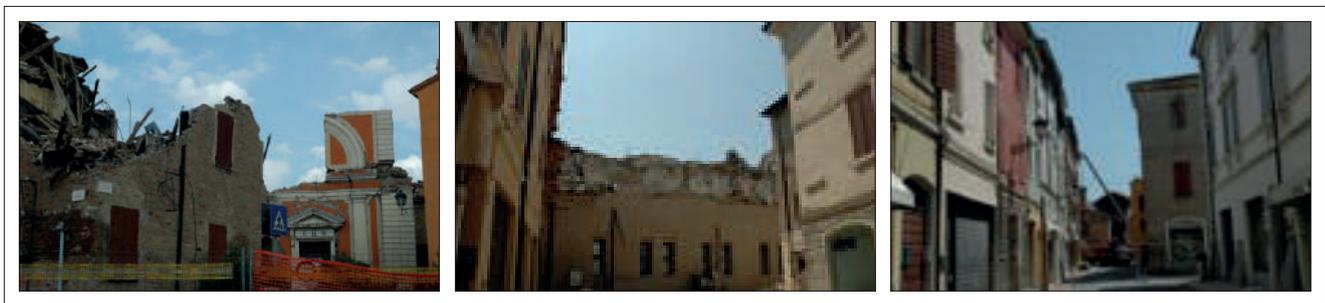
FIGURE 3 Historic centres of San Felice sul Panaro (photo 1) and Mirandola (photos 2 & 3)

quake of May 20th. The first photo of Figure 3 shows a view of the square in front of the cathedral of San Felice sul Panaro, with the church damaged by repeated shocks; photos 2 and 3 of the same figure show two views of the historic centre of Mirandola, the first close to the cathedral whereas the second offers a view of what remains of the church of San Francesco.

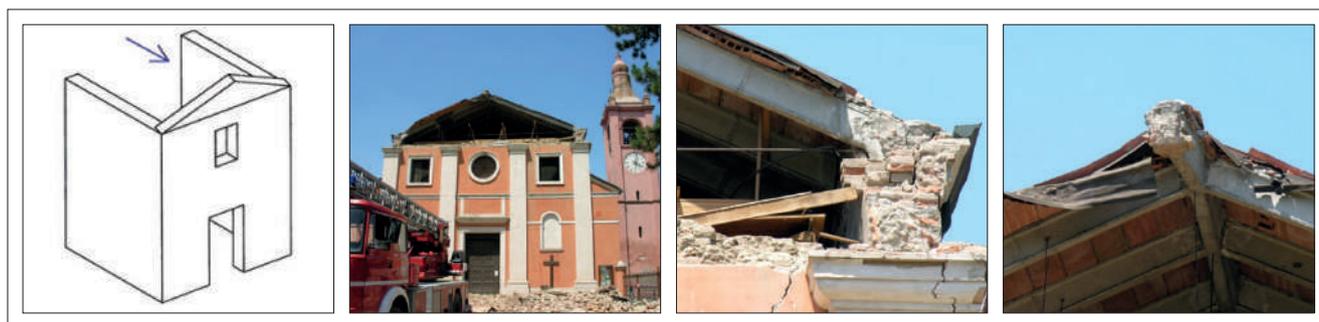
FIGURE 4 Church of Natività, Rivara, San Felice sul Panaro (drawing by [2])

One of the most common failure mechanisms in cases of severe damage was the out-of-plane collapse of the tympanum. In some cases the damage displays a horizontal crack and the collapse of the entire macroelement (Figs. 4 & 5).

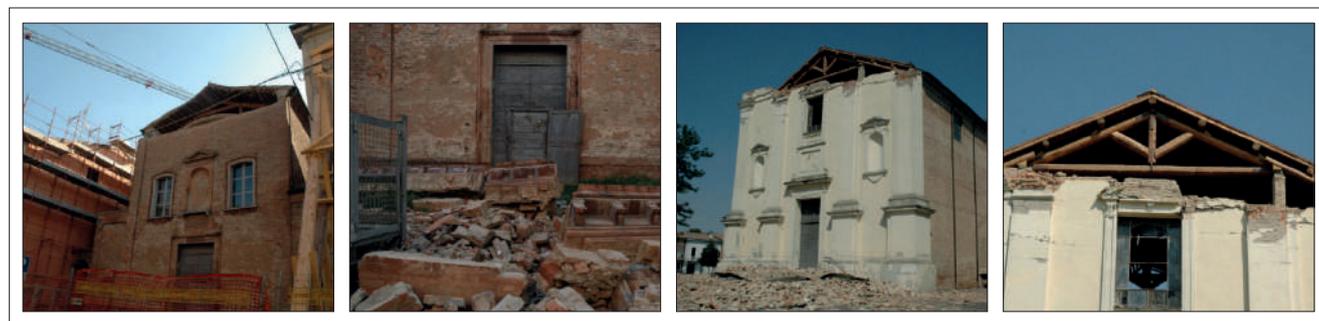
FIGURE 5 Church of Annunziata in Finale Emilia (photos 1&2); Church of S. Possidonio, San Possidonio (photos 3&4)

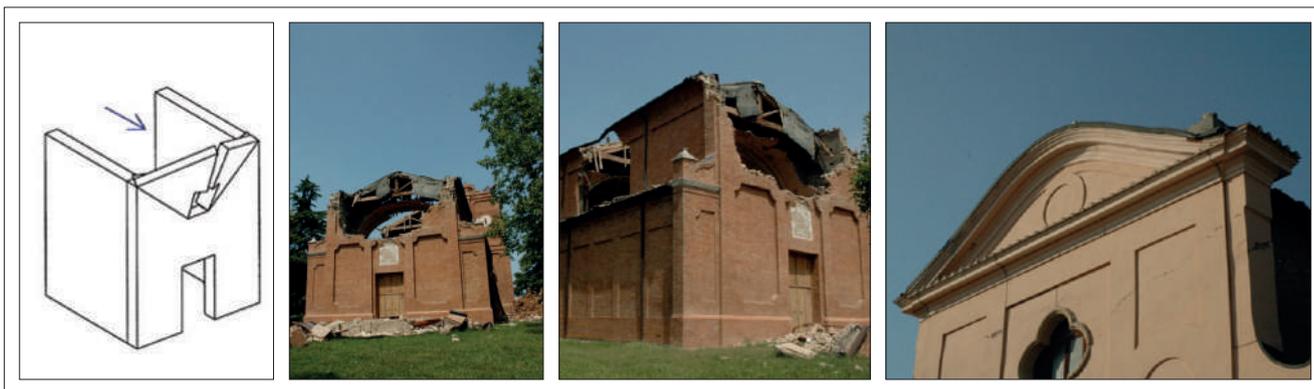
In other cases, the collapse occurred with a V shaped crack and the crumbling of the masonry, as in the badly damaged church of S. Luca in Camurana (photos 1 & 2 in Fig. 6). Another case of V shaped crack is shown in the church of S. Francesco d’Assisi in Finale Emilia (photo 3 in Fig. 6).

FIGURE 6 Church of S. Luca, Camurana, Medolla (photos 1&2), Church of San Francesco d’Assisi, Finale Emilia (photo 3) (drawing by [2])

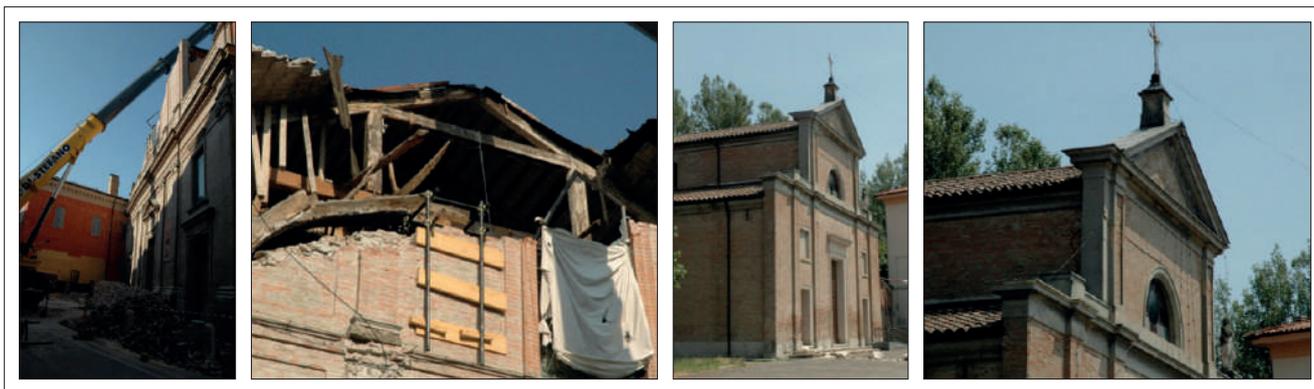
masonry in such a way as not to make the collapse mechanism clear (photos 1 & 2 in Fig. 7), or cases of horizontal cracks in a position lower than the base of the tympanum (photos 3 & 4 in Fig. 7).

FIGURE 7 Church of SS Filippo e Giacomo, Cathedral, Finale Emilia (photos 1&2), Church of Santi Senesio e Teopompo Martiri, Medolla (photos 3&4)

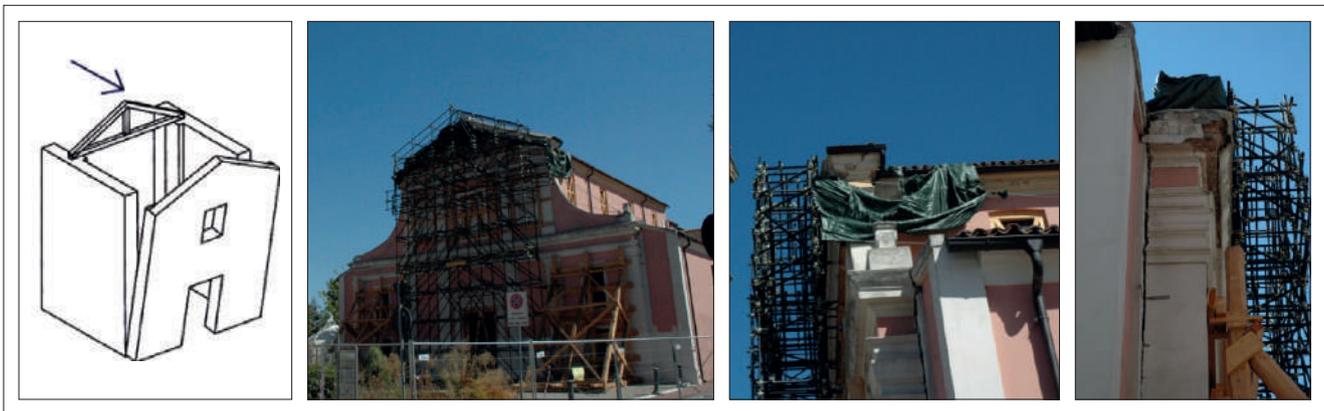
Another mechanism observed in many damaged churches is the detachment with consequent overturning of the façade as in the church in Vigarano Mainarda (Fig. 8). The beginning of the mechanism in the top part is quite widespread, and required many interventions for safety with provisional tie rods (photo 3 in Fig. 12).

FIGURE 8 Church of Natività della Beata Vergine Maria, Vigarano Mainarda (drawing by [2])

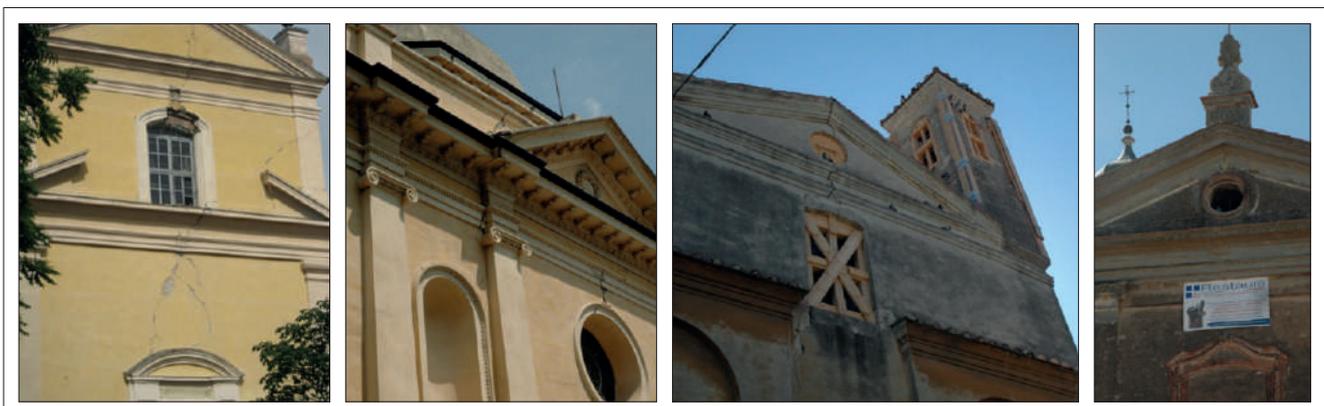
FIGURE 9 Church in Finale Emilia (photo 1); Church of Madonnina, Mirandola (photo 2); Church of SS. Rocco e Sebastiano (photo 3), Pieve di Cento; Church of S. Giovanni, Bondeno (photo 4)

In plane, the damage mechanism of the façade – often with vertical cracks from the tympanum to the architrave of the entrance portal through the rose windows of the churches – has been observed too. Figure 9 shows the various severity levels of this type of damage.

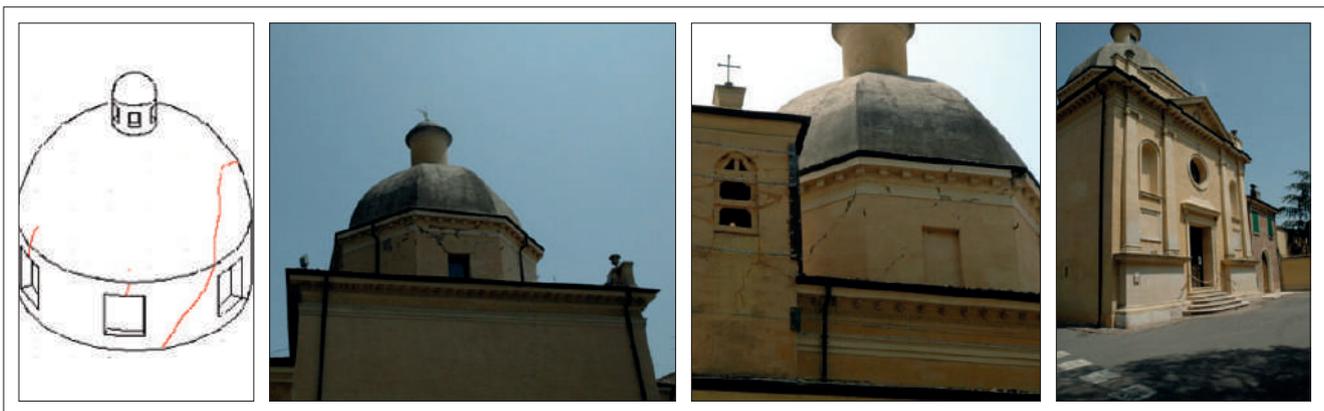
FIGURE 10 Church of the Madonnina, Mirandola (drawing by [2])

The figures below show some cases of this typology of damage. The drum of the Church of Madonnina in Mirandola was seriously damaged, from the outside it is not possible to see any damage to the dome because of the covering.

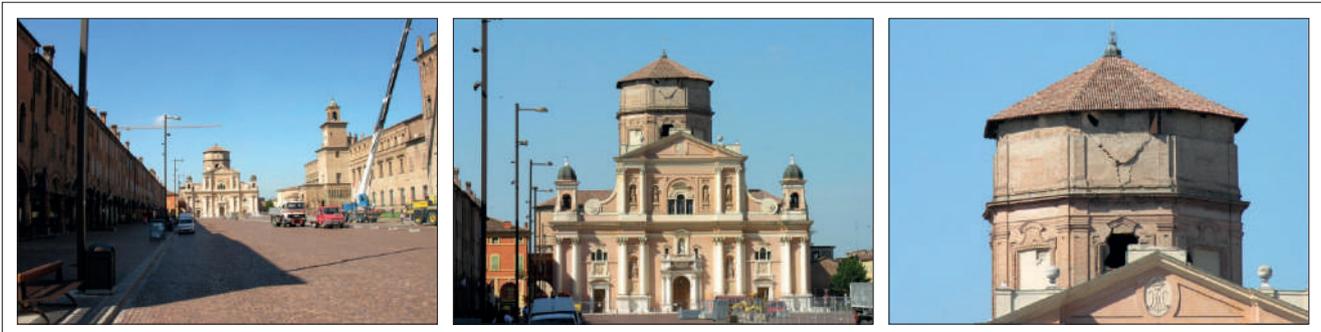
The *tiburium* of the cathedral of Carpi shows clearly visible cracks in the front facing the square (Fig. 11), whereas the dome of the church of S. Maria Maggiore in Pieve di Cento has completely collapsed and its drum is now bounded with provisional tie rods (Fig. 12).

FIGURE 11 Cathedral of S. Maria Assunta, Carpi (MO)

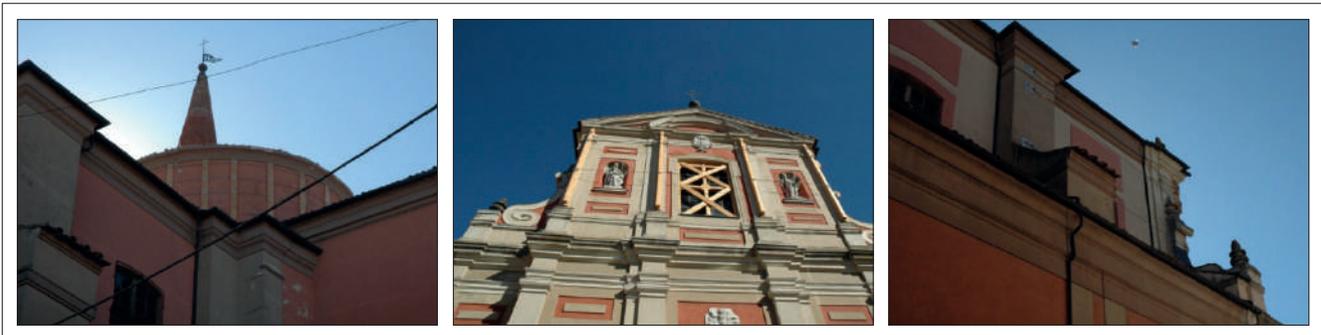
FIGURE 12 Church of S. Maria Maggiore, Pieve di Cento (BO)
