4-5/2012 - Parte II

**The Pianura Padana
Emiliana Earthquake**

58 Damage to religious buildings due to the Pianura Padana Emiliana earthquake

105 Damage mechanisms in some residential building typologies during the Pianura Padana Emiliana Earthquake

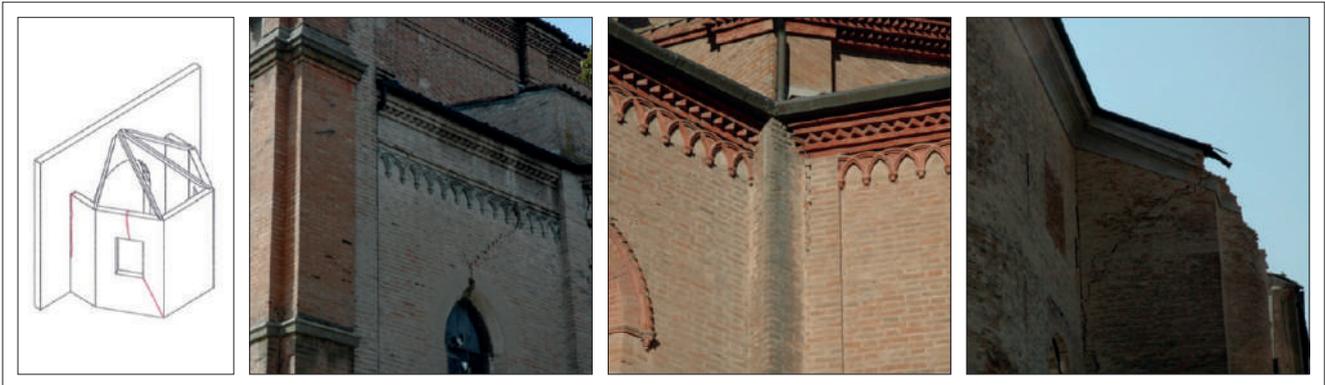
Significant shear cracks are present in the lateral chapels of several churches. The detachment of the outer walls of the chapels from the walls of the church and shear cracks in the walls of chapels and side aisles are often observed (Fig. 13).

FIGURE 13 Church of S. Silvestro, Crevalcore (BO); Church of San Michele Arcangelo, Poggio Renatico (FE); Church of San Possidonio, San Possidonio (MO); (drawing by [2])

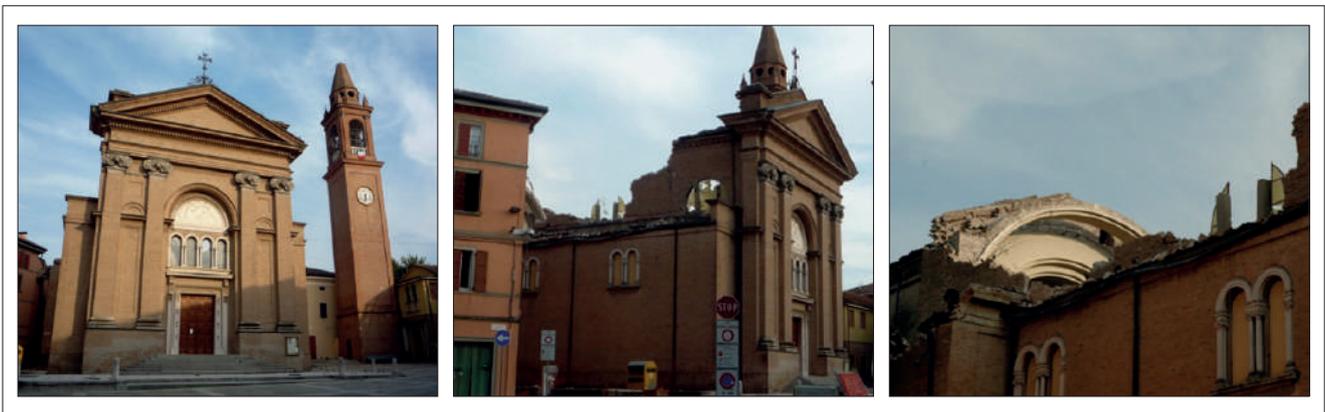
The figures below show some important collapses of structural parts. The church of S. Egidio Abate in Cavezzo was particularly damaged with the collapse of roof and vault. The first photo of Fig. 15 shows the church of S. Francesco, already severely damaged by the earthquake of May 20th, almost completely collapsed after the event of May 29th.

FIGURE 14 Church of Sant'Egidio Abate, Cavezzo (MO)

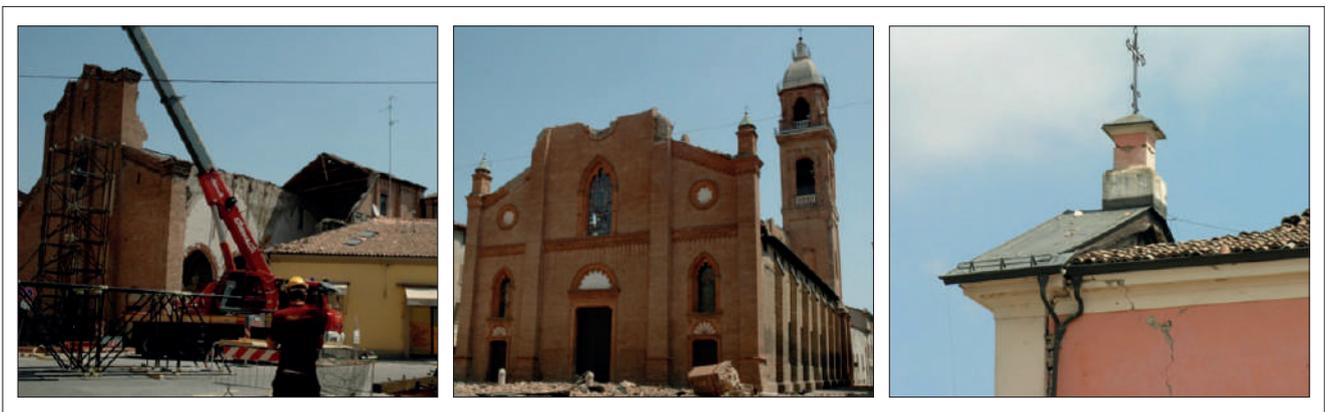
Already damaged by the earthquake of May 20th, also the cathedral of Mirandola, with the event of May 29th, saw the partial collapse of the façade and the roof. The roof

FIGURE 15 Church of S. Francesco (photo 1) and Cathedral (photo 2) in Mirandola; Church of Santa Caterina d'Alessandria, Rovereto di Novi (photo 3, by courtesy of P. Clemente)

collapse in the badly damaged church of Santa Caterina d'Alessandria in Rovereto di Novi, in Novi di Modena town, has become infamous for causing the death of the priest. Little is left – except for the perimeter walls and piles of rubble to recover – of the church of S. Martino in Buonacompra, and of the Oratorio Ghisilieri in San Carlo, in Sant'Agostino town.

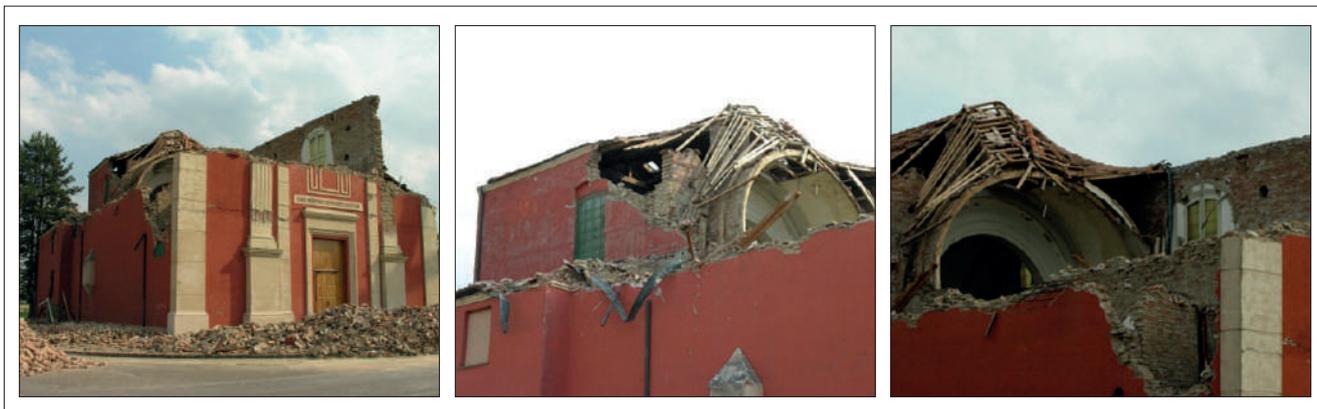
FIGURE 16 Church of S. Martino, Buonacompra, Cento (FE)

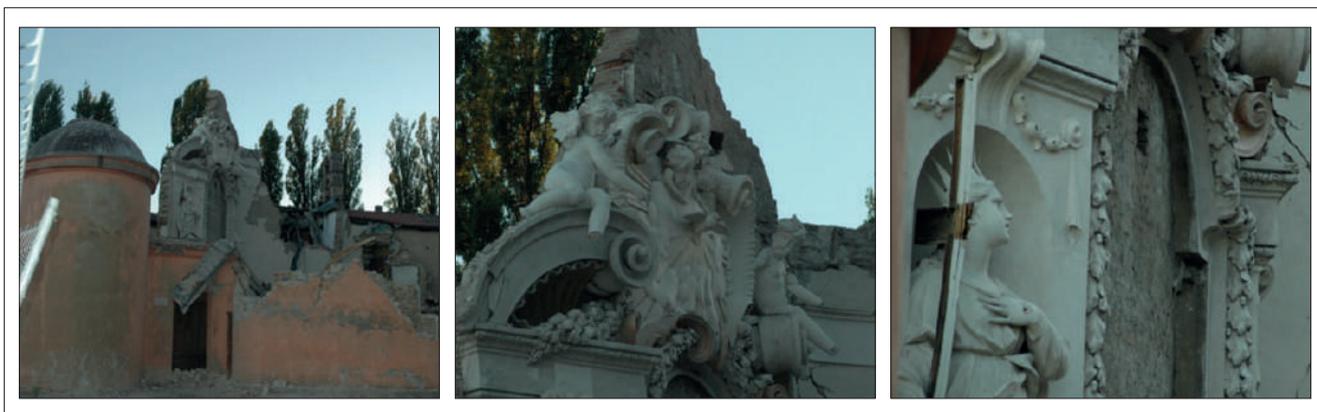
FIGURE 17 Oratorio Ghisilieri, San Carlo, Sant'Agostino (FE)

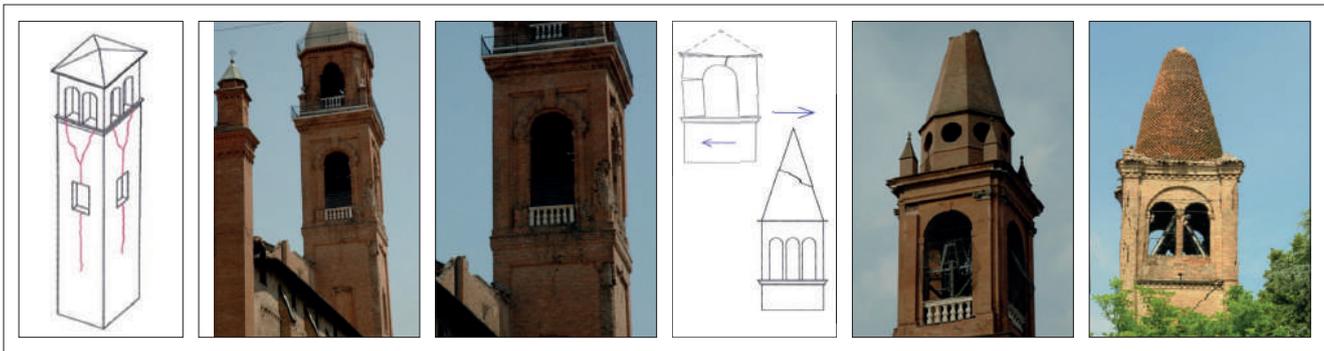
tion (frequent cases in the area where inclined steeples are found) and to masonry in bad state of conservation. The bell cells, with large openings, show serious shear cracks in the little columns, with sliding in the most severe cases (Fig. 18). Some of them are disaggregated under the action of the earthquake, others have been

FIGURE 18 Steeples of: Cathedral, Mirandola (photos 1 & 2); Church of Sant'Egidio Abate, Cavezzo (photo 3); Church of Santa Caterina d'Alessandria, Rovereto di Novi, (photo 4, by courtesy of P. Clemente), (drawings by [2])

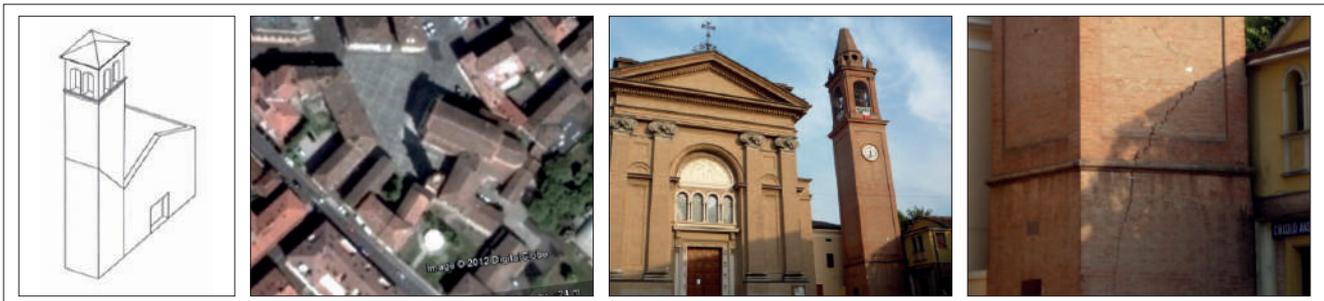
removed from firefighters, others made safe. When the steeple is placed in contact with other structures of lower height, this can cause local damage; an example is the bell tower of church in Cavezzo (Fig. 19). In the pictures in Fig. 20, two cases of severe damage are reported; the first two photos show the bell tower

FIGURE 19 Steeple of Sant'Egidio Abate Church, Cavezzo (drawing by [2], photo 1 by Google maps)

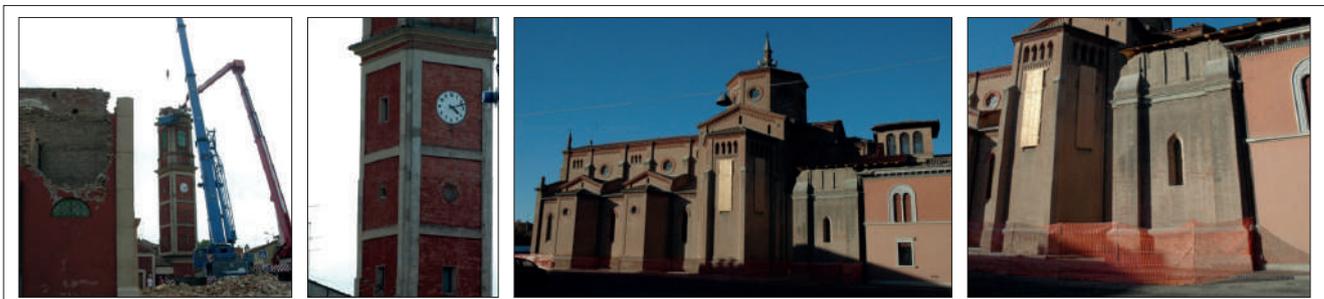
FIGURE 20 Steeples of: Church of S. Martino, Buonacompra, Cento (FE), Church of S. Michele Arcangelo, Poggio Renatico (FE)

of the Church in Buonacompria during the demolition. Photo 2 shows the severe shear two-level damage, due to torsional stress, that led to the decision to demolish the tower. The last two pictures in Fig. 20 show the church of S. Michele in Poggio Renatico deprived of its bell tower, blown up as a threat to public safety due to its serious structural problems.

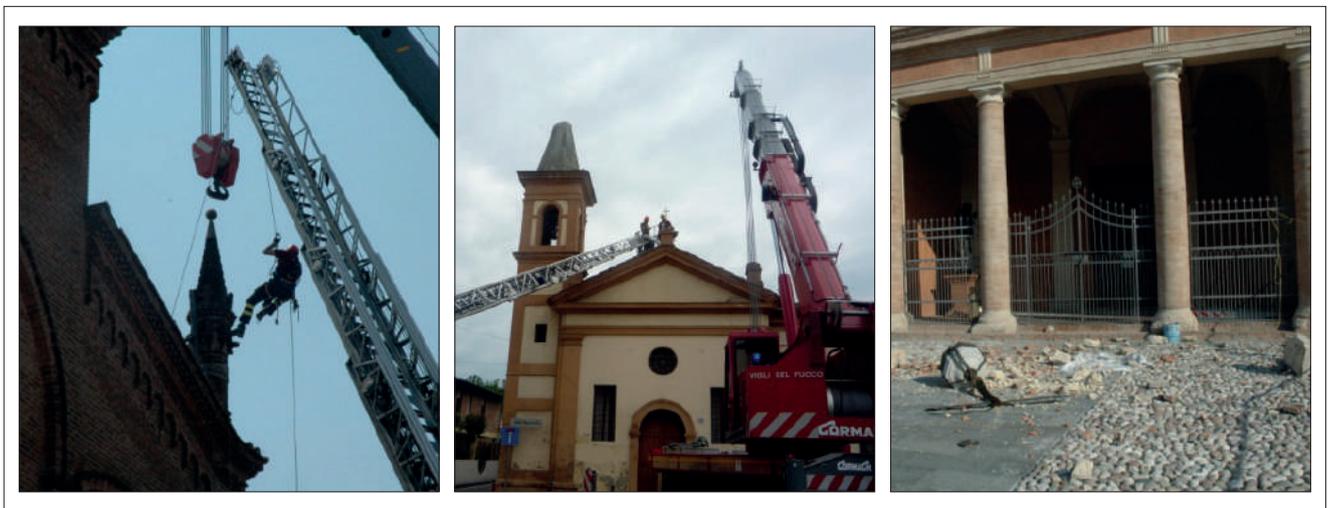
Firefighters intervened many times on the top of the church façades and bell towers to remove slender elements, such as statues and spears, with vulnerability due to their low vertical load and weight, which provides a limited stabilizing effect in regard to the turnover. Spiers, crucifixes, statues that fall from the church roofs, often with metal anchors

FIGURE 21 Church Matildica and Church of the Sante Grazie in Bondeno; Church of San Bartolomeo, Finale Emilia

weak or too short, represent a danger often underestimated.

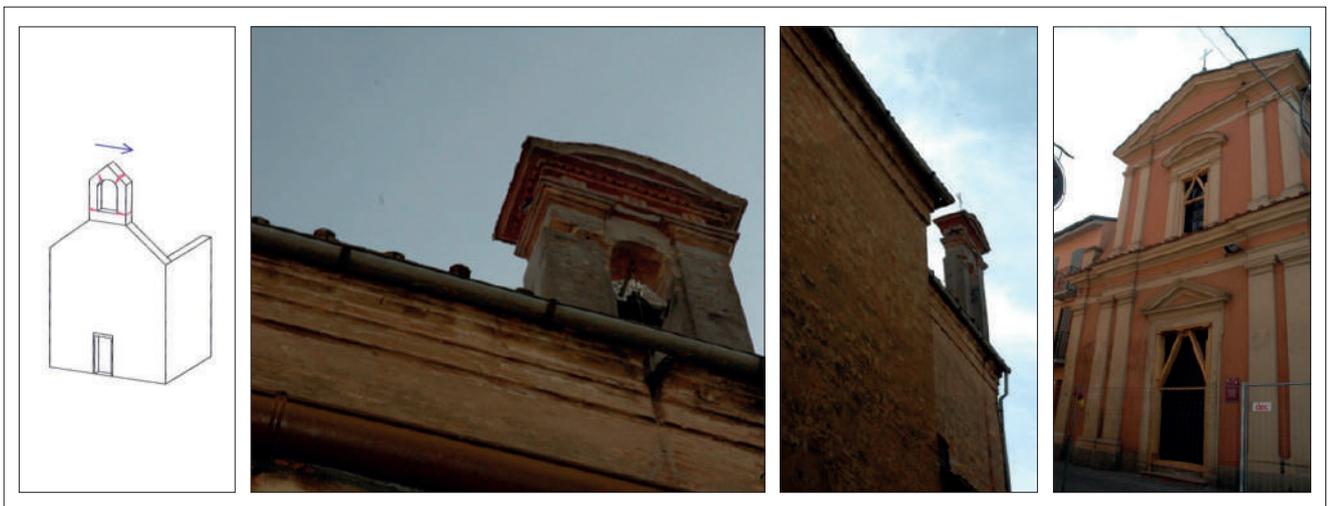
FIGURE 22 Church of Santa Croce, Crevalcore (BO), (drawing by [2])

Many interventions have been made to put the bell cells in safety and, in some cases, disassemble them. In other cases, overhang host bells have reported shear cracks with displacements due to sliding along the shear cracks, as in the church of Santa Croce in Crevalcore (Fig. 22).

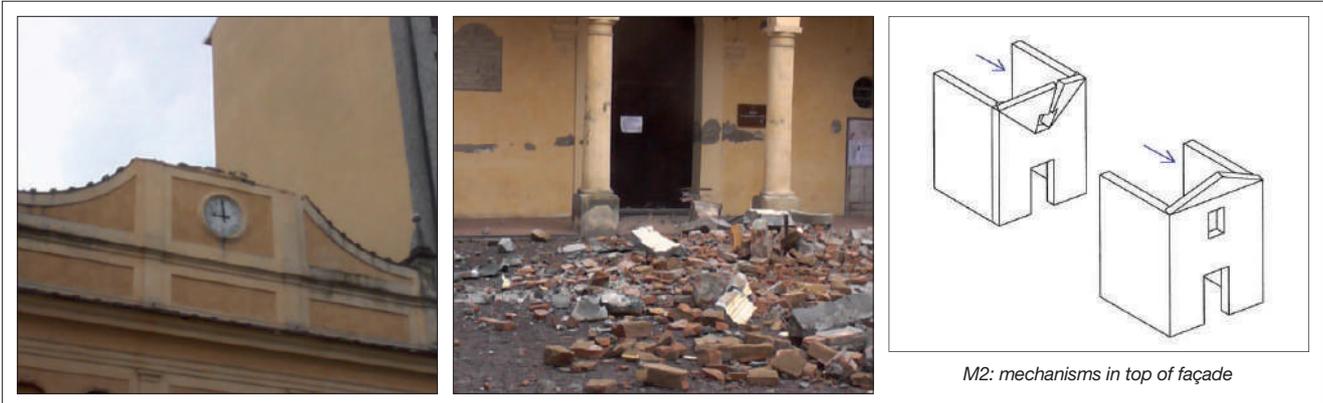
FIGURE 11 Cento (Ferrara) historic centre: the Church of San Sebastiano and San Rocco (Convent of Friars Capuchins) and main collapse mechanisms

Inside the historic centre of Cento (Ferrara), most of the damage occurred after the shock of May 29th (Cento recording station, PGA 0.30g): Church of San Filippo Neri (detachment of the façade, Fig. 10); Church of San Sebastiano and San Rocco (collapse of the tympanum, Fig. 11); Church of San Biagio (instability of the top part of the bell-tower, Fig. 12); Church of San Pietro (detachment of the façade, Fig. 13); Church of the Rosario (vault collapse, Fig. 14).

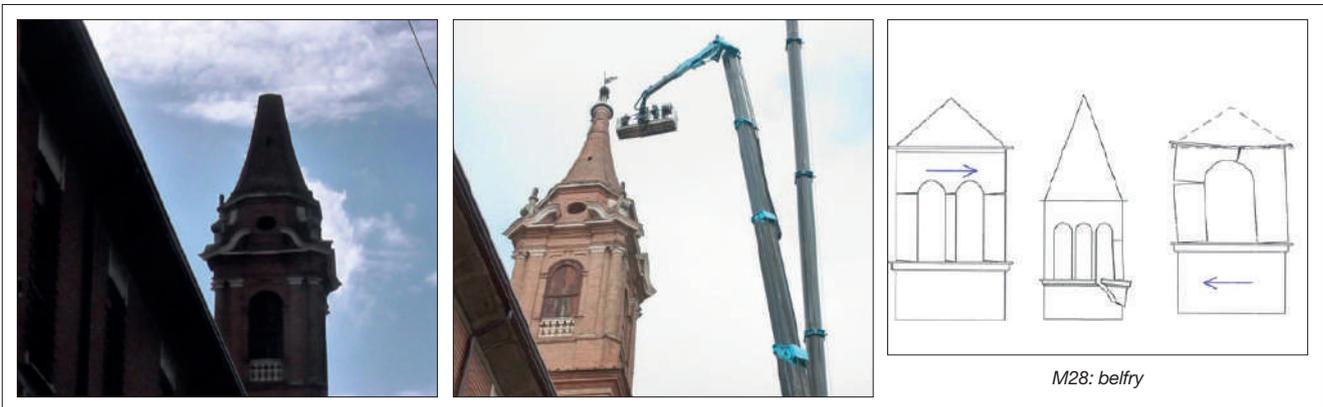
FIGURE 12 Cento (Ferrara) historic centre: the Church of San Biagio and main collapse mechanisms

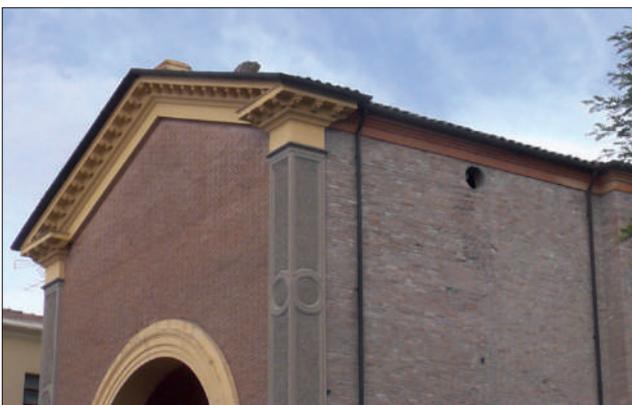
FIGURE 13 Cento (Ferrara) historic centre: the Church of San Pietro and main collapse mechanisms (middle above)

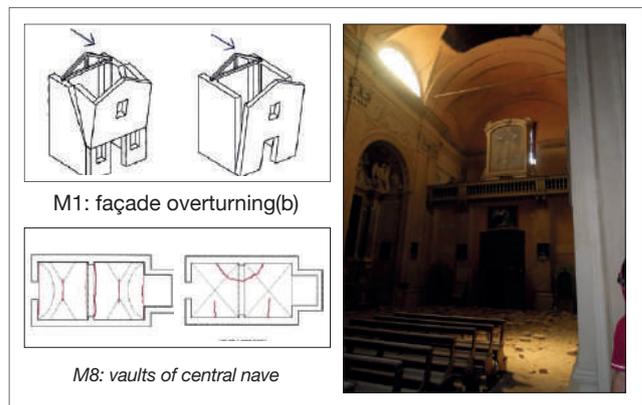
FIGURE 14 Cento (Ferrara) historic centre: the Church of the Rosario and main collapse mechanisms (middle bottom)

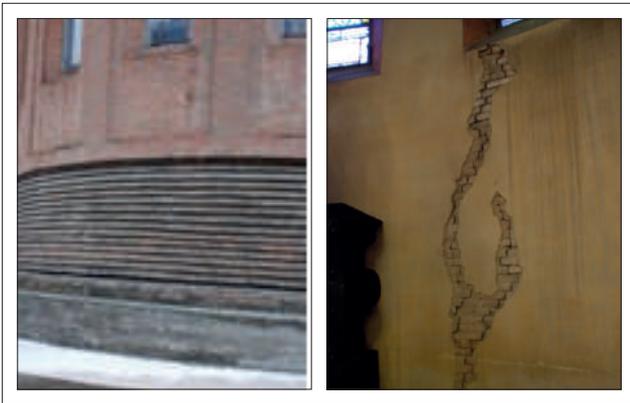
- The survey evidenced damage due to the recent seismic event, but also previous ones. The latter are caused by subsidence, because of different soil mechanical properties.

The old cracks (Fig. 16) increased with the recent earthquake, which originated new local/global damage mechanisms.

FIGURE 16 Subsidence phenomena: a) external view; b) internal view

Finally, a damage index of about 0.27 has been obtained. Soil geotechnical survey and seismological microzoning is considered mandatory, in order to evaluate how to enhance the foundations.

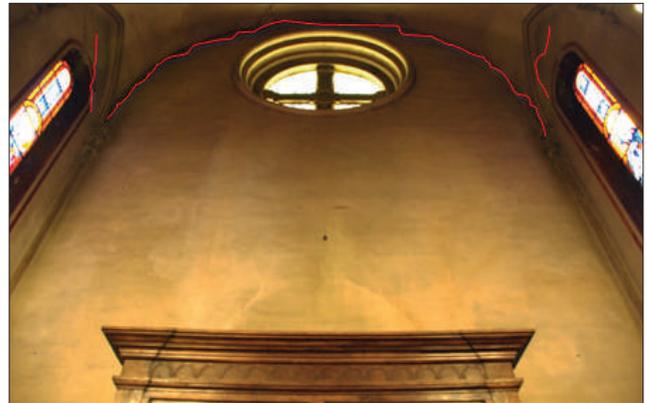
The major cracks of the main façade are highlighted with a red line (Fig. 17), and the mechanisms plotted in Fig. 18. It is worth noticing that the mechanisms related to church lateral apses have been considered as chapel mechanisms (M22 and M23).

FIGURE 17 Façade overturning mechanism (M1), internal view

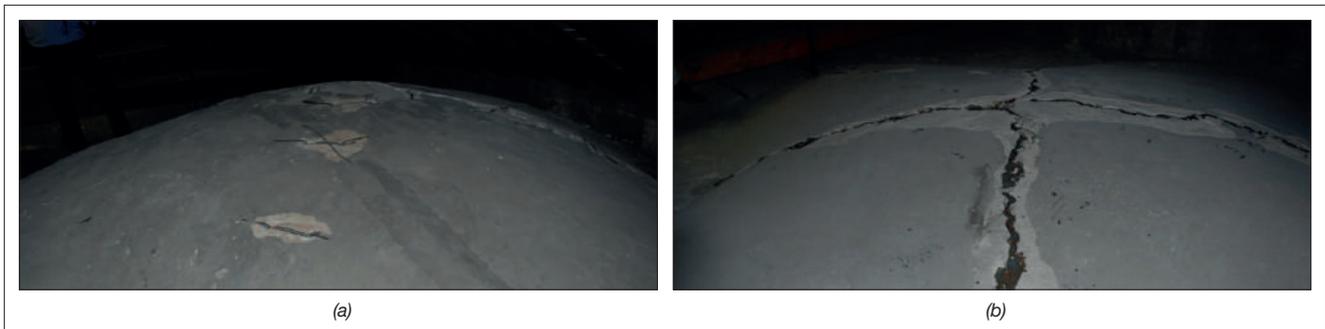
the lateral nave. Cracks along the ribs and falling of bricks were found. Such damage has been repaired through prompt interventions (almost completed at the time of our visit), ringing of the ribs with metallic plates fixed to the vaults (Fig. 23a), and filling the cracks with resin (Fig. 23b).

FIGURE 23 The San Geminiano Cathedral: a) ringing of the vault ribs; b) filling of the cracks

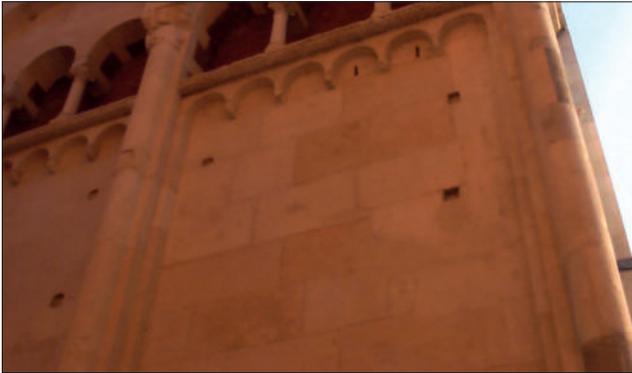
In addition, the main façade showed a potential overturning mechanism, slightly triggered, highlighted with a black line in Fig. 24. Moreover, the opening of the transversal walls (corresponding to the lateral nave) from the longitudinal one has been observed (Fig. 25), due to the variability of the mechanical properties of the soil foundation.

FIGURE 24 The San Geminiano Cathedral: potential overturning of the façade

The following several interventions were suggested after the investigation: structural re-establishment of damaged vaults, arches, ribs and unconnected wall portions. The implementation of the monitoring system – for a deep and permanent dynamic characterization of the whole complex, evaluating in particular church/tower interactions – is considered necessary and propaedeutic to complete the existing strengthening systems, in both the Cathedral and the Ghirlandina.

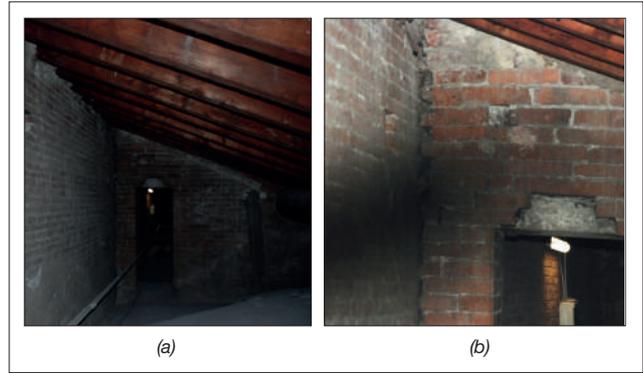
FIGURE 25 The San Geminiano Cathedral: overturning of the lateral transversal walls

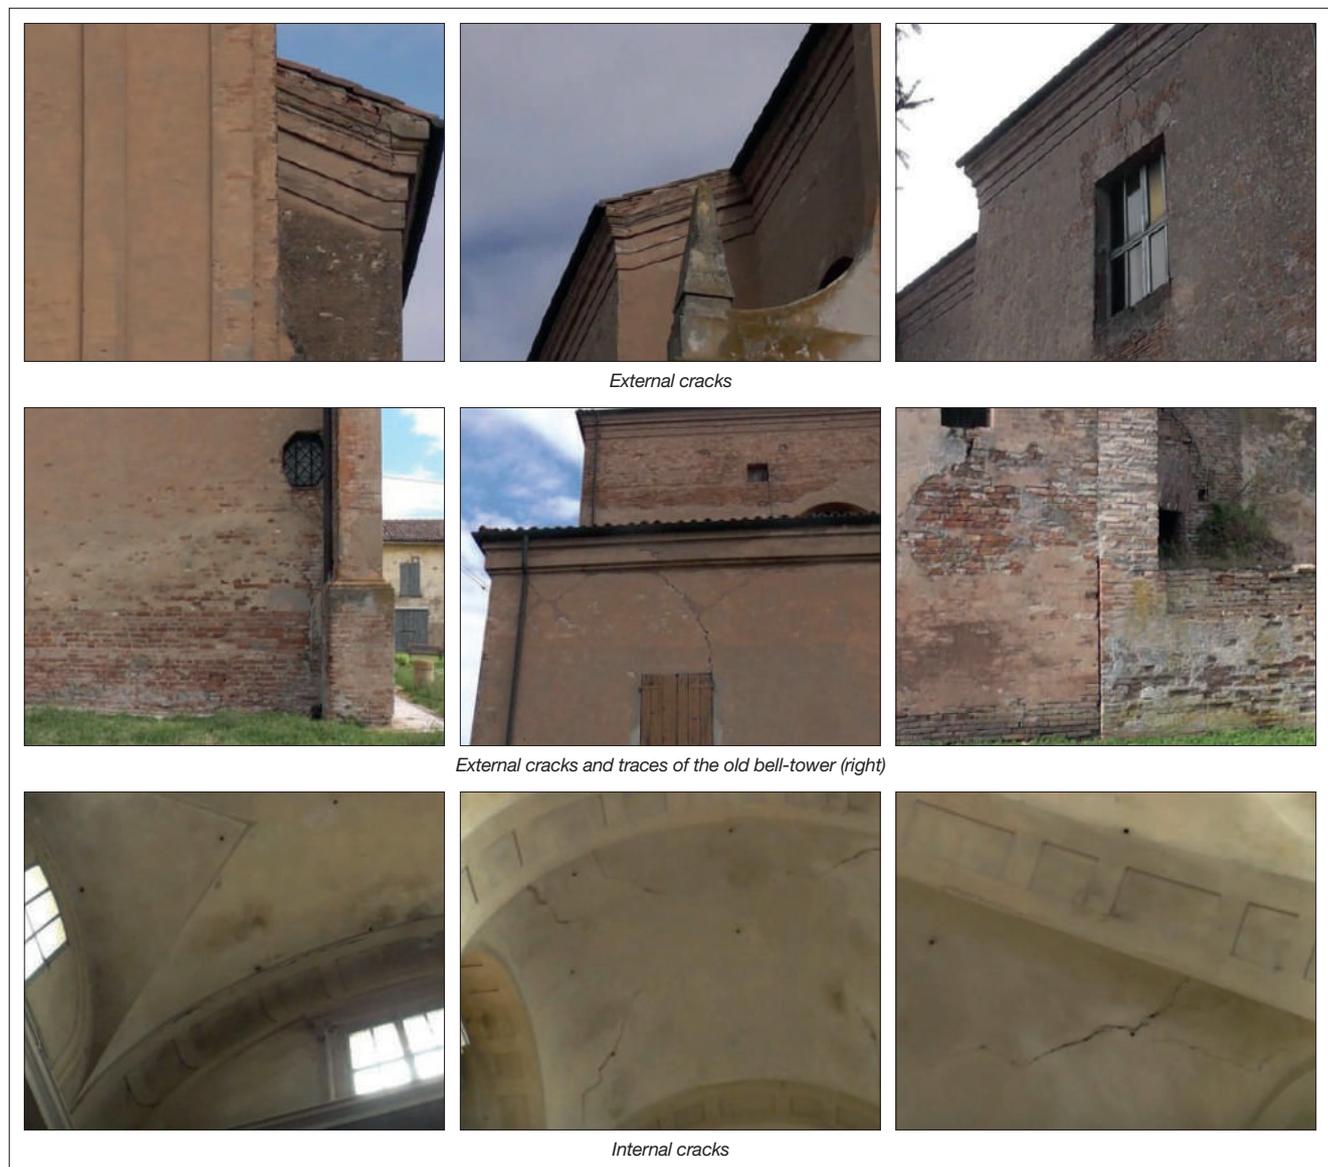
Damage survey and observed mechanisms - The church was bombed during the Last World War and the original bell-tower collapsed. Never completely restored, at the time of our visit it showed a generalised previous damage in walls, vaults and arches, worsened by the earthquake (Fig. 29). The main mechanisms are reported in Fig. 30, corresponding

FIGURE 29 Damage mechanisms in the Ghirlandina Tower (Modena)

to a global damage index equal to 0.16. During the May 2012 seismic events, the church experienced a PGA maximum value of 0.040g (Medicina recording station). After the survey, it was considered safe, but the maintenance poor (previous cracks, humidity due to rain). Tying enhancements of nave and tympanum have been suggested.

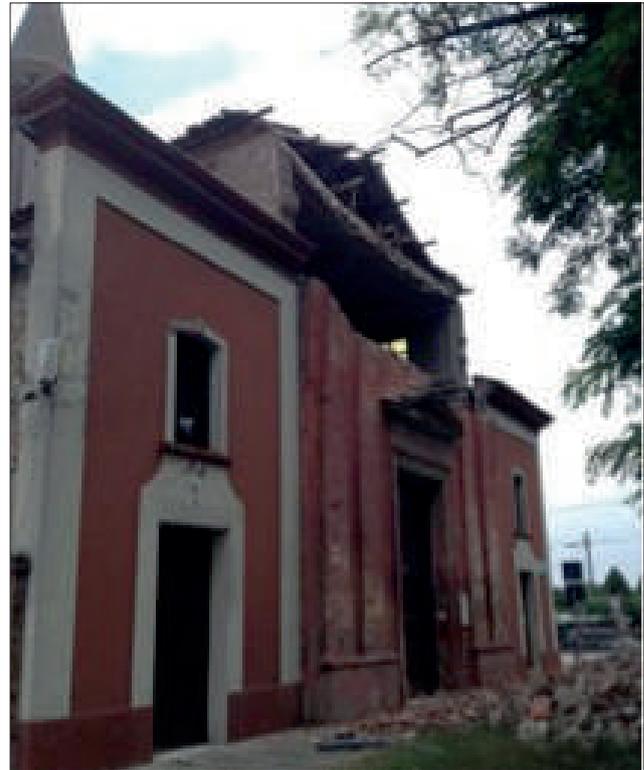
The most evident effect of the seismic action is the collapse of the upper portion of the main façade of the church, due to the lack of connection with the transversal walls. The occurred mechanism is the vertical overturning of the Façade and the collapse of the top one. The non-collapsed part of the façade is separated from the transversal walls and greatly inclined towards the churchyard. The two façades of the lateral naves are connected to the transversal walls and are lower than the main one, therefore they are less damaged (Figs. 2-3).

FIGURE 2 The main façade

- 1) Safety of the overturning mechanism of the façade;
- 2) Ringing of the perimeter walls;
- 3) Removal of the cover;
- 4) Ringing of the original bell-tower;
- 5) Ringing and insertion of vertical ties on the more recent bell-tower.

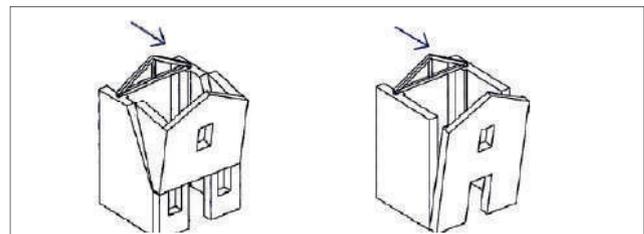
Both the portion of the roof directly connected to the main façade and the façade itself collapsed at the same time. The timber trusses appear to be connected to the walls, with the “*capochiave*” (anchor plate)

FIGURE 3 Overturning of the façade

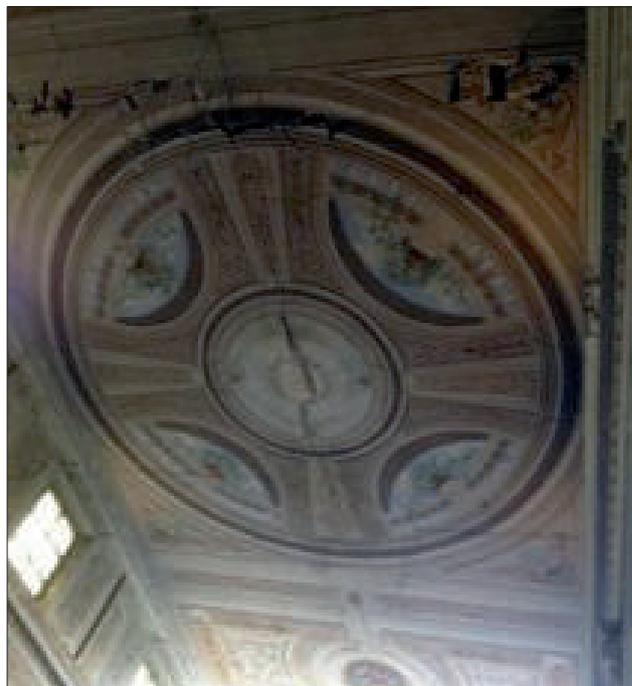
timber trusses and is severely damaged (Fig. 4). On the contrary, the frescoed ceiling of the lateral naves, which are made of “*in sheet*” arranged bricks, have collapsed in many parts, especially in the left nave (Fig. 5). In addition, the cracks’ distribution and their depth outline a dangerous condition for the entrance.

FIGURE 4 The false ceiling of the central nave

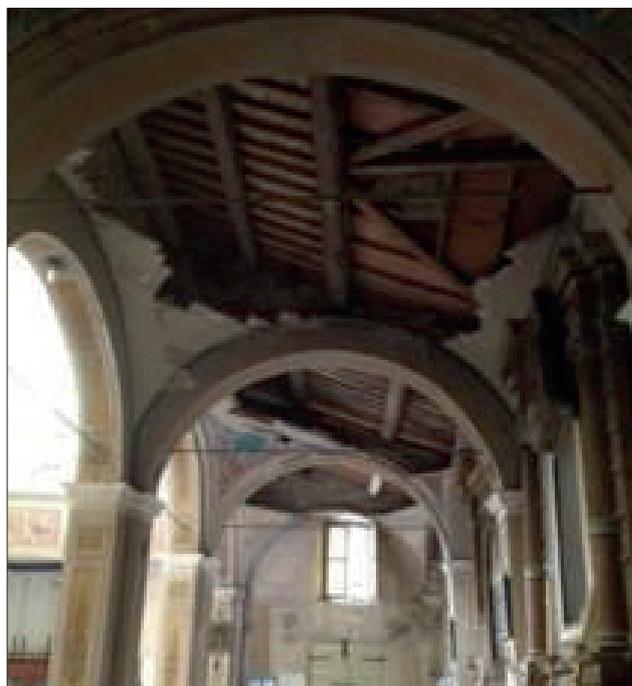
FIGURE 5 The collapsed vaults of the left nave

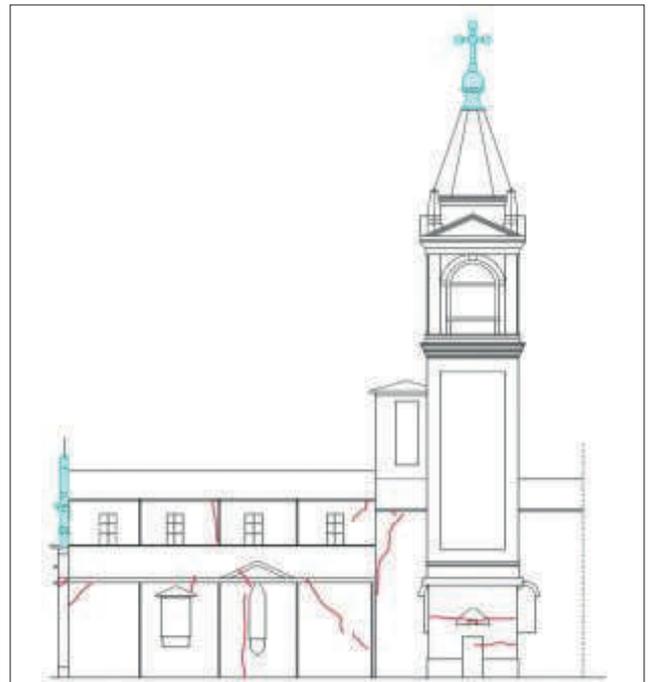
The cracks’ pattern (Figs. 6-8) related to the façades shows a rather critical situation: in addition to the overturning mechanism, many other deep cracks are visible, which are particularly severe. Moreover, a passing through vertical crack located between the second and third arch has been surveyed, also by using a thermal imaging camera (Figs. 9-10).

FIGURE 7 Cracks on the east side

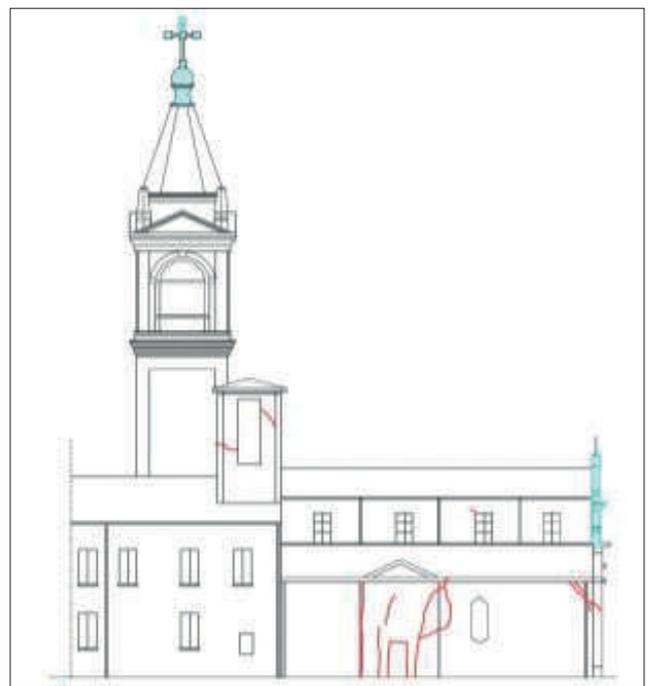
FIGURE 8 Cracks on the west side

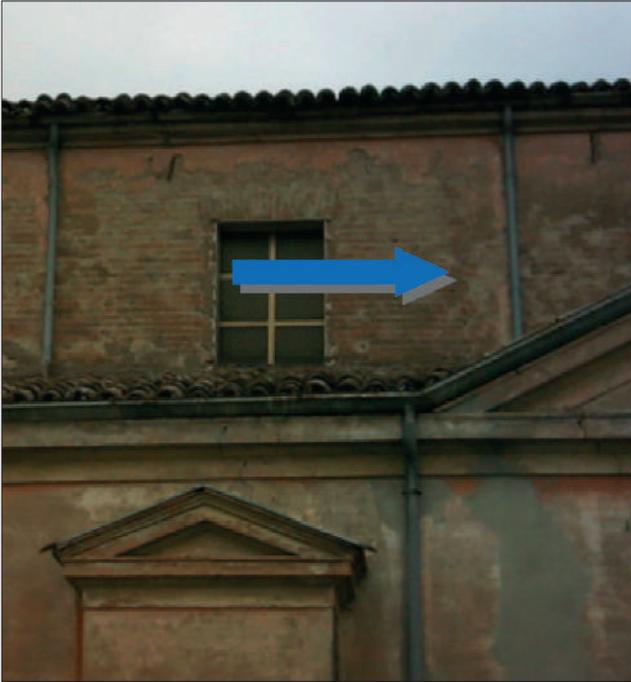
FIGURE 9 Passing through vertical crack

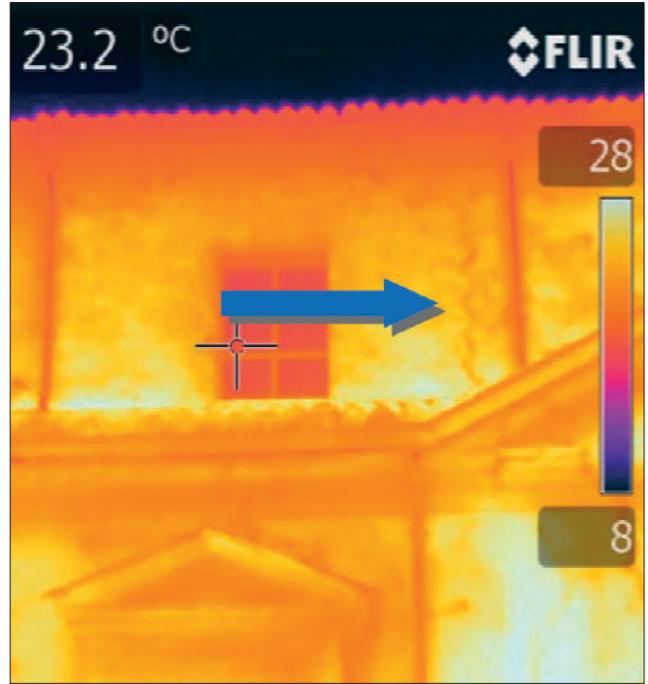
FIGURE 10 Passing through vertical crack (thermal imaging camera)

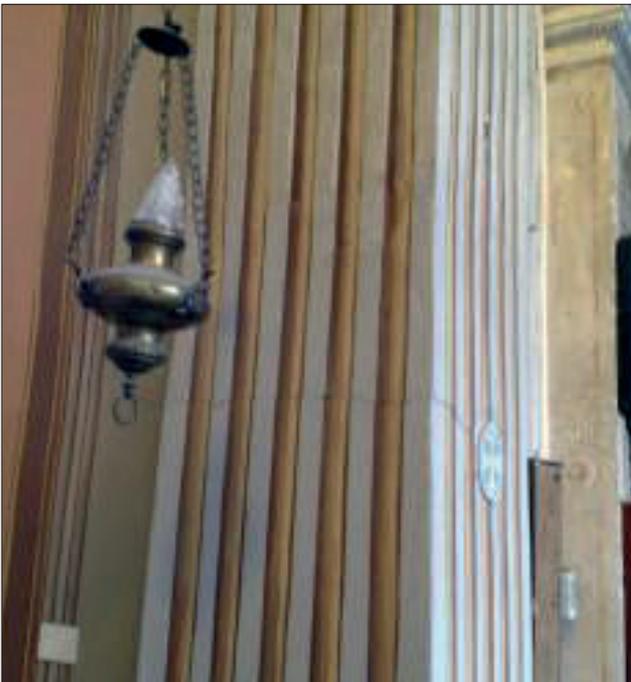
Other evident cracks are located between the central nave and the apse, where the walls seem unconnected to each other. A horizontal crack at about 2 meters from the ground level is surveyed on the pilaster on the right of the apse, in addition to a slight rotation. Moreover, diagonal cracks on the doors and separation of the corner have been evidenced on the wall located on the right of the apse (Fig. 11). On the contrary, on the left side of the apse, the presence of the oldest tower has provided a connection function between the two walls. In any case, the sacristy wall has been damaged because of the hammering action of the more rigid structure of the oldest tower on it (Fig. 12). Cracks are also present at the bottom wall of the apse.

FIGURE 11 Horizontal crack on the pilaster

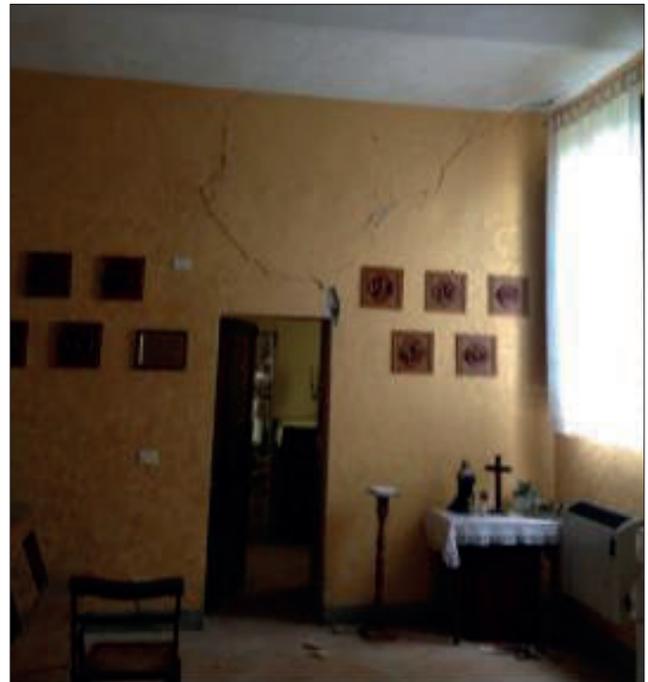
FIGURE 12 Diagonal crack on the sacristy wall

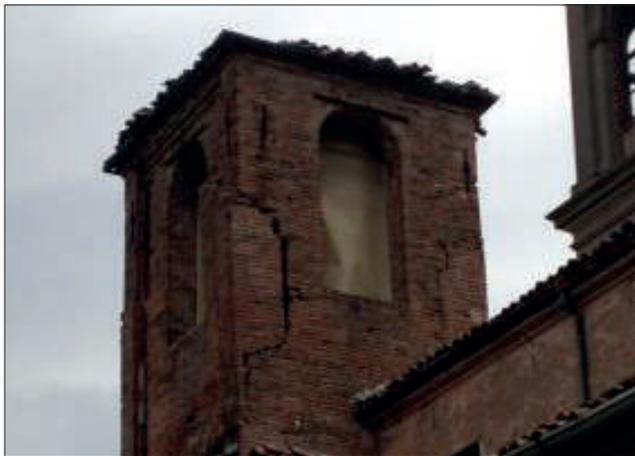
Very serious damage have been surveyed on the two towers of the church. The oldest tower – which is the original bell tower nowadays substituted from the more recent one – is about 16 meters high. With masonry structure and equipped with metallic ties in both directions, it shows a very critical situation. The separation and expulsion of the corners (cantonal) occurred, which predicts a potential global collapse of the tower and the subsequent increasing in the damage of the structures below it (Figs. 15-16).

FIGURE 15 Separation and expulsion of the corner

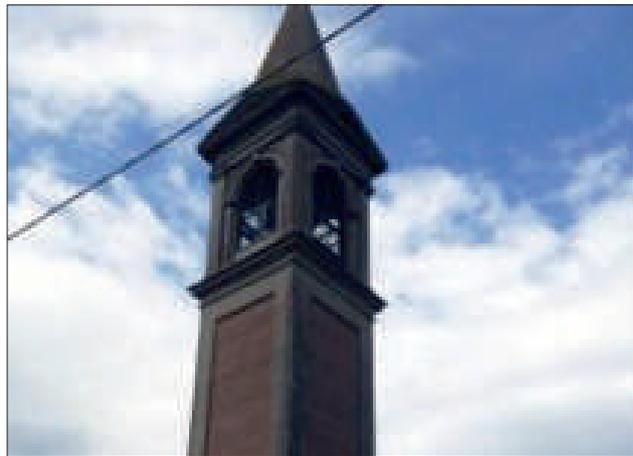
FIGURE 17 The more recent bell tower

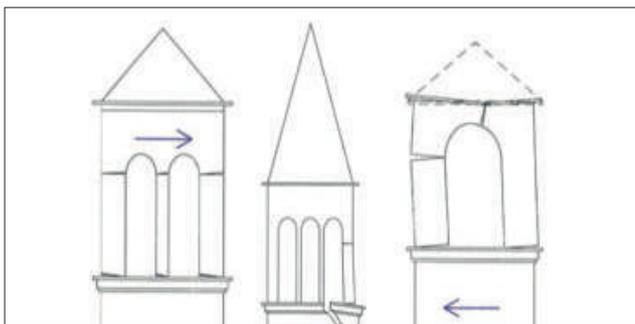
FIGURE 16 Typical damage mechanisms for bell cells

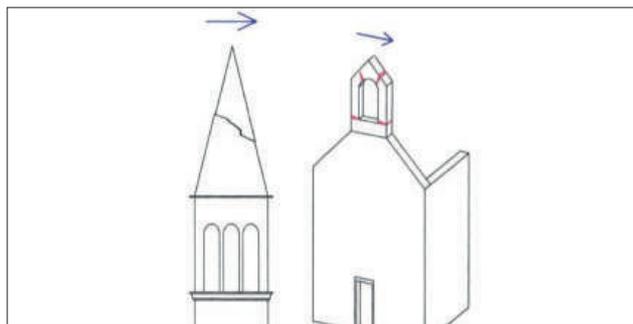
FIGURE 18 Typical damage mechanisms for projections

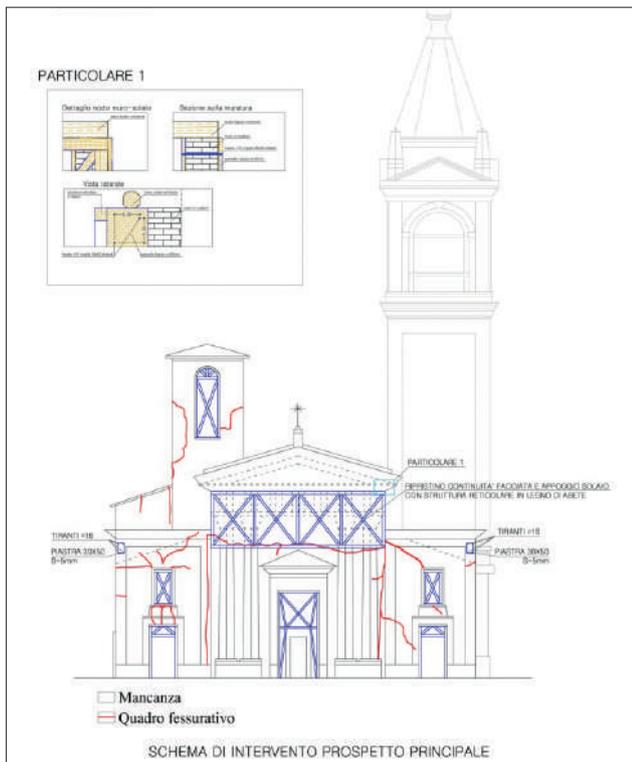
FIGURE 19 Main façade

Afterwards, the existent covering structure, which is severely damaged, should be removed by means of a telescopic mobile platform, on which workers can operate safely from the external side. A new temporary steel structure will be realized, which accomplishes three functions (Fig. 19): it realizes the temporary cover of the church, protecting it against both rain and snow; it provides the upper protection plan and allows to enter the church for the subsequent con-

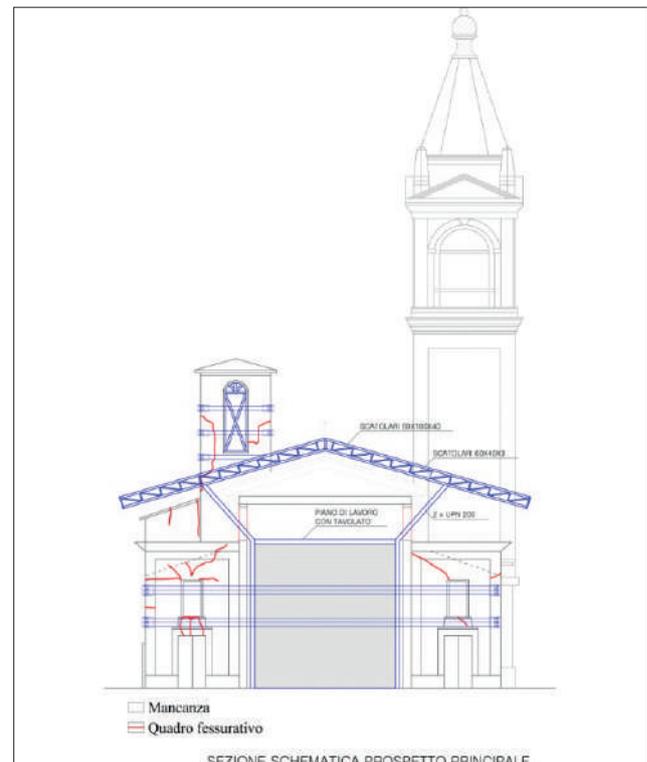
FIGURE 20 Covering protection systems

solidation phases; it provides the work plan support below the ceiling, when the latter is being restored. In particular, both vertical and horizontal structures are realized by coupled C profiles, while the inclined one consists of a reticular structure made of box profiles. The horizontal working floor is realized by wooden planks, which are light and of easy realization. The whole structure is reversible and easy to assemble and dismantle. It is worth noticing that the vertical structures are Y-shaped and are located at the windows' position, aiming at avoiding additional damage to the frescoed ceiling (Fig. 20).

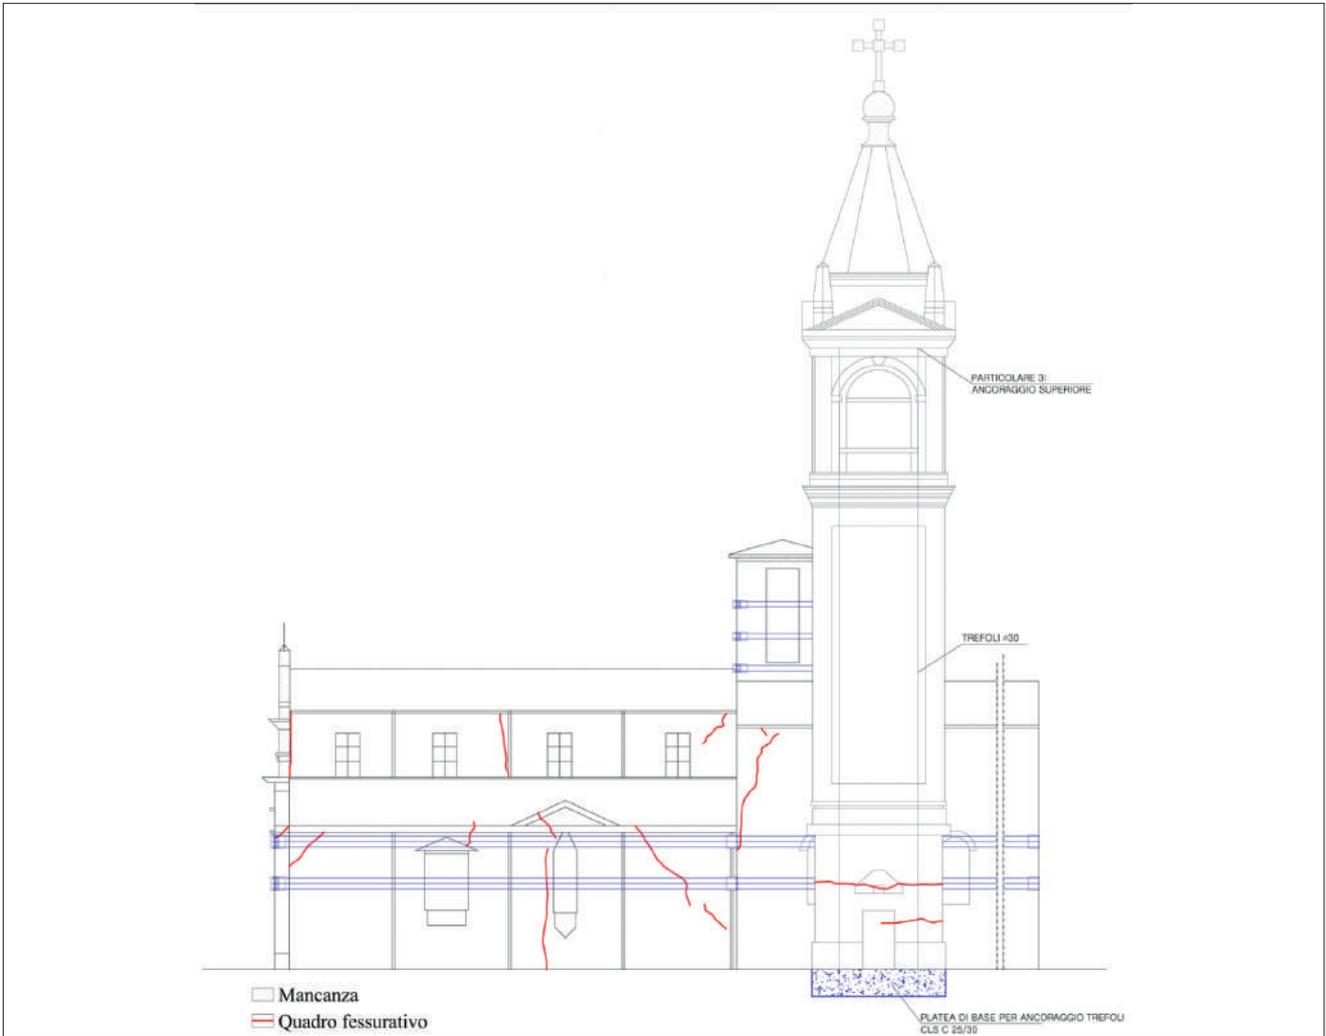
FIGURE 21 Ties' positioning on the East façade

anism of the façades is realized by ties made of high-resistance, 20mm-diameter steel cable (Fig. 21), anchored to the masonry walls by employing the Bossong system (Fig. 22). At the corners, the cables are anchored to the corner-shaped, 50x40 cm steel plates, in order to adequately distribute the actions on the masonry walls.

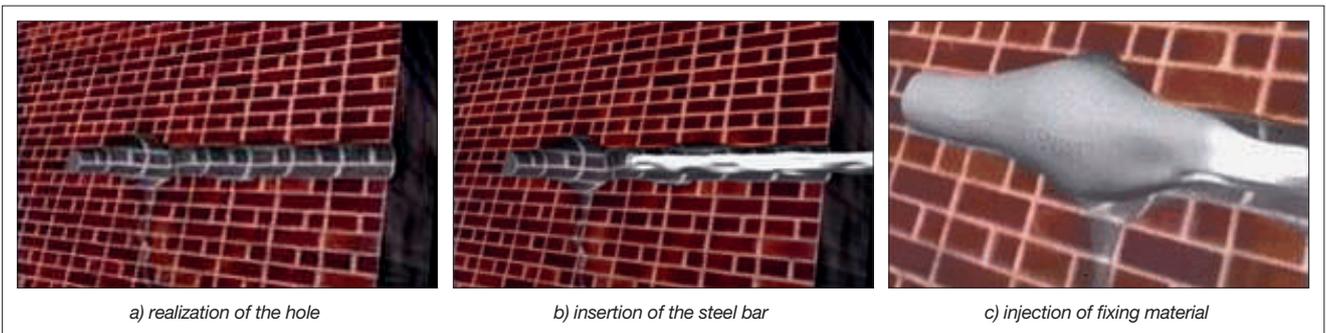
FIGURE 22 The Bossong system

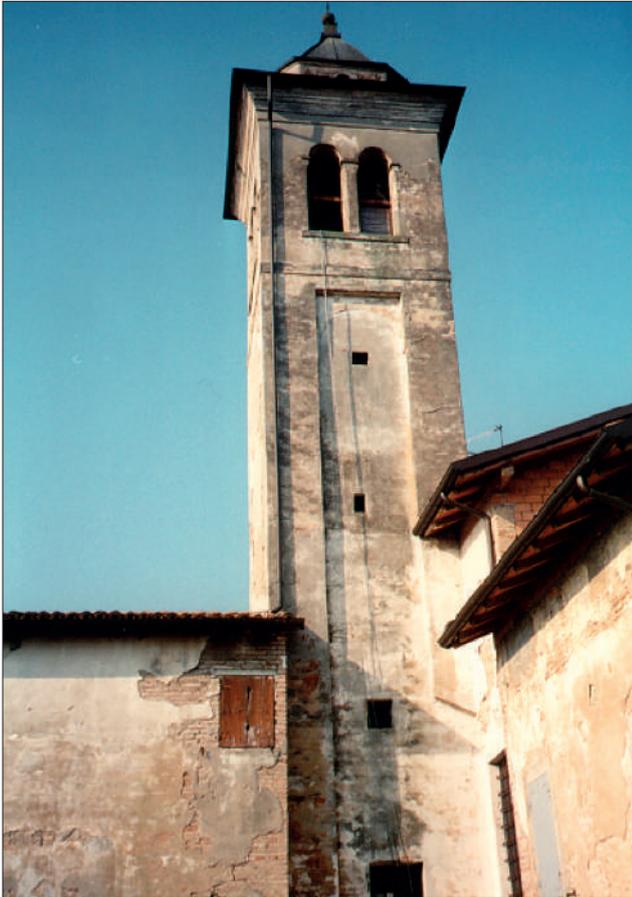
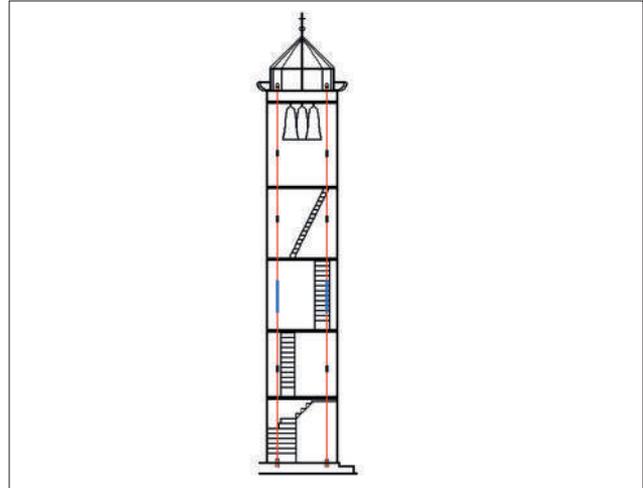
FIGURE 23 The San Giorgio in Trignano bell-tower

FIGURE 24 The San Giorgio in Trignano bell-tower: consolidation system

formed under the scientific supervision of ENEA [1]. The innovative intervention – chosen as the subject of the pilot application of seismic Innovative Techniques (TIA) within the EU project ISTECH (Development of innovative techniques for the improvement of stability of cultural heritage) – consisted in inserting four post-tensioned metal ties formed by six modular units at the inner corners of the tower, in order to increase the structure's resistance to bending without perforating the masonry (Figs. 23-24).

In series with the ties, four shape memory devices (SMAD, Shape Memory Alloy Devices) have been incorporated, tested to ensure the constancy of compression on the masonry, by maintaining the applied force at a set value. Each SMAD is composed

by 60 wires (each of 1 mm in diameter and 300 mm in length) made of hyperelastic nickel-titanium alloy. In addition, suitable anchorages have been realized (in the foundations and at the top of the tower) in order to support the concentrated actions transmitted by the ties. Dynamic identification tests have been performed immediately after the earthquake, aiming at the validation of the system. The ENEA researchers have installed an accelerometric pattern to record the behaviour of the structure under the action of 67 earth tremors. The last experimental campaign was carried out when the consolidation intervention was completed.
