4-5/2012 - Parte II

**The Pianura Padana
Emiliana Earthquake**

58 Damage to religious buildings due to the Pianura Padana Emiliana earthquake

105 Damage mechanisms in some residential building typologies during the Pianura Padana Emiliana Earthquake

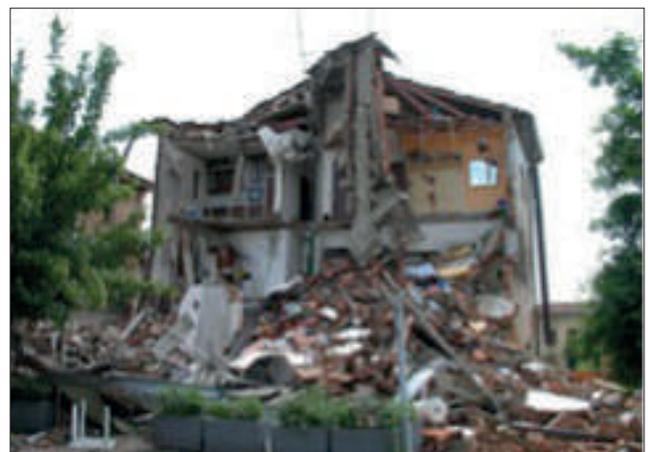
FIGURE 4 The front part of the building has completely collapsed; the damage grade is 5

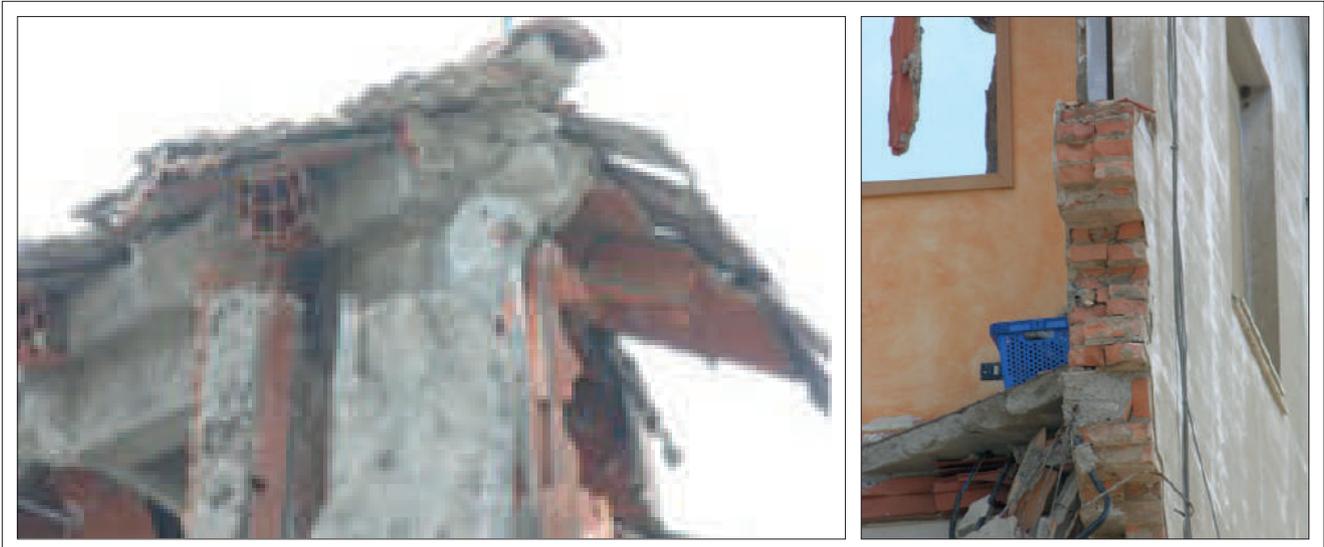
FIGURES 5-6 Details of RC elements

ity and well preserved conditions. On the other hand, where heavy structural alterations were introduced (for example the insertion of RC floors not properly connected to the walls or the replacement of light wooden roofs with heavy RC ones), the vulnerability increased dramatically. Fig. 4 shows a case of near to total collapse (damage of grade 5 EMS98). Note the heavy roof structure bearing on slender walls, the poorly reinforced beams (Fig. 5) and ring course concrete, as well as the absence of steel reinforcement in the floor slabs (Fig. 6).

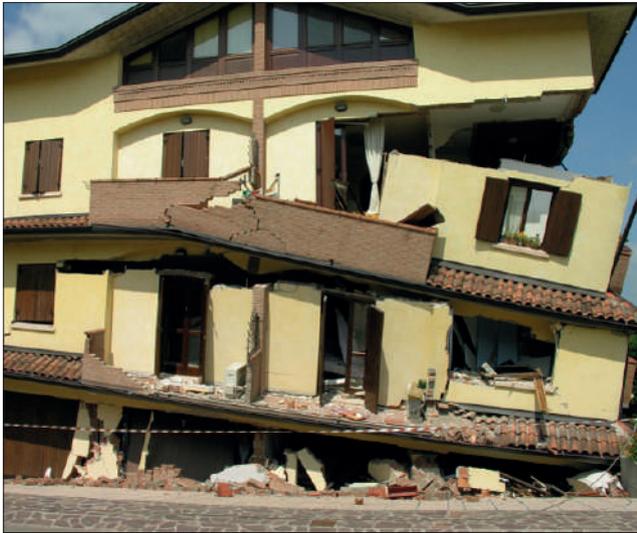
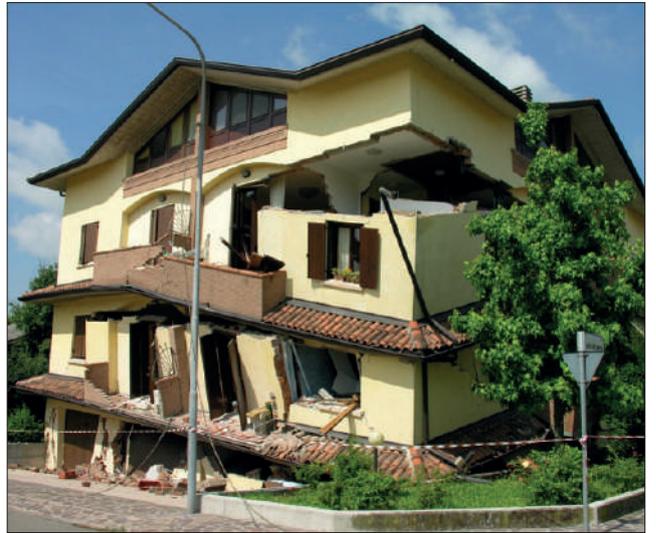
The collapse was caused by the presence of a soft storey in which there were large openings and small piers between openings and corners. Due to the absence of any reinforcements, the masonry corner pier on the right (Fig. 11) completely crushed, with the consequent opening up of the structure up to the top (Fig. 12). Even though the change in stiffness between the rigid upper floors and the ground soft storey has further aggravated the response of the building under the seismic stress, undoubtedly the main cause of the collapse depends on the type of masonry used (hollow bricks) and its inadequate dimensioning.

FIGURES 11-12 The soft storey has collapsed, the damage grade is 5

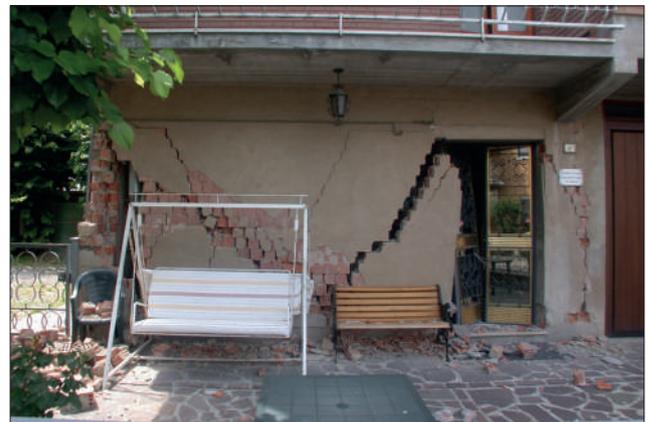
The weakness of ground floors walls built in perforated bricks is again dramatically shown in Fig. 13, where the failure reached almost the collapse. Making of niches in load-bearing walls, containing pipelines and boiler (Fig. 13, on the left), contributes considerably to increase the seismic vulnerability of masonry buildings.

FIGURE 13 Serious failure of the walls, the damage is grade 4

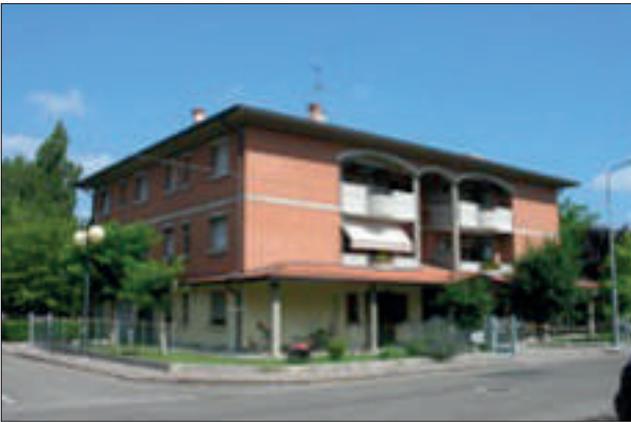
In recently erected buildings, the structure is often provided with RC columns and beams, but they are never placed in all the four sides of the building, in order to perform as a moment resistant frame. In other cases (Fig. 16), when a sort of RC frame is present, the beams run in the thickness of the floor slab (“thickness beam” is the equivalent Italian technical term), making the beam-column joints very vulnerable to lateral loads. This type of structure performed badly and suffered heavy damage (Fig. 17).

FIGURE 16 Example of mixed structure

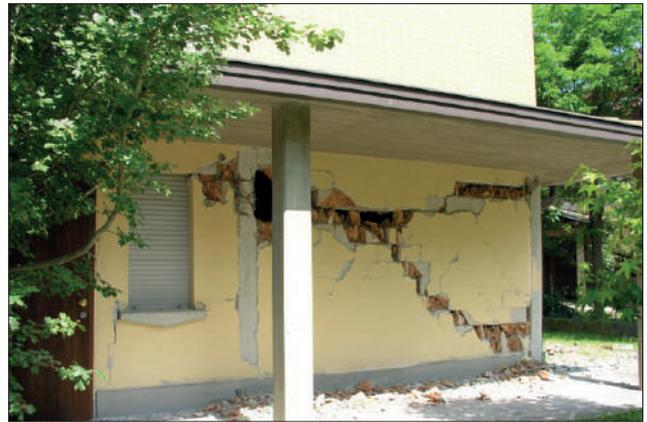
FIGURE 17 Damage to ground floor wall

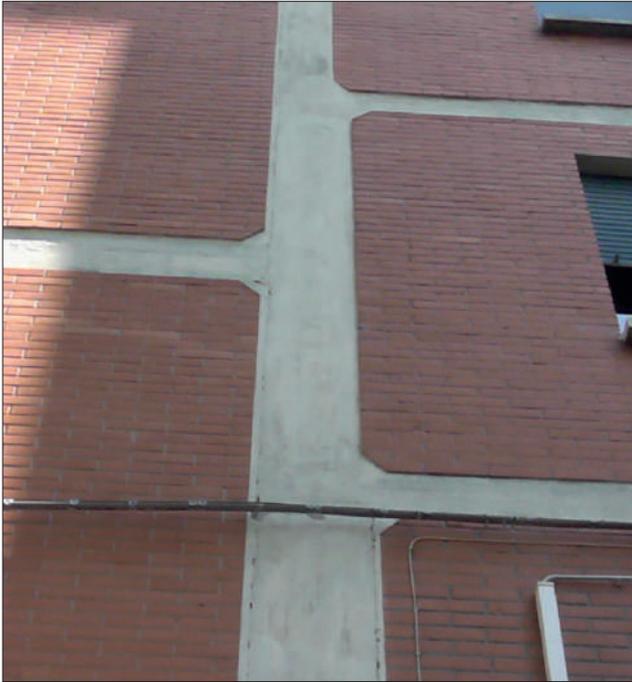
FIGURE 26 Separation between adjacent buildings

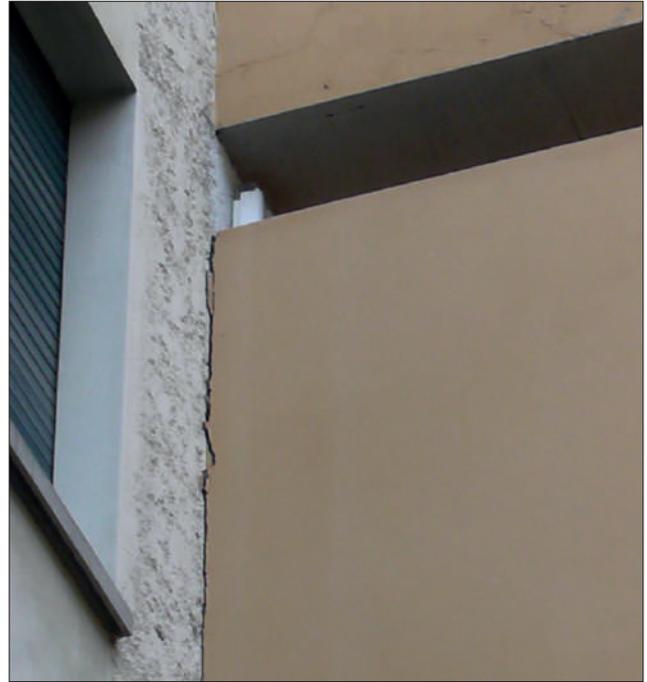
In particular, in the apartments on the first floor of the buildings located at the two ends of the aggregate, the damage to cladding was stronger, making the overturning of the cladding itself possible in case of aftershocks, with consequent danger to the occupants. Some apartments (civic numbers 5, 7 and 17) have also been declared usable after prompt interventions thanks to the separation of the parapet of the balcony.

FIGURE 27 Detachment of the parapet of some balconies

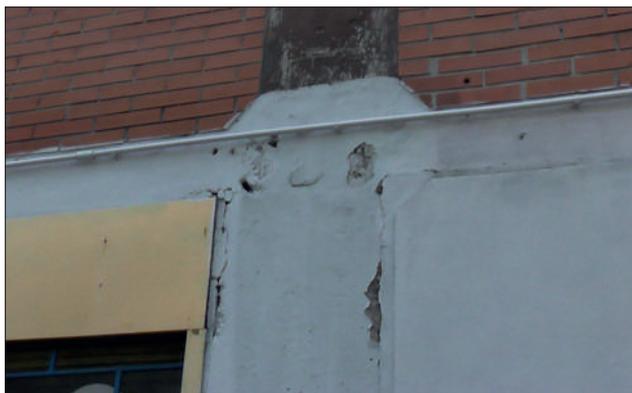
FIGURE 28 Separation between cladding and structure elements

With regard to the detachment of plaster, observed in some parts of the façades, and the damage to covering structures and chimneys, the urgent removal of loose or damaged parts was requested to the Fire Department, in order to ensure the safety of passers-by. As a result of these actions, the occupants of all the usable units were
