## THE PIANURA PADANA EMILIANA EARTHQUAKE

# Behaviour of industrial buildings in the Pianura Padana Emiliana Earthquake

■ *Fernando Saitta, Giovanni Bongiovanni, Giacomo Buffarini, Paolo Clemente, Alessandro Martelli, Anna Marzo, Giuseppe Marghella, Maurizio Indirli, Alessandro Poggianti*

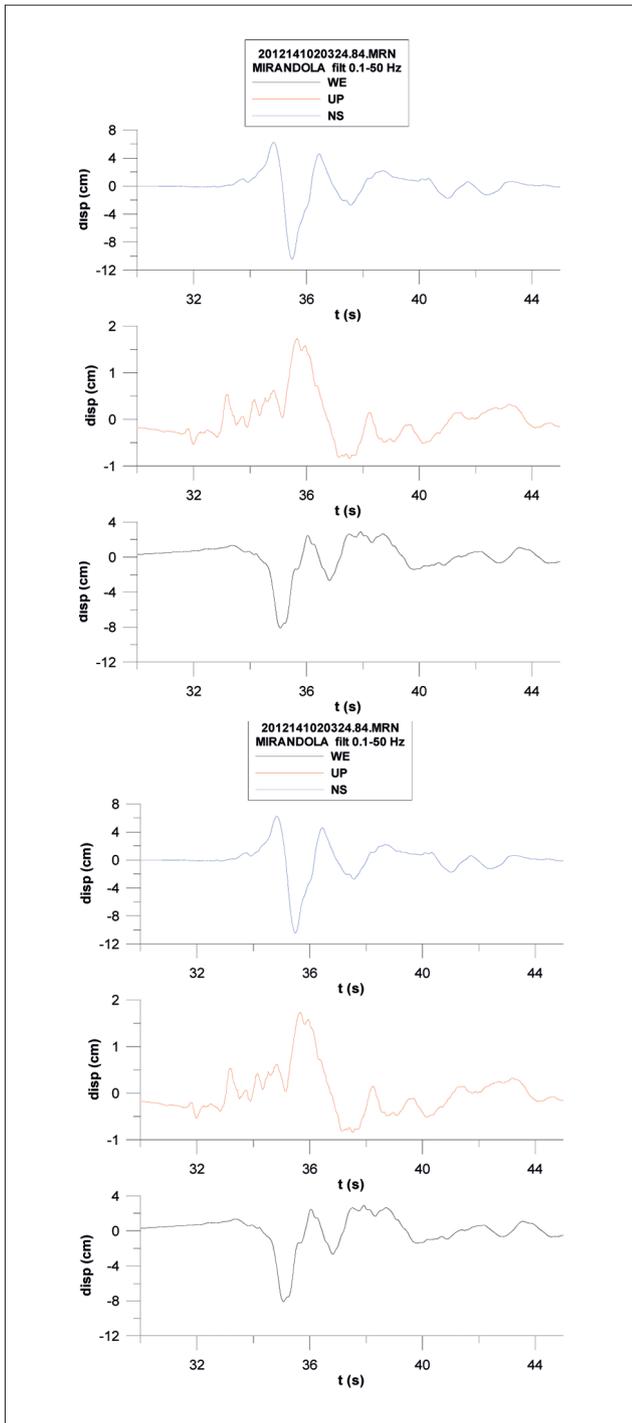
**FIGURE 1** Displacement time-histories recorded at Mirandola (A) and Modena (B)  
 Source: ENEA elaboration of INGV data

The displacement time-histories (Fig. 1) show that, in near field, the displacement had a pulse-like shape with a very low duration. Going far from the epicenter, surface waves were generated with low-frequency content, lasting several tens of seconds. Since the propagation velocities of surface waves are a little lower than those of shear waves [3], structures with significant dimensions in plan could have been subjected to differential motion. Therefore, this effect could have played an important role in the collapse of several industrial buildings, in addition to other concurrent effects.

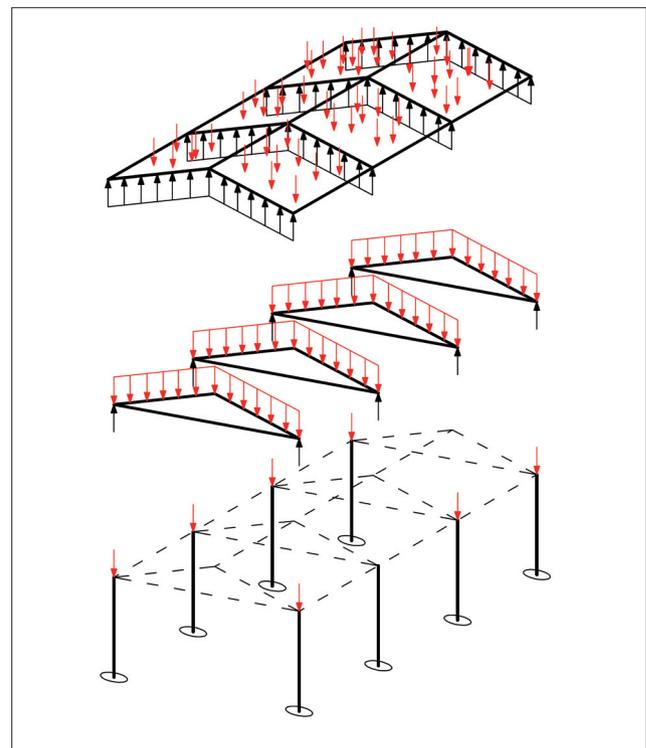
**FIGURE 2** Structural conception of the industrial buildings  
 Source: ENEA

A scheme of a typical one-story industrial building is outlined in Fig. 2, where the vertical load path from roof to foundation is clearly depicted. The critical points of the considered structures were the joints between the different elements, beams and columns, so much as the connections between the roof panels and the beams. Before showing some failure cases, structural peculiarities of precast buildings are summarised.

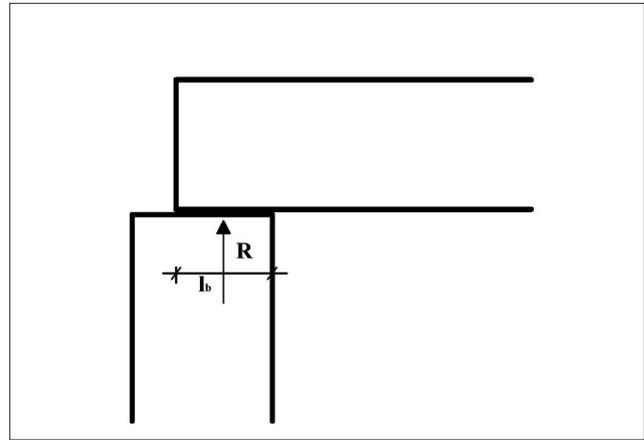
With reference to Fig. 3, in which a column-beam interface is represented schematically, various effects, such as shrinkage, thermal or external loads, can induce strains. The interface friction, at the mating surface, prevents movements, generating the friction force  $\mu R$ , where  $R$  is obviously the normal force to the surface, i.e., the vertical reaction.

**FIGURE 3** Schematic representation of the column-beam interface  
Source: ENEA

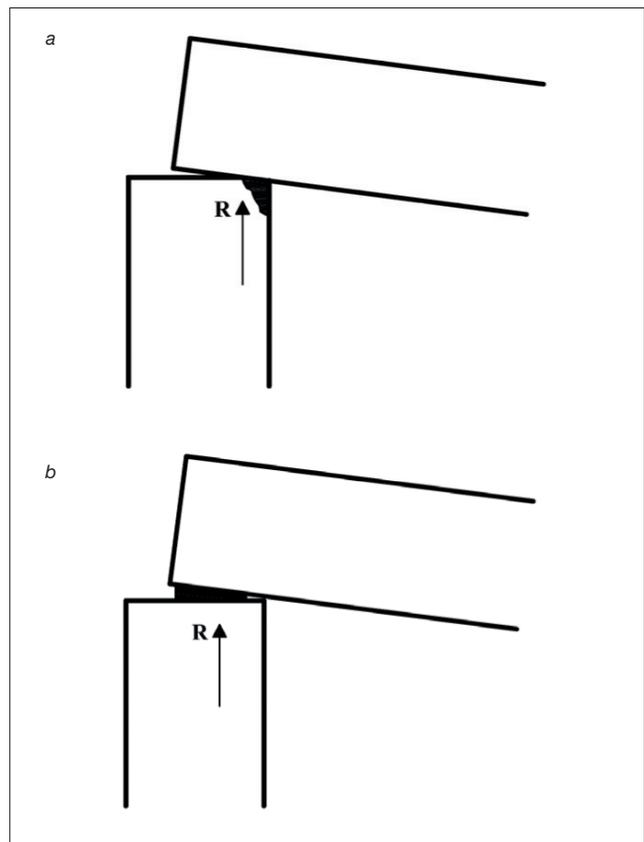
The bending rotation of the beam creates a stress concentration at the top of the pillar, with possible spalling of the concrete (Fig. 4a). This suggests the interposition of a bearing pad (Fig. 4b). If a horizontal force overcomes the friction force, the beam can lose its bearing. A steel dowel or a reinforcing bar can prevent this kind of collapse (Fig. 5).

**FIGURE 4** Bending stresses and concrete spalling on the column, avoided by means of the interposition of bearing pads  
Source: ENEA

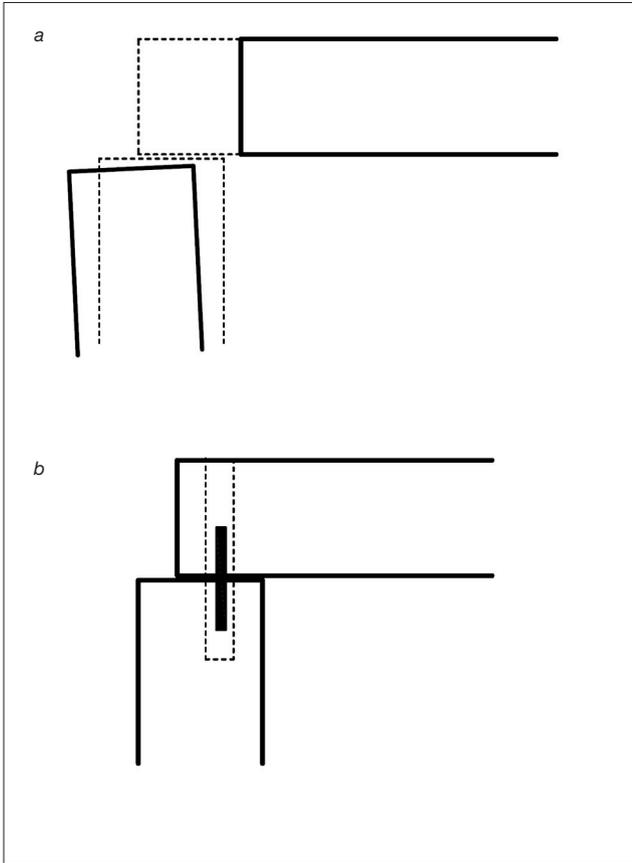
**FIGURE 5** Possible relative displacement induced by external forces and insertion of a steel dowel to increase the shear resistance  
Source: ENEA

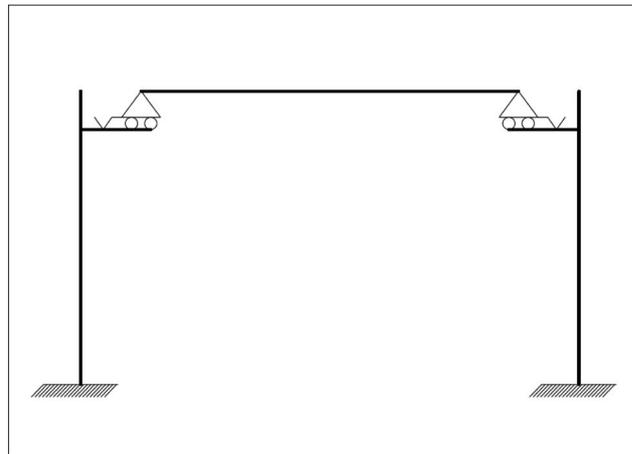
**FIGURE 8** Scheme of the simply supported beams with friction  
Source: ENEA

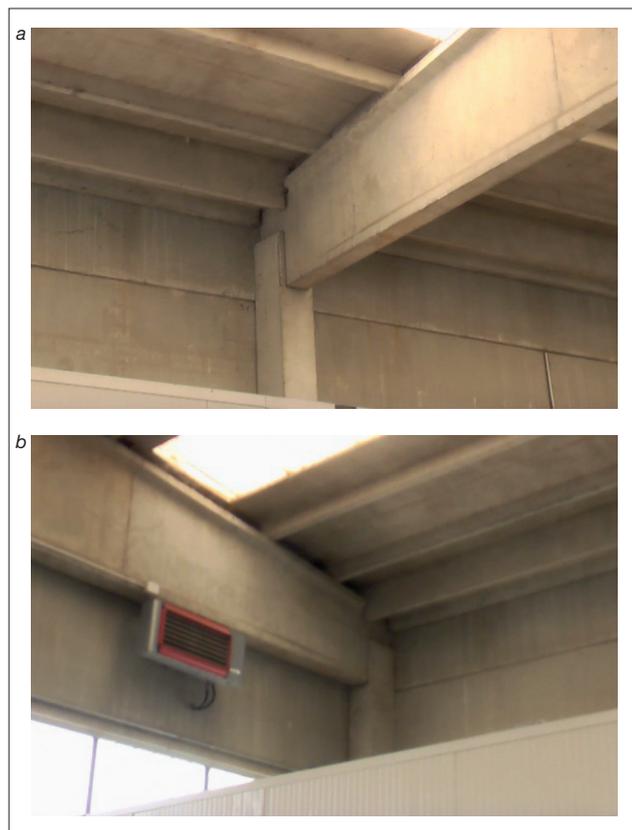
**FIGURE 9** Undamaged structure: a) covering structure to beam connection; b) corner configuration  
Source: ENEA

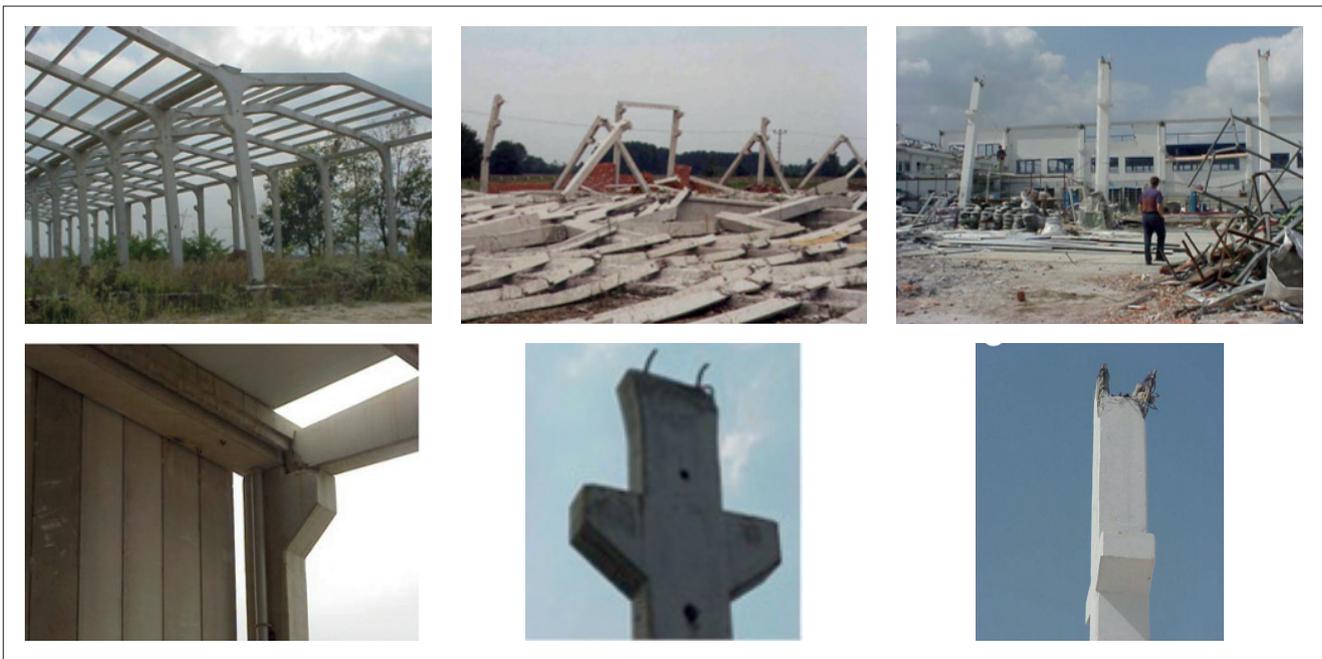
**FIGURE 17** P/p. r.c. structures, with different stages of construction and seismic behaviour, located in the epicenter area of the Kocaeli earthquake, and details of the connections [11-14]

hand, collapse and extensive damage was concentrated in pre-1981 r.c. and steel stock. Some typical one-storey industrial pre-cast structures (Fig. 16), located in the epicentre area of the August 17<sup>th</sup>, 1999, Kocaeli earthquake (Turkey,  $M_w=7.4$ ), didn't show good results, while others remained undamaged (Fig. 17) [10].

The collapse was mainly due to poor design, detailing, and construction, leading to the lack of diaphragm action caused by the inadequate connections (pinned or dowel, simple to realize by the prefabricators) between columns and beams. In addition, buildings under construction were susceptible to collapse when the roof girders rotated off their supports.
