THE PIANURA PADANA EMILIANA EARTHQUAKE

Post-earthquake safety interventions on the Visitazione di Maria Santissima Church in Reno Finalese

■ Bruno Carpani, Giuseppe Marghella, Anna Marzo, Alessandra Gugliandolo, Maria-Anna Segreto

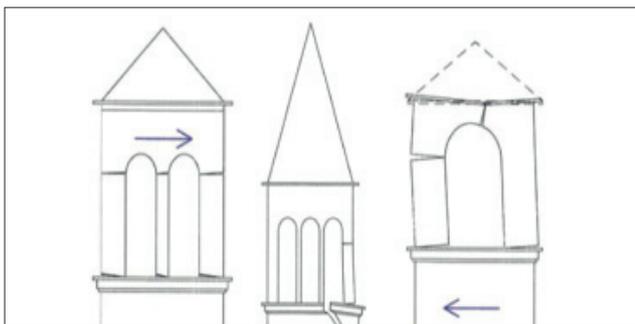
Very serious damage have been surveyed on the two towers of the church. The oldest tower – which is the original bell tower nowadays substituted from the more recent one – is about 16 meters high. With masonry structure and equipped with metallic ties in both directions, it shows a very critical situation. The separation and expulsion of the corners (cantonal) occurred, which predicts a potential global collapse of the tower and the subsequent increasing in the damage of the structures below it (Figs. 15-16).

FIGURE 16 Typical damage mechanisms for bell cells

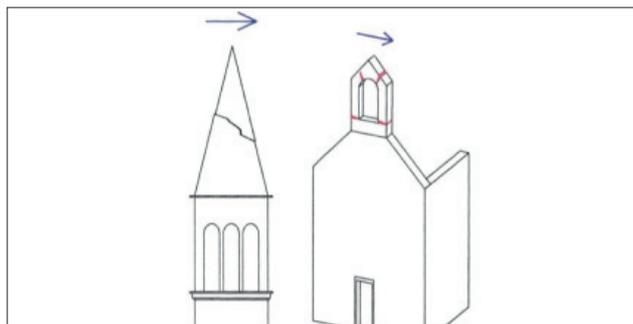
The more recent tower, being made of solid bricks, is more than 38 meters high and was built adjacent to the right side of the church using bricks and concrete. The earthquake caused the twisting of the whole structure, cutting it at about 2 meters from the ground, in correspondence of a discontinuity in the material of the basement. In addition, a minor rotation occurred (Figs. 17-18).

FIGURE 18 Typical damage mechanisms for projections

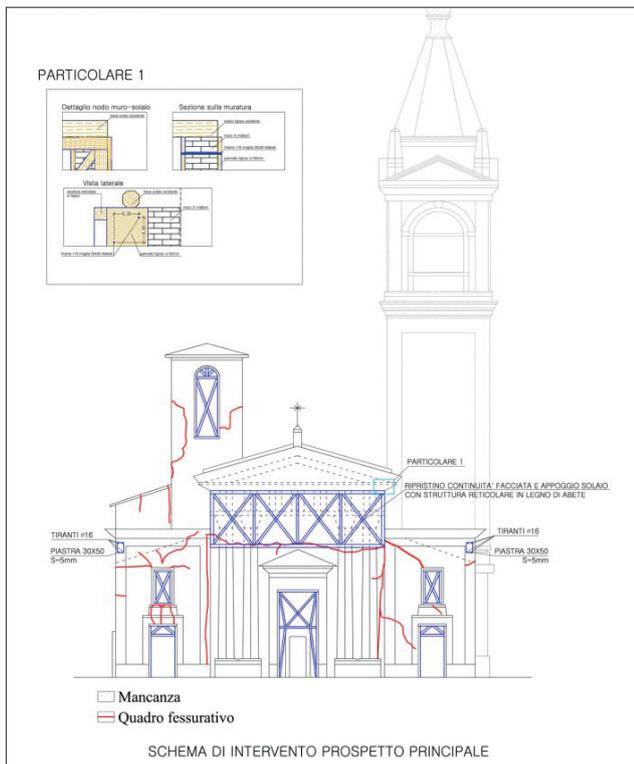
FIGURE 19 Main façade

Afterwards, the existent covering structure, which is severely damaged, should be removed by means of a telescopic mobile platform, on which workers can operate safely from the external side. A new temporary steel structure will be realized, which accomplishes three functions (Fig. 19): it realizes the temporary cover of the church, protecting it against both rain and snow; it provides the upper protection plan and allows to enter the church for the subsequent con-

solidation phases; it provides the work plan support below the ceiling, when the latter is being restored. In particular, both vertical and horizontal structures are realized by coupled C profiles, while the inclined one consists of a reticular structure made of box profiles. The horizontal working floor is realized by wooden planks, which are light and of easy realization. The whole structure is reversible and easy to assemble and dismantle. It is worth noticing that the vertical structures are Y-shaped and are located at the windows' position, aiming at avoiding additional damage to the frescoed ceiling (Fig. 20).

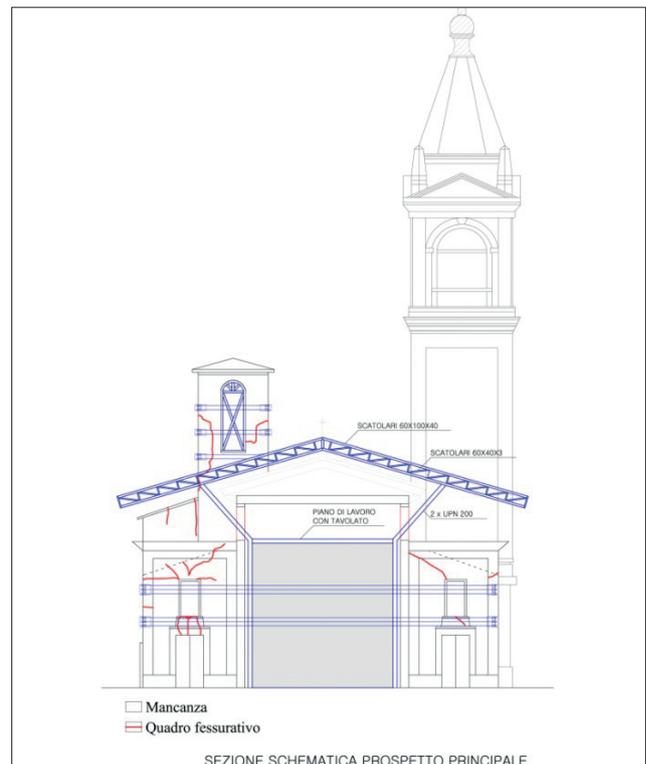
FIGURE 20 Covering protection systems

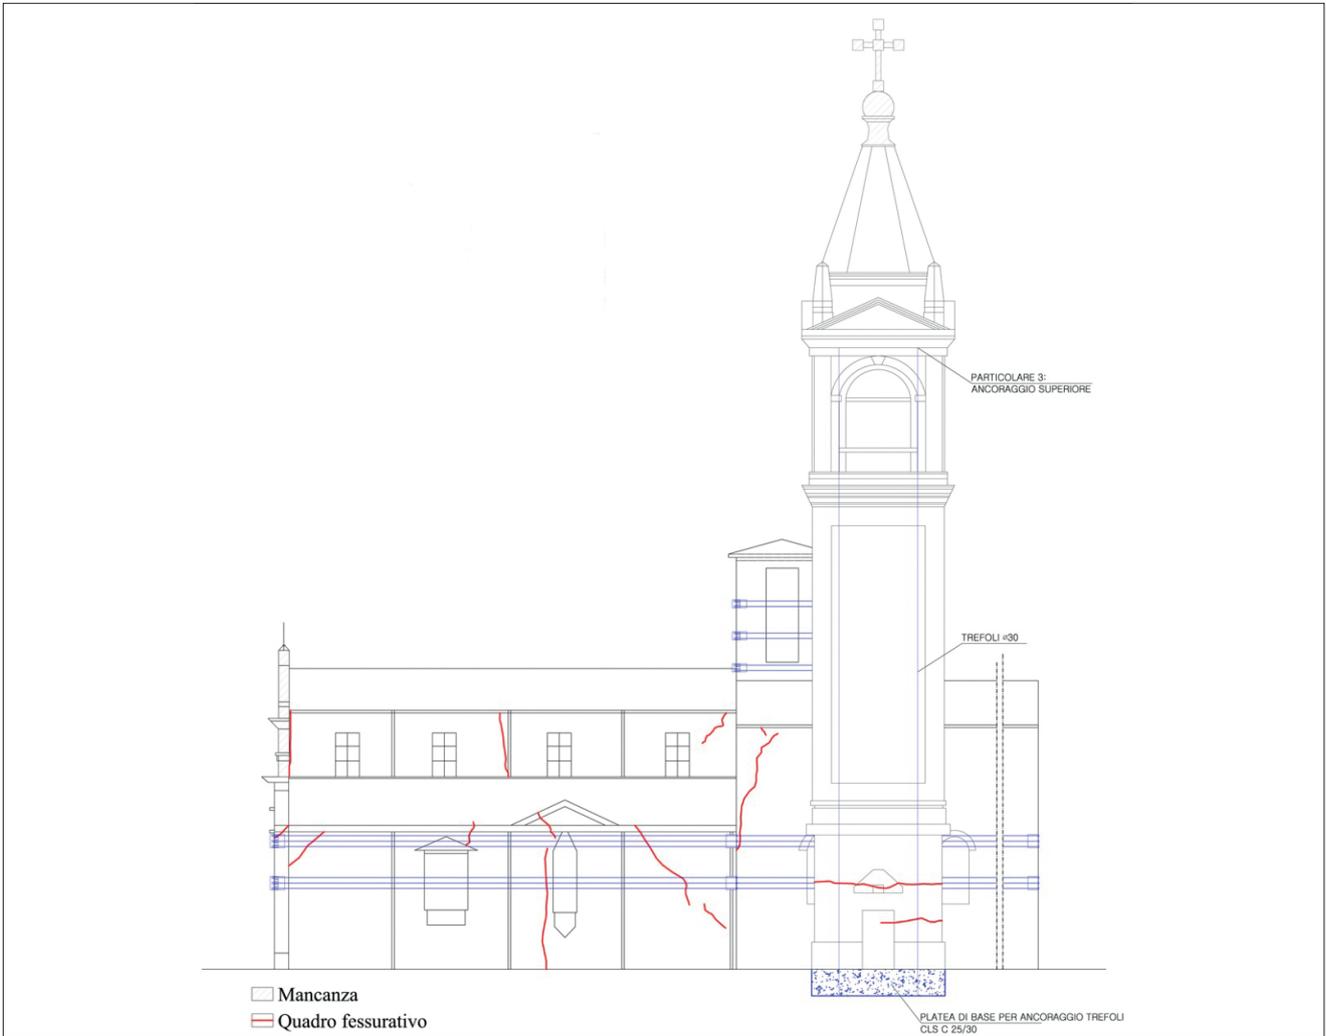
FIGURE 21 Ties' positioning on the East façade

anism of the façades is realized by ties made of high-resistance, 20mm-diameter steel cable (Fig. 21), anchored to the masonry walls by employing the Bossong system (Fig. 22). At the corners, the cables are anchored to the corner-shaped, 50x40 cm steel plates, in order to adequately distribute the actions on the masonry walls.

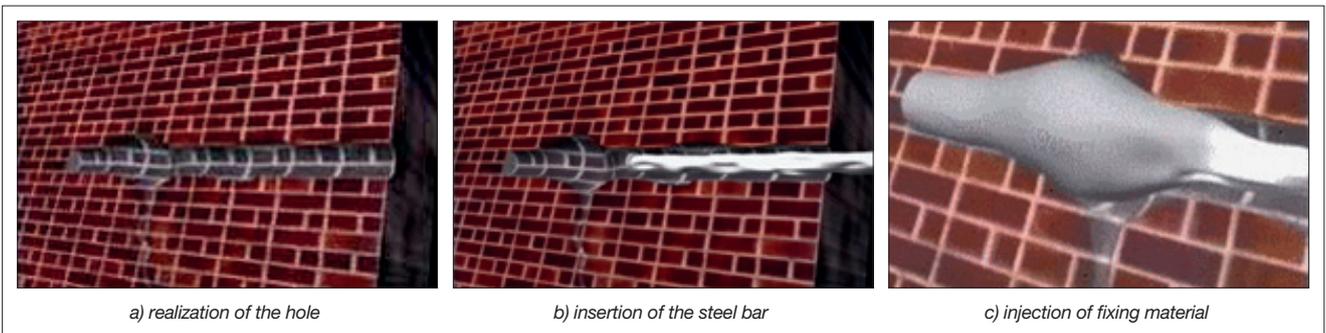
FIGURE 22 The Bossong system

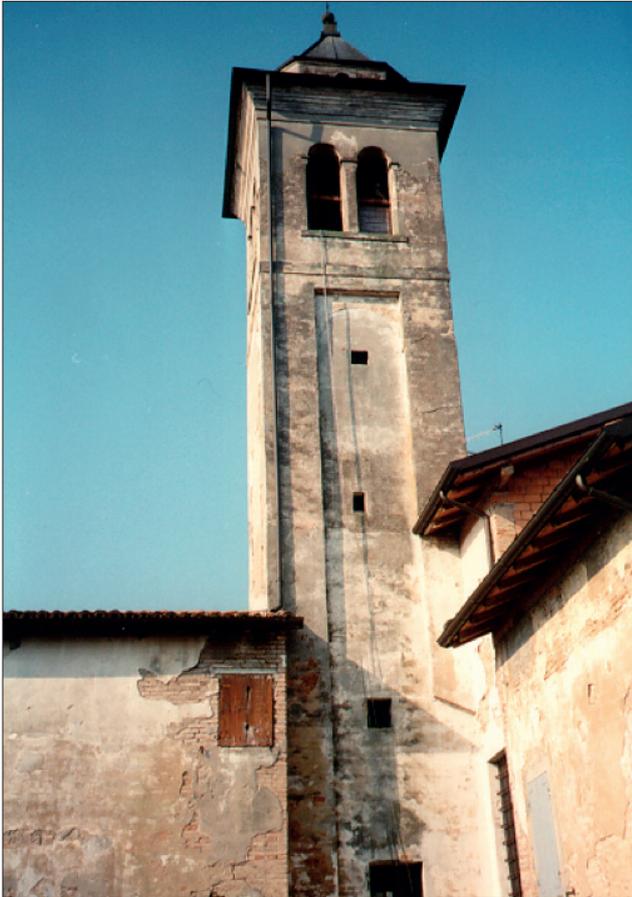
FIGURE 23 The San Giorgio in Trignano bell-tower

formed under the scientific supervision of ENEA [1]. The innovative intervention – chosen as the subject of the pilot application of seismic Innovative Techniques (TIA) within the EU project ISTeCH (Development of innovative techniques for the improvement of stability of cultural heritage) – consisted in inserting four post-tensioned metal ties formed by six modular units at the inner corners of the tower, in order to increase the structure's resistance to bending without perforating the masonry (Figs. 23-24).

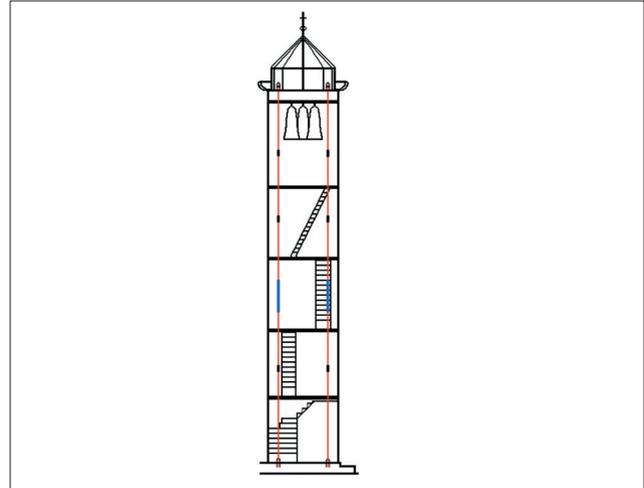
FIGURE 24 The San Giorgio in Trignano bell-tower: consolidation system

In series with the ties, four shape memory devices (SMAD, Shape Memory Alloy Devices) have been incorporated, tested to ensure the constancy of compression on the masonry, by maintaining the applied force at a set value. Each SMAD is composed

by 60 wires (each of 1 mm in diameter and 300 mm in length) made of hyperelastic nickel-titanium alloy. In addition, suitable anchorages have been realized (in the foundations and at the top of the tower) in order to support the concentrated actions transmitted by the ties. Dynamic identification tests have been performed immediately after the earthquake, aiming at the validation of the system. The ENEA researchers have installed an accelerometric pattern to record the behaviour of the structure under the action of 67 earth tremors. The last experimental campaign was carried out when the consolidation intervention was completed.
