THE PIANURA PADANA EMILIANA EARTHQUAKE

Damage and collapse mechanisms in churches during the Pianura Padana Emiliana earthquake

■ Maurizio Indirli, Giuseppe Marghella, Anna Marzo

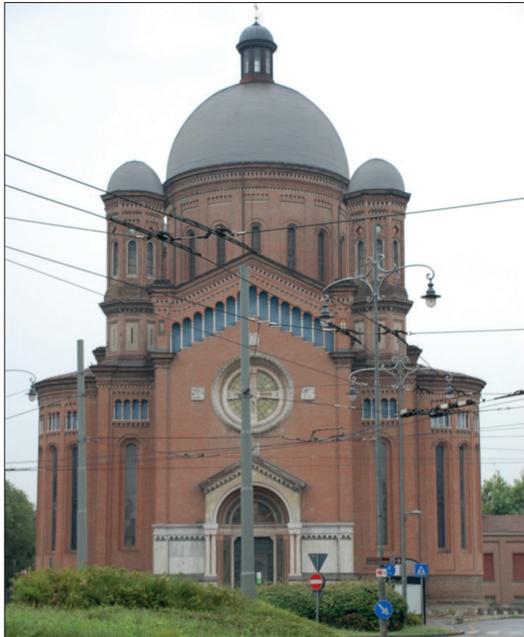
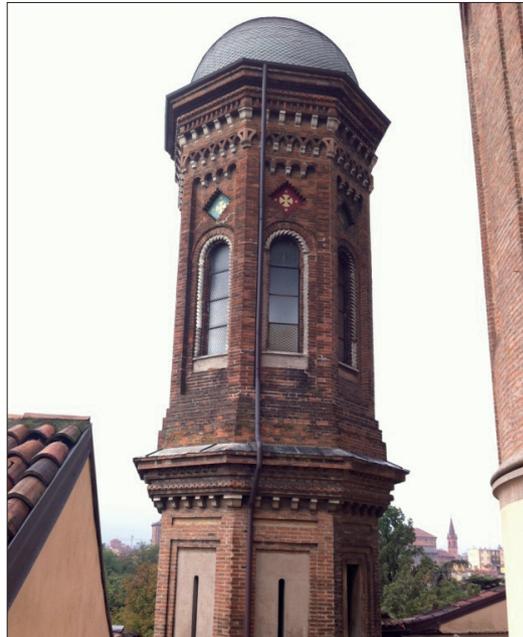
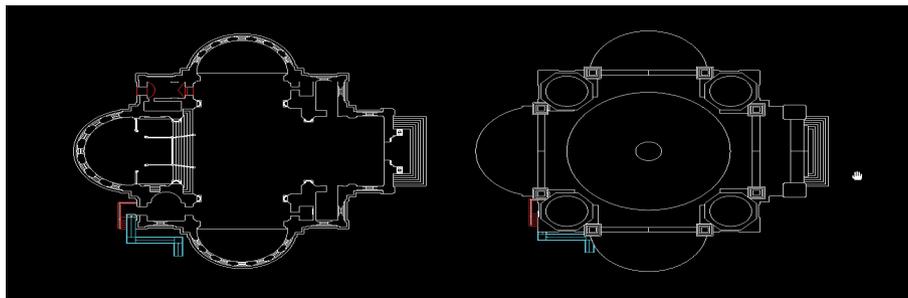
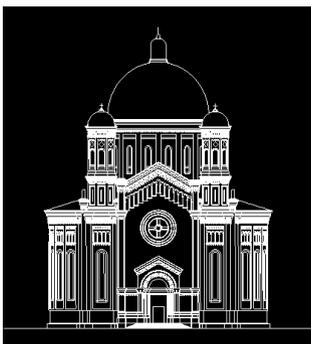
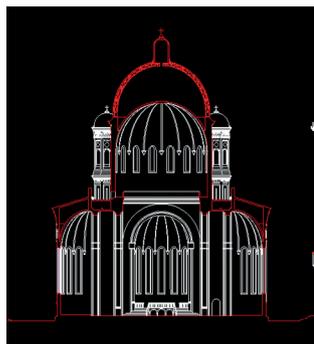
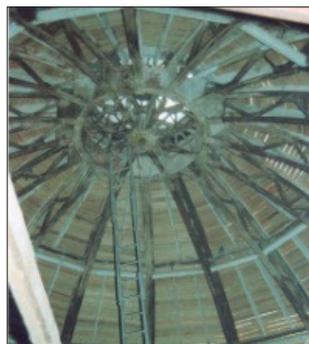
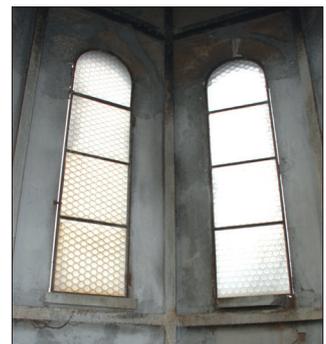
FIGURE 15 The Monumental Temple of Fallen in Modena

Description - The Monumental Temple of Fallen in Modena (Fig. 15), located in Natale Bruni Square, was built for the perpetual memory of the Fallen of Modena, dead during the First World War. The building, designed by the architect Domenico Barbanti in cooperation with Achille Casanova, is dedicated to St. Joseph.

- The survey evidenced damage due to the recent seismic event, but also previous ones. The latter are caused by subsidence, because of different soil mechanical properties.

The old cracks (Fig. 16) increased with the recent earthquake, which originated new local/global damage mechanisms.

Finally, a damage index of about 0.27 has been obtained. Soil geotechnical survey and seismological microzoning is considered mandatory, in order to evaluate how to enhance the foundations.

Moreover, also extensive material diagnostics and dynamic characterization should be carried out, aiming at a general (conventional and/or innovative) anti-seismic reinforcement. Restoration should regard all the decorative apparatus.

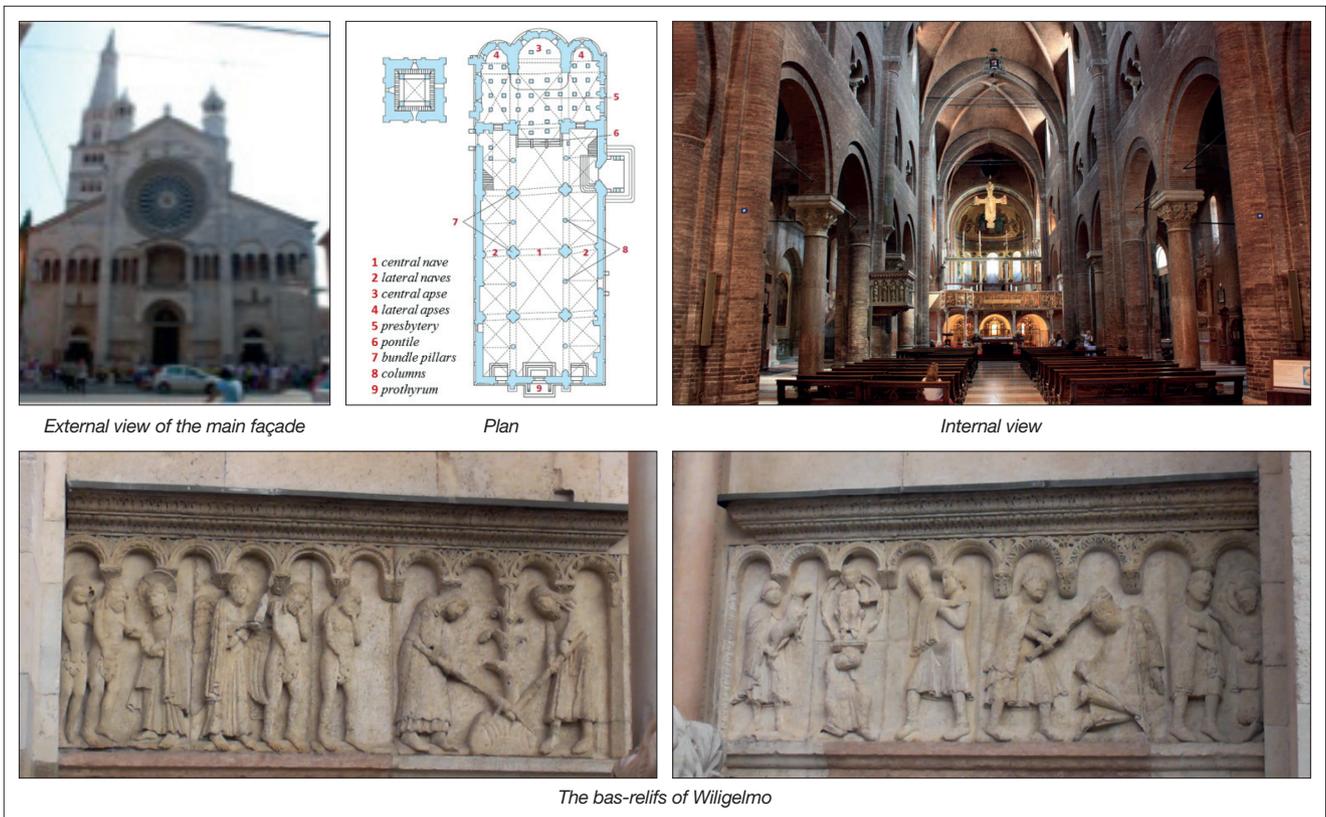
FIGURE 19 The San Geminiano Cathedral in Modena

Description - The San Geminiano Cathedral in Modena was constructed from 1099 onwards, on the rests of two previous churches, and consecrated by Pope Lucio III in 1184. It is one of the best masterpieces of the European Romanesque, thanks to the architectural structure of Lanfranco and the sculptural pieces of Wiligelmo (Fig. 19). In 1106, the building was already covered and the rests of Saint Patron Geminiano were moved from the old church to the new cathedral crypt. As told in Section 2, during the 1117 catastrophic seismic event, the church did not suffer any damage. The original project was later modified, starting from 1167, by the Campionesi Masters; they: opened the gothic rose-window and two lateral doors on the fa-

Damage survey and observed mechanisms
- The cathedral survey permitted to detect some damage, mainly related to the masonry cross-vaults of

the lateral nave. Cracks along the ribs and falling of bricks were found. Such damage has been repaired through prompt interventions (almost completed at the time of our visit), ringing of the ribs with metallic plates fixed to the vaults (Fig. 23a), and filling the cracks with resin (Fig. 23b).

The following several interventions were suggested after the investigation: structural re-establishment of damaged vaults, arches, ribs and unconnected wall portions. The implementation of the monitoring system – for a deep and permanent dynamic characterization of the whole complex, evaluating in particular church/tower interactions – is considered necessary and propaedeutic to complete the existing strengthening systems, in both the Cathedral and the Ghirlandina.

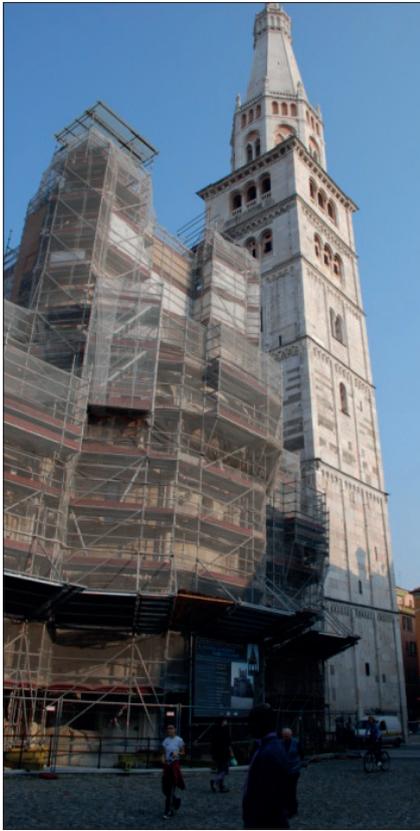
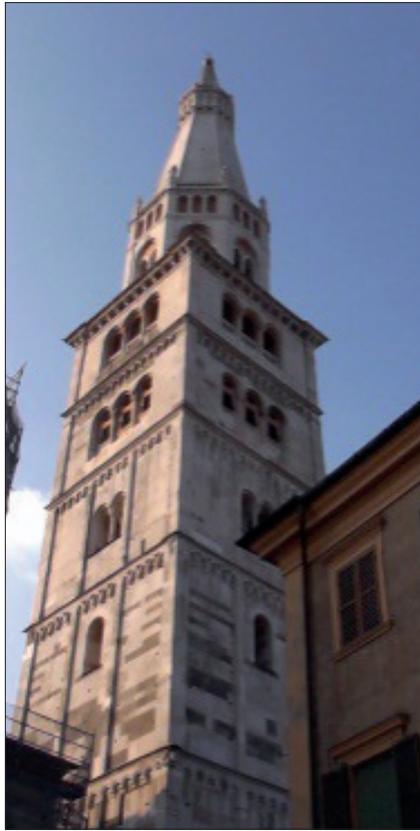
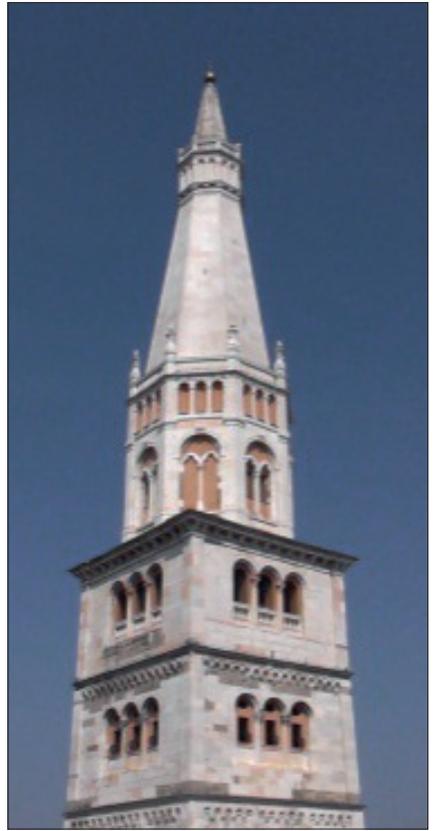
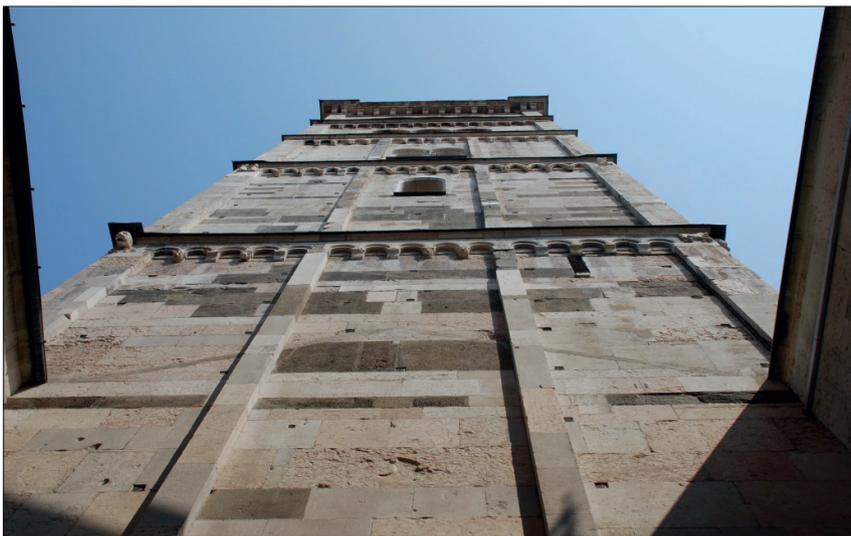
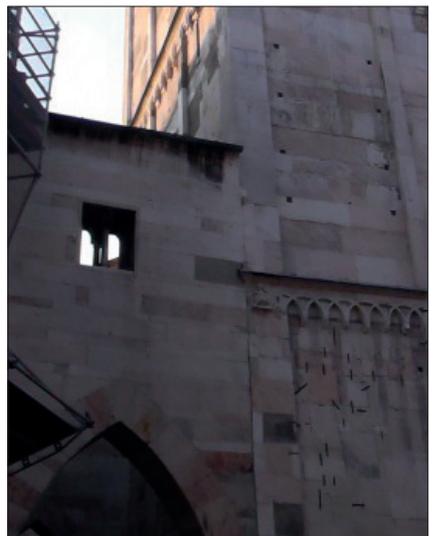
FIGURE 20 Pictures of the Ghirlandina Tower

The chronology of Ghirlandina (pictures in Fig. 20) is still uncertain, as primary historical sources were destroyed during a fire in the XI century. The Tower (height 88 m) knew different construction phases over time (Fig. 21, [10] in [14]); the square levels can be attributed to Lanfranco and Wiligelmo (XII century), while the Campionesi Masters realised, in exquisite gothic style, the octagonal tambour and the cusp between 1261 and 1319. Prospects, sections and plans are reported again in Fig. 21 ([11] in [14]). Since the beginning, the Tower was subjected to subsidence and inclination ([12] in [14]). The constructors placed the heaviest stones on the opposite side of the slope; therefore, the centre of mass changes level by level. Nowadays, the sinking depth is about 1 m and the inclination more than 1.5 m. In 1997 UNESCO inscribed the Cathedral and the Ghirlandina Tower in the World Heritage List, together with the Piazza Grande.

The 1996 earthquake (see again Section 2) affected all the complex, which was restored between 2007 and 2008; the cathedral underwent: the substitution of some timber trusses, the repairing of masonry cracks, the restoring of the rose window, the small columns and the XV century polychrome glass-windows, together with diagnostic and monitoring campaigns [13]. Ghirlandina was subjected to a whole conservation project [14]. Among other interventions, monitoring systems and reinforcement devices are shown by Fig. 22. During the May 2012 seismic events, the whole complex supported the PGA maximum value of 0.037g and 0.055g (Modena recording station), respectively on May 20th and 29th.

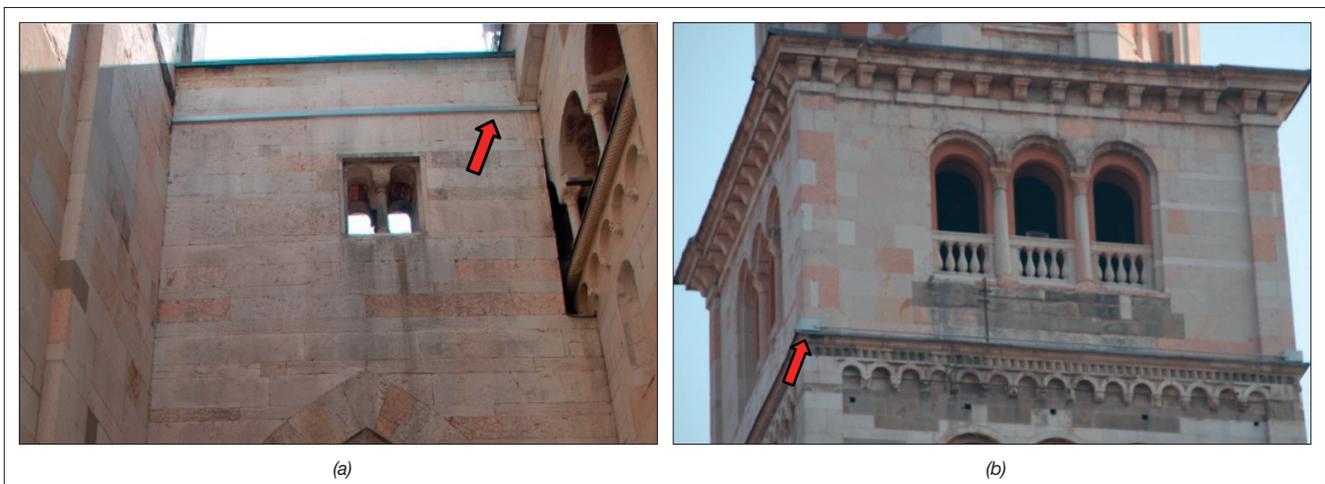
FIGURE 22 Monitoring and seismic devices: relative displacement measure device between Cathedral and Tower (left); b) steel tie all around the last square level of the Tower (right)

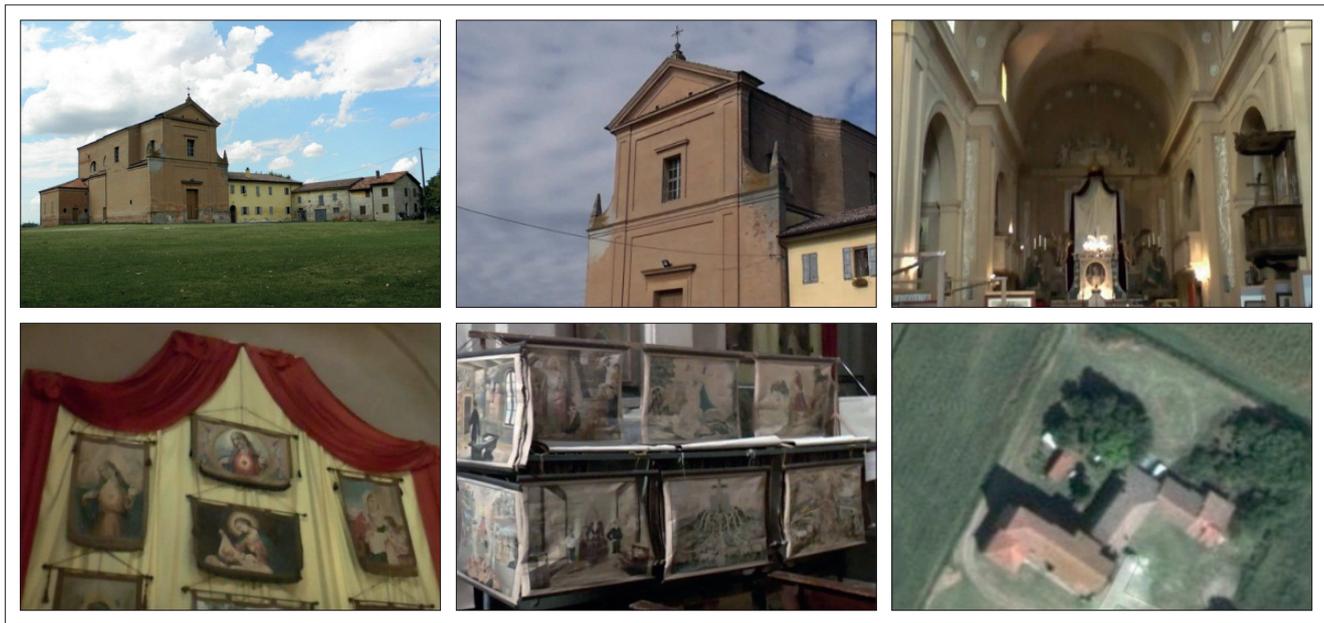
FIGURE 28 The Parish of San Giovanni Battista in Triario (Minerbio, Bologna)

Description - The Parish of San Giovanni Battista in Triario (Fig. 28) is located in the hamlet of San Giovanni in Triario, countryside of Minerbio, a little town 15 km far from Bologna. The first building was probably built around the XI century, but the current neo-classic construction (full brick masonry, designed by

Damage survey and observed mechanisms - The church was bombed during the Last World War and the original bell-tower collapsed. Never completely restored, at the time of our visit it showed a generalised previous damage in walls, vaults and arches, worsened by the earthquake (Fig. 29). The main mechanisms are reported in Fig. 30, corresponding

to a global damage index equal to 0.16. During the May 2012 seismic events, the church experienced a PGA maximum value of 0.040g (Medicina recording station). After the survey, it was considered safe, but the maintenance poor (previous cracks, humidity due to rain). Tying enhancements of nave and tympanum have been suggested.

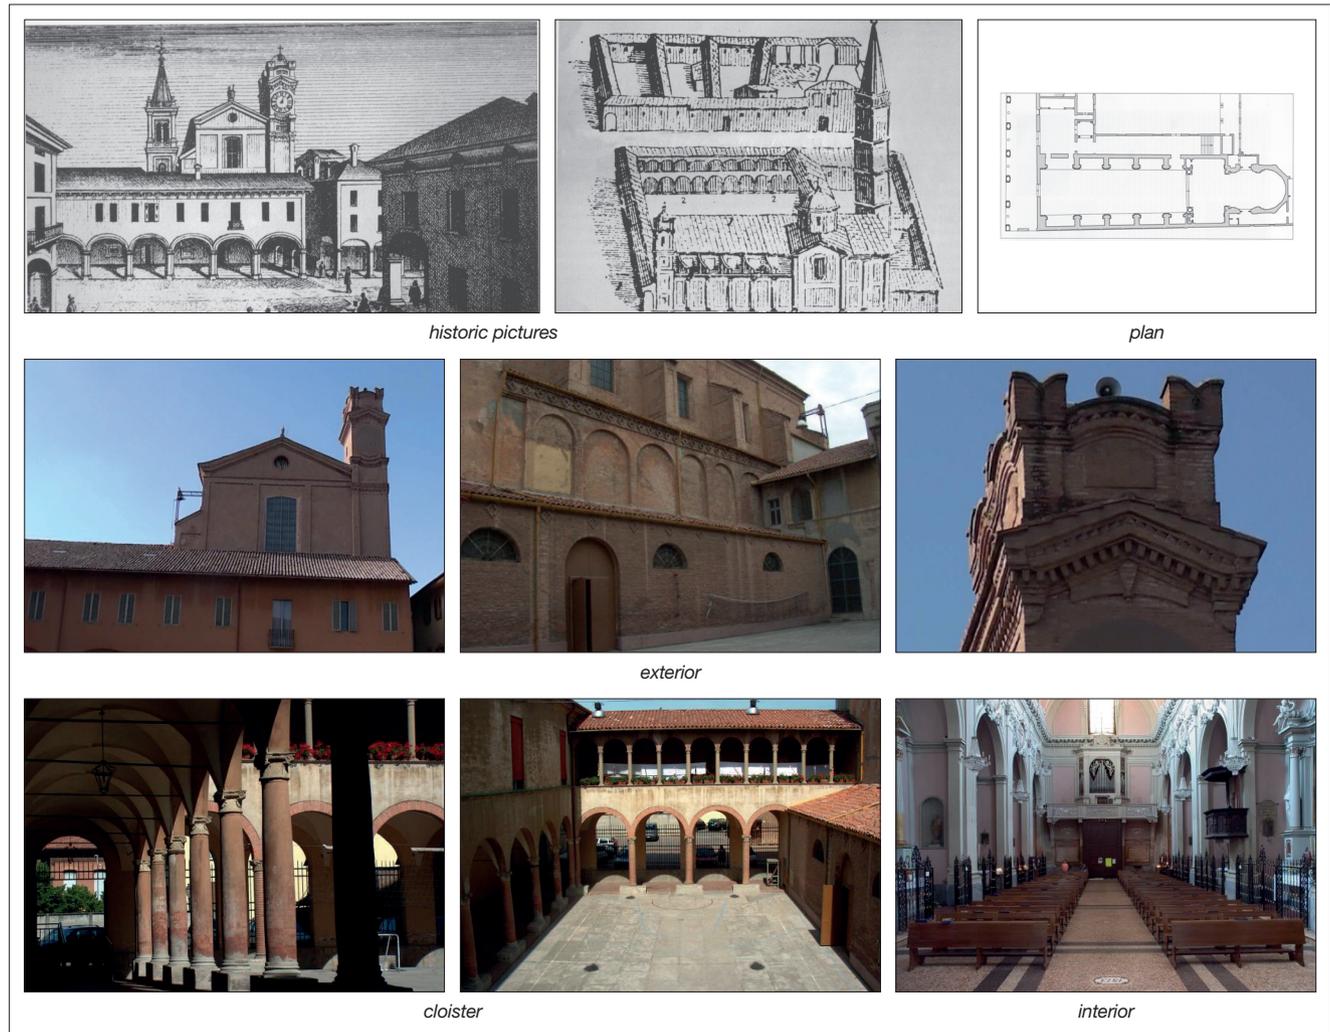
FIGURE 31 The Church of San Lorenzo (Budrio, Bologna)

Description - The Church of San Lorenzo (full brick masonry, see Fig. 31) is located in the historic centre of Budrio (Bologna), just in front of the Municipality Palace. Founded together with the convent between the XI and the XII century, it saw restorations and extensions after 1406, when the Friars Servants of St. Mary became the regents. Building modifications continued over time, and the final version took place in the XVII-XVIII centuries, when the church was com-

The current church showed external buttresses and transversal steel ties in the central nave arches. In good conditions of maintenance, it was declared unsafe after the last earthquake (shaken by a maximum PGA of 0.040g, Medicina recording station), and partially unsafe after our investigation.

Damage survey and observed mechanisms - The observed damage in the church was clear enough: in the dome, in the triumphal arches, in the central nave (vaults and colonnade); in the vaults of the lateral naves; in the apse vaults (Fig. 32). Probably, the construction moved with a longitudinal response, because steel ties were present only in the transversal direction. Many stucco pieces detached from the rich

decorations and were collected by the church personnel. The fresco of the dome was also injured. The main mechanisms are reported in Fig. 33, corresponding to a global damage index equal to 0.13. Together with an overall restoration of the harmed parts, a strengthening intervention is recommendable, in particular in the nave longitudinal direction, anticipated by an accurate dynamic characterization of the structure.
