# Earthquake tragedy and application of seismic isolation, energy dissipation and other seismic control systems to protect structures in China

90% of the Chinese territory is seismic. Earthquakes cause victims, but also damage to non-structural elements and inside facilities, stopping the city's life. New techniques, as base isolation and energy dissipation, protect both structures and inside facilities. In China there are many structures with seismic isolation or passive or hybrid control systems. Some recent application, experimental records of real earthquakes, shake table tests as well as future trends on seismic isolation and passive and active control technique in China and in the world are described

Fu Lin Zhou

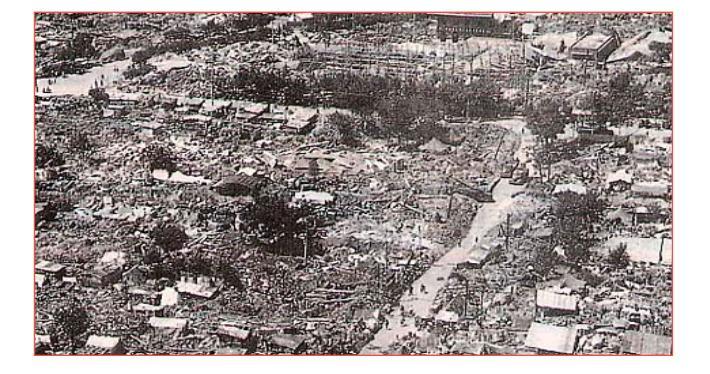
FIGURE 1 Tangshan city after the shock of 1976

A tragically strong earthquake, the Tangshan earthquake of magnitude M = 8.5, happened at 3:15 a.m. on July 26, 1976. The epicenter depth was only 13 km. The broken faults run through the city. The whole city became ruins, 240000 people died, 96% of buildings collapsed, including houses, schools, hospitals, office blocks, all buildings (Figures 1-3).

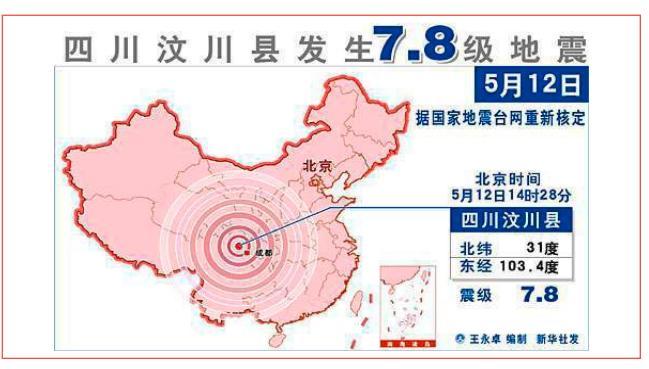
FIGURE 4 The Wenchuan earthquake in China

Another tragically strong earthquake, the Tangshan earthquake of magnitude M = 8.0, happened at 2:28 p.m. on May 12<sup>th</sup>, 2008. The epicenter depth was only 17 km. The broken faults run through the city. The whole city became ruins, 90000 people died, 80% of buildings collapsed (Figures 4-6).

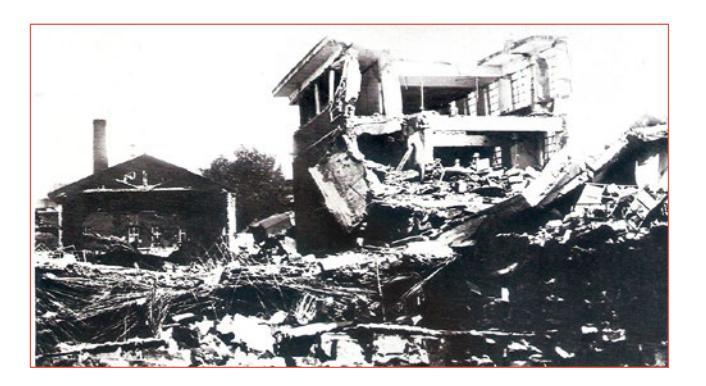
FIGURE 2 A school in Tangshan

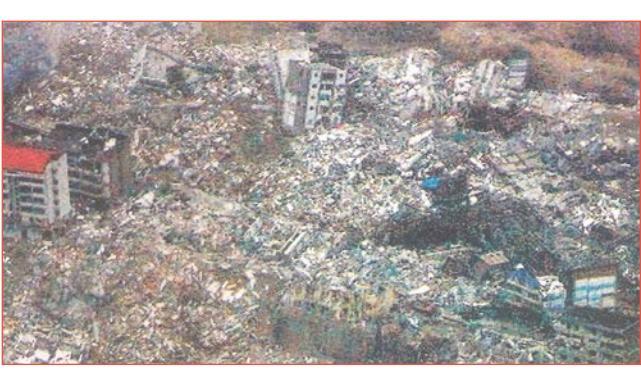
FIGURE 5 Most buildings collapsed in Wenchuan

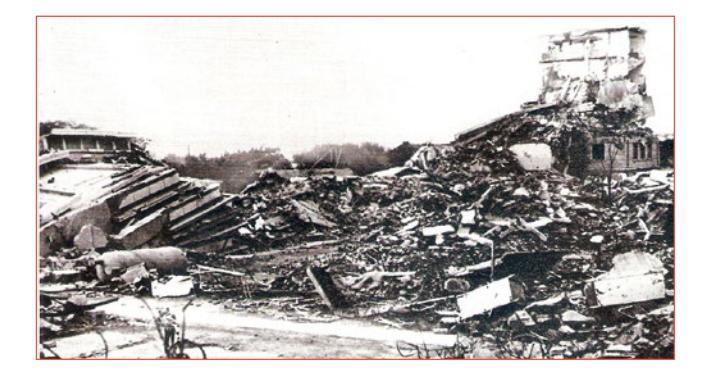
FIGURE 3 A hospital in Tangshan

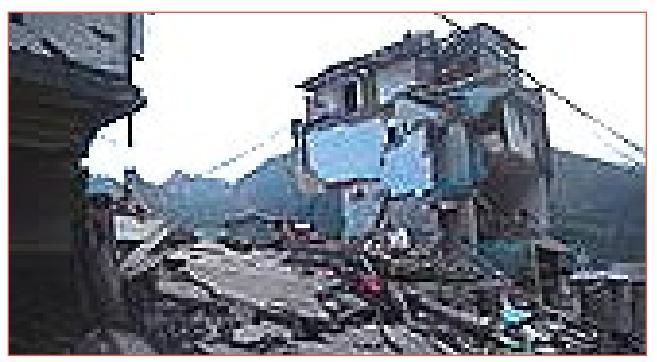
FIGURE 6 A school collapsed in Wenchuan

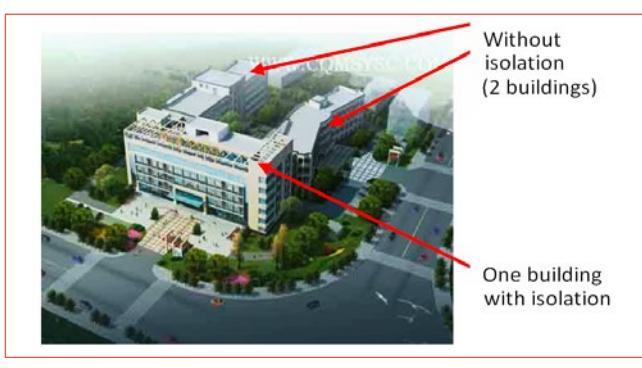
FIGURE 7 Damage of an office building during the Lu Shan earthquake

predicted design value. So it caused damage or collapse of 75% of buildings (about 40,000 buildings) in the Lu Shan County (Figures 7-9), let's say a standing ruin. 196 persons died, 21 were not found, 250000 were injured and the directness economy losses were 5.57 billion Yen.

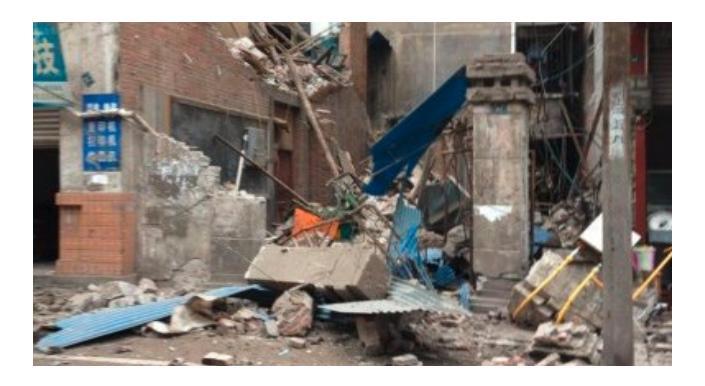
FIGURE 8 Collapse of a house building during the Lu Shan earthquake

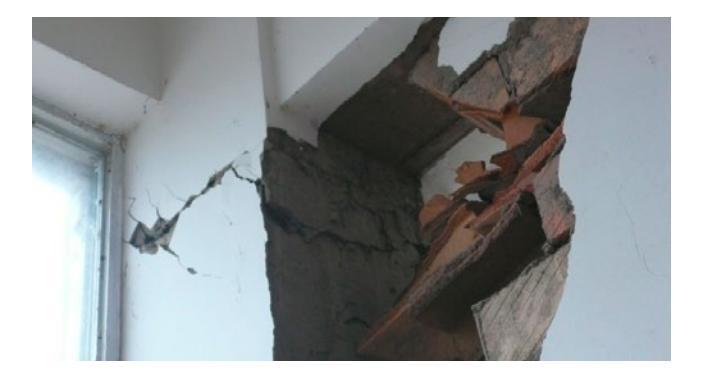
FIGURE 9 Structure damaged during the Lu Shan erathquake

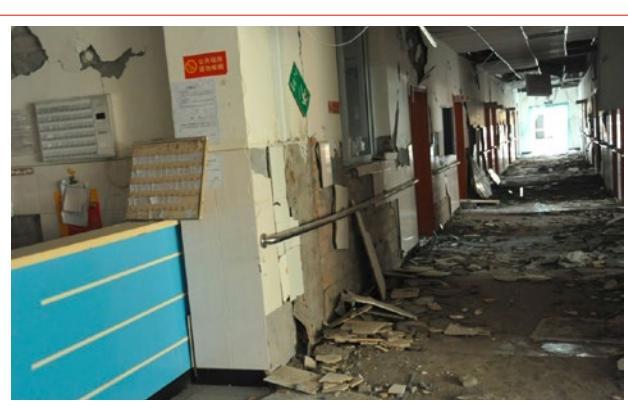
FIGURE 10 Lu Shan County Hospital, formed by 3 buildings

Actually, there were 3 buildings in the Lu Shan County Hospital; all were reinforced concrete structures with 7 storeys and 1 story basement (Figure 10). One building was seismically isolated and, as mentioned, did not suffer any damage to the structure and decoration, any fall down of the facilities and equipment that were installed inside it. The persons inside it had no panic during the earthquake, this Isolated hospital building become an unique rescue

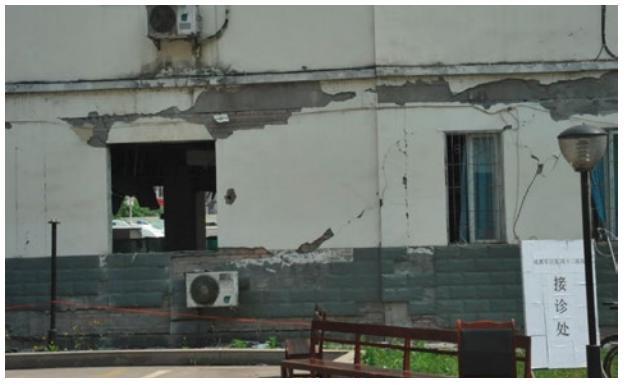
FIGURE 11 The two buildings without seismic isolation in the Lu Shan County Hospital

isolation: the persons inside them felt the shaking very severely, the buildings suffered damages in the structure, walls and ceilings, all facilities and equipment fell down and the hospital was fully out of service (Figure 11).

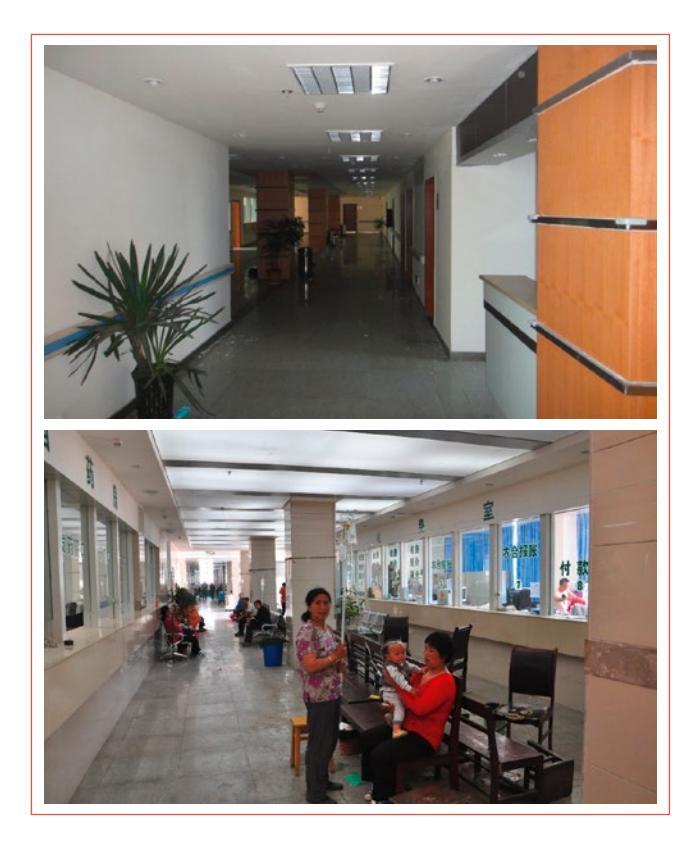
FIGURE 12 The building with seismic isolation in the Lu Shan County Hospital

center in the whole county after the earthquake, thousands of injured people received first aid in it (Figure 12). On the contrary, the other 2 hospital buildings had been built according to a traditional anti-seismic design without

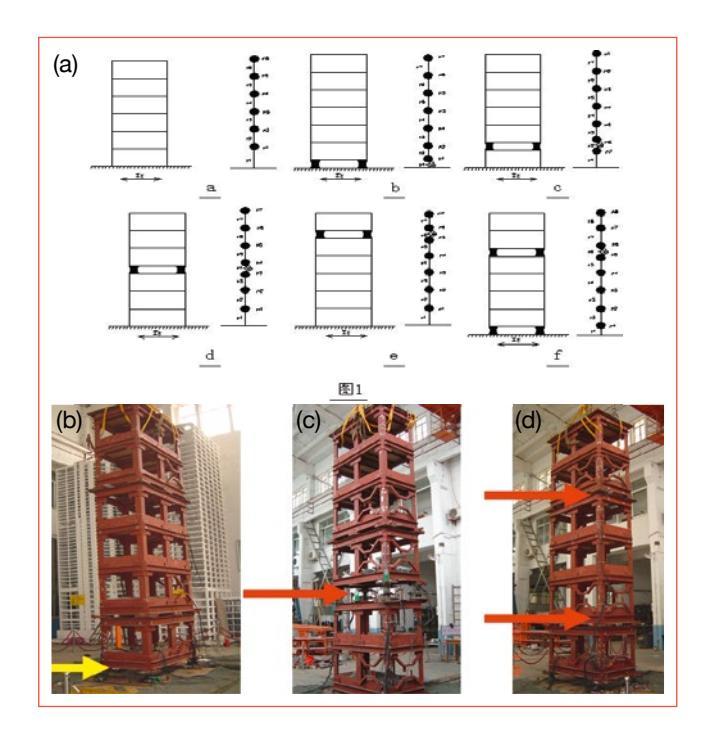
FIGURE 13 Shake table test for different locations of the isolation system. (a) Different locations of isolation system; (b) At the base; (c) On a storey; (d) Multi-layers

- tests on the mechanical characteristics of the isolator, which include compression tests (capacities, stiffness) and compression with shear cycle loading tests (stiffness, damping radio and maximum horizontal displacement);
- 2. tests on the durability of isolator, which include low cycle fatigue failure tests and creep and ozone aging tests;
- 3. tests on the structural system, which concern shaking table tests for large scale structural models. In particular, a 6-storey steel frame model with different locations of the isolation system was tested on shaking table (Figure 13): the test results show that the acceleration responses on each storey of the structural model are somewhat different, depending on the ratio between the super structure mass and that of the substructure (Huang, 2003).

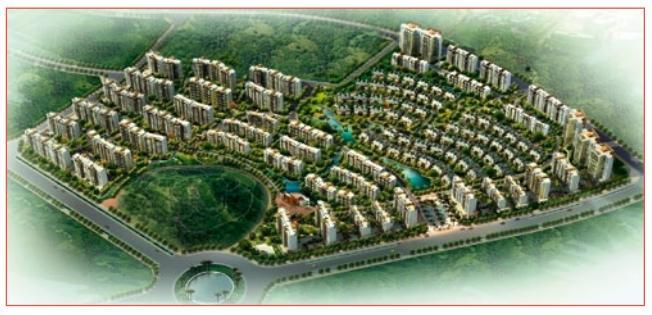
FIGURE 14 Group of 72 seismically isolated dwelling buildings including (4-16 storeys)

It consists of a group of seismically isolated houses including 72 buildings (4-16 storeys), with a total floor area of 210,000  $m^2$ , located in the Yunnan Province in Western China (Figure 14).

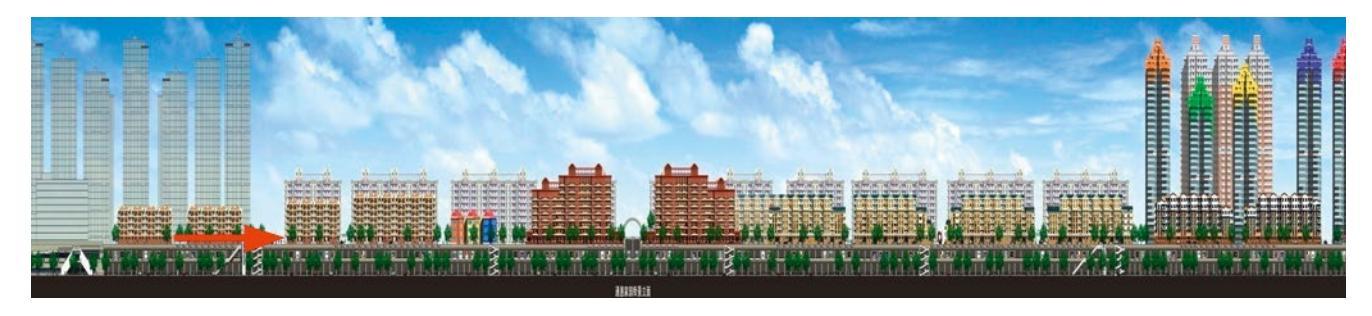
FIGURE 15 Group of 48 isolated buildings with storey isolation supported by an unique r.c. platform

It is the largest group of seismically isolated buildings in the world to have been erected on an unique slab (Figure 15). In fact, it consists in a very large platform (2-storey r.c. frame), 1500 m wide and 2000 m long, which covers a railway area in Beijing and supports 48 isolated buildings (7 to 9-storey buildings with r.c. frame) with a total floor area of 240,000 m<sup>2</sup>, built on its top floor. The isolators (rubber bearings) are located on the top floor of the platform to protect the buildings from both the seismic motion and the railway-induced vibrations.

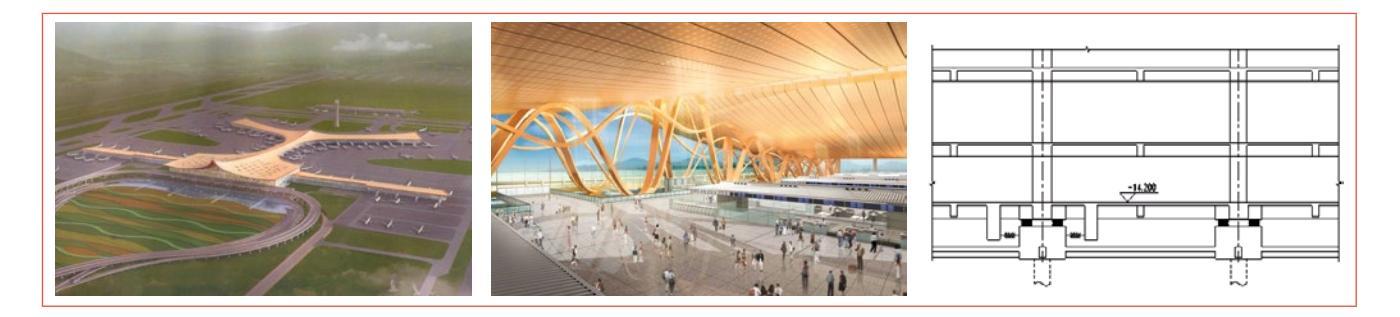
FIGURE 16 Seismic isolation of the Kunming New Airport Terminal (2007-2012)

The total floor area of this airport is  $500,000 \text{ m}^2$ . Because its location is near seismic faults (10 km), it was indispensable to protect the complex structure of the airport, its curved columns, large glasses and large ceiling, as well as the important inner facilities. The only way was to use seismic isolation (Figure 16). This project made use of 1892 rubber bearings (1,000 mm diameter) and 108 oil dampers to reduce the displacement of the isolated superstructure during earthquakes.

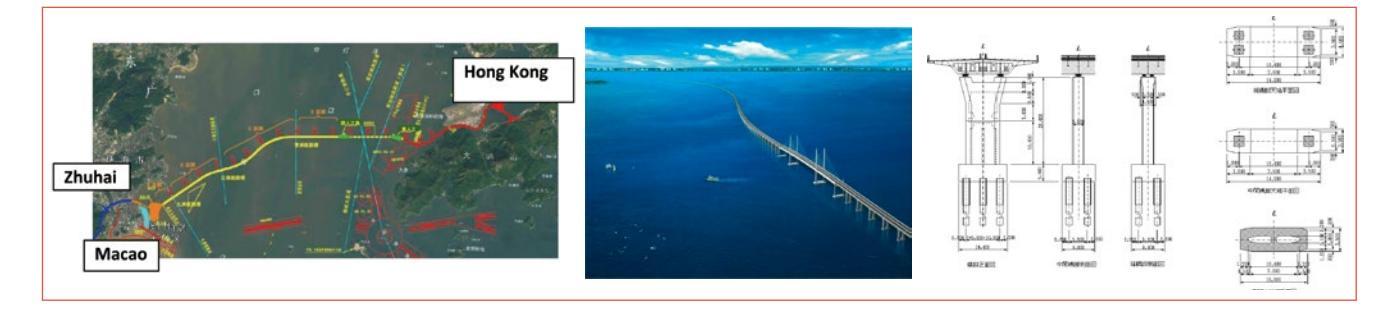
FIGURE 17 Seismically isolation bridge (Hong Kong-Macau-Zhuhai), 26 km long

For this bridge, which crosses the sea and is 26 km long (Figure 17), it was very important to reduce the seismic response of its structures, in particular to avoid damage and cracks at the bottom of the piers and to move the area with nonlinear behavior from the bottom of the piers to the isolators installed on their top. To achieve this, the use of seismic isolation was found necessary.

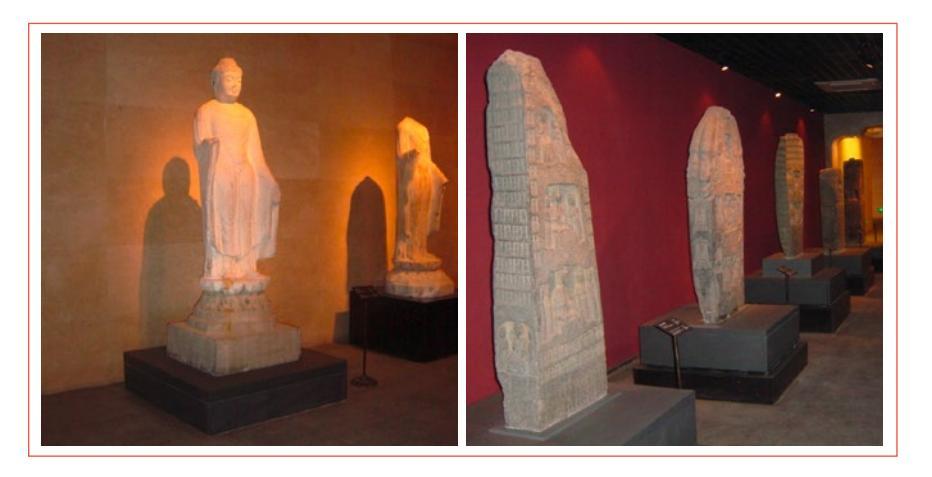
FIGURE 18 Protection of historic statues and stone tablets (1,200 years old) by means of seismic isolation in China

It is also important to protect from earthquakes the cultural heritage structures, the statues that are located inside them, paintings on their columns and walls: thus, we need to use seismic isolation to this purpose too (Figure 18).

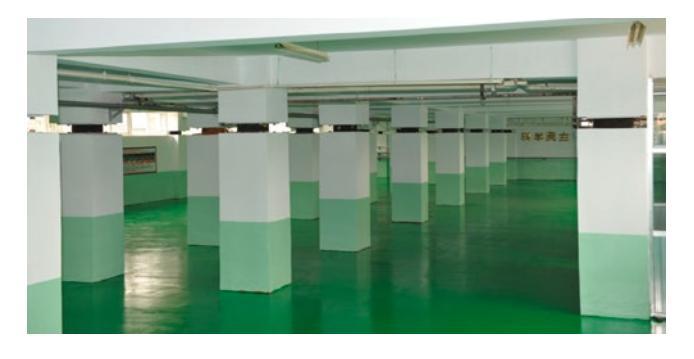
FIGURE 20 Isolation system installed in 1st storey of a retrofitted school

Millions of school buildings need to be retrofitted to withstand strong earthquake. In China, in the Shanxi Province, seismic isolation was successfully used to retrofit school buildings (Figures 19 and 20). As a consequence, the Government organized a national meeting to promote the extensions of this kind of retrofits to Chinese schools.

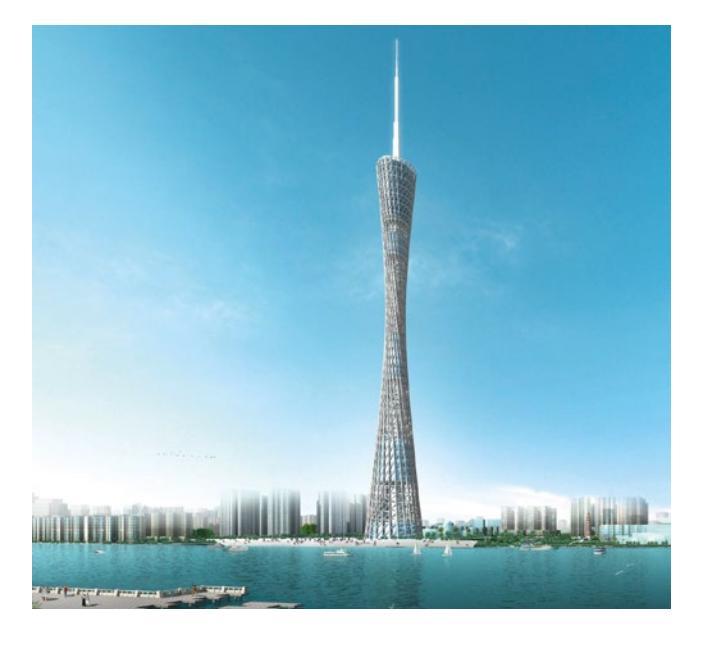
Actuator Spring Spring AMD Damper TMD Building

FIGURE 23 Hybrid control system (Tuned Mass Damper + Active Mass Damper)

Mass Damper (TMD) was a low cost solution, but the design requirements were not satisfied: Active Mass Damper (AMD) is an effective, but its use was too expensive;

A combination of TMD and AMD, namely a hybrid system (on the top of tower), may be the best balance solution.

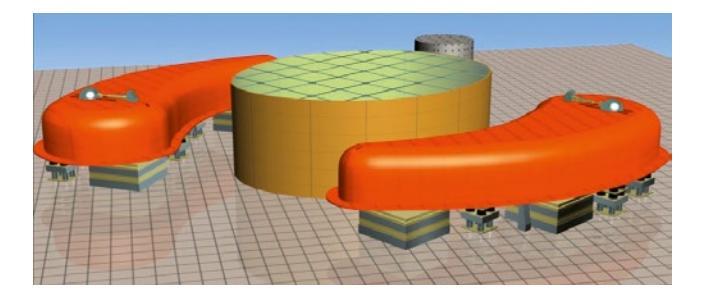
FIGURE 22 Use of 2 water tanks as mass of the Tuned Mass Damper
